Hovel 1 – Cleeve Prior

MARKET GARDENING HERITAGE PROJECT

BUILDING RECORDING SHEET

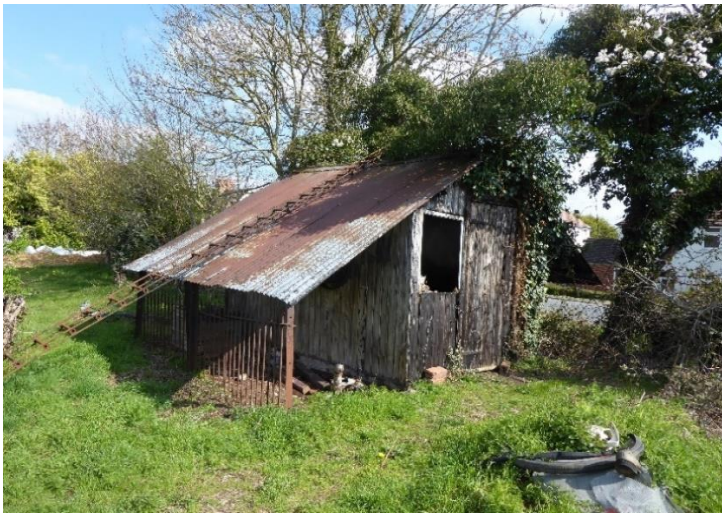
South and west sides

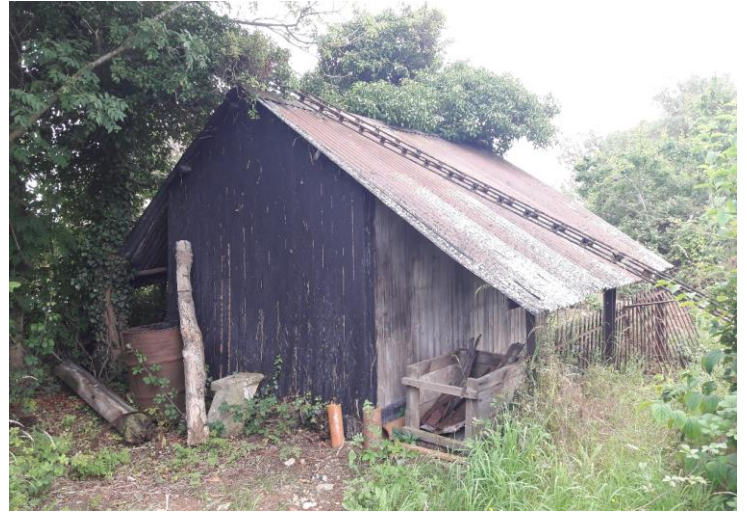
North and west sides

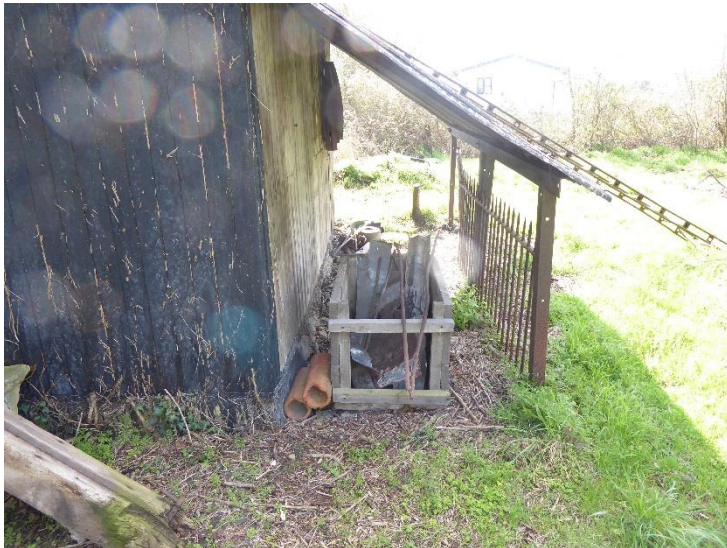
Lean-to on west side

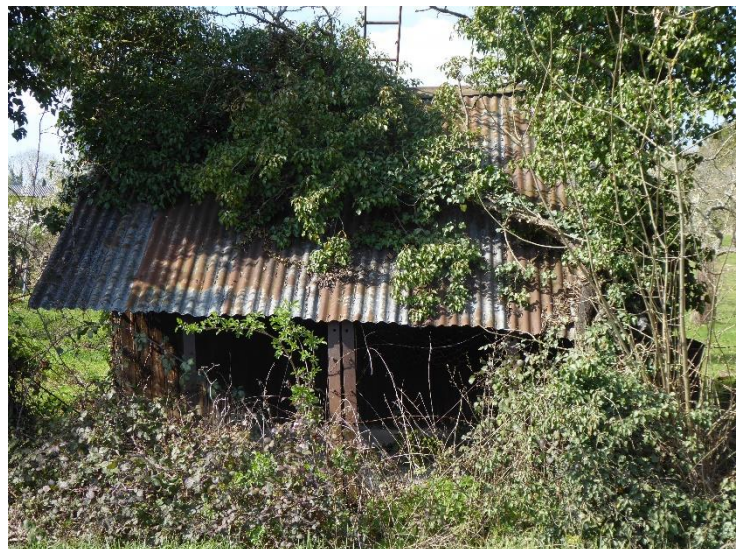
East side

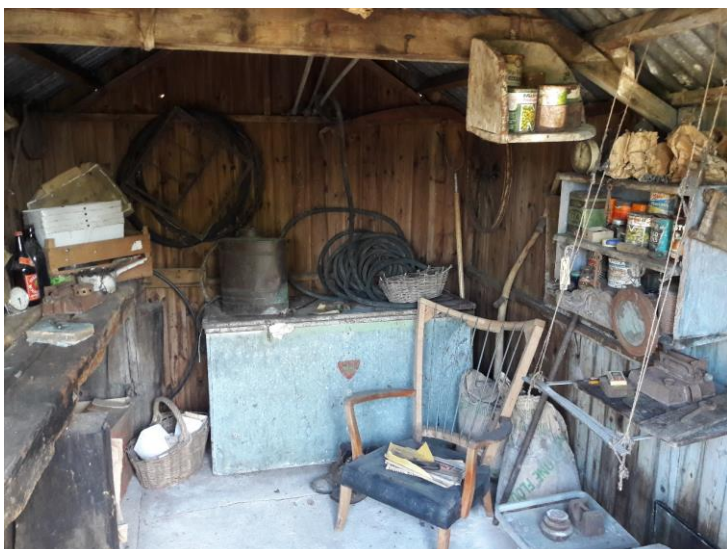
Inside hovel - workbench on left, metal storage box at back and shelves to right

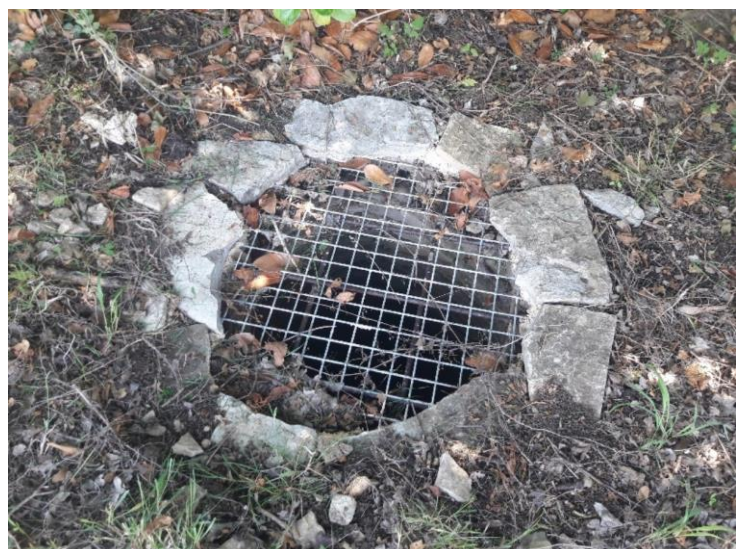
Well to north of hovel

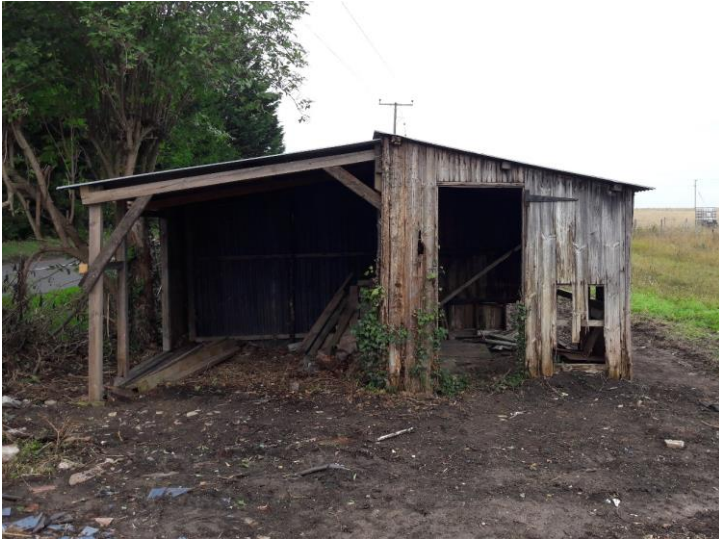
East side

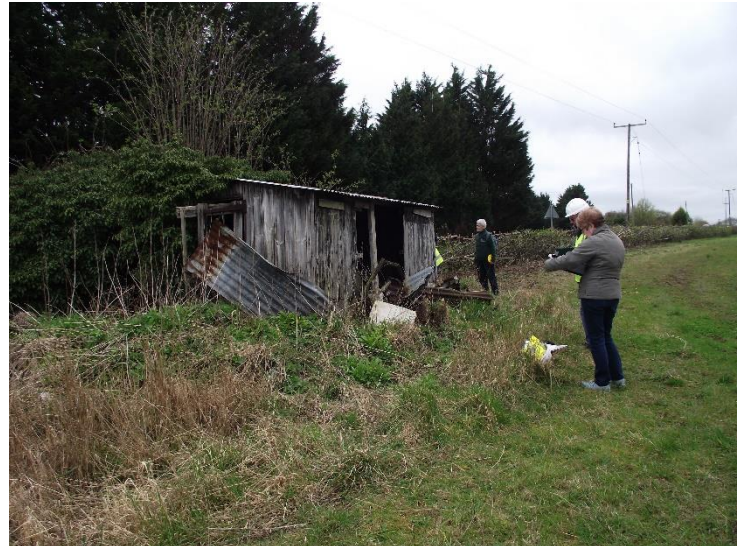
East and north sides

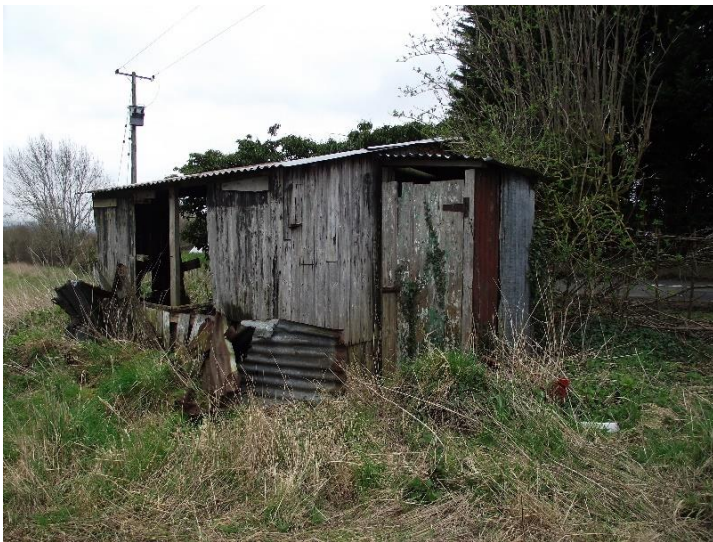
North and west sides

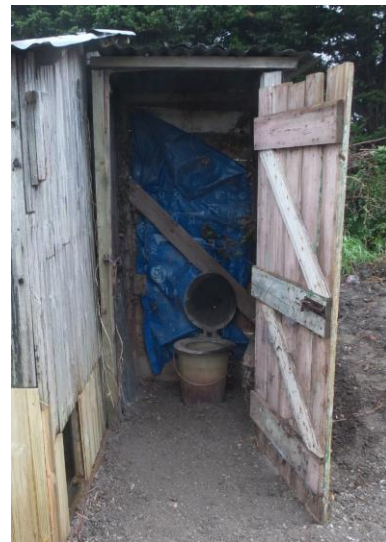
Toilet

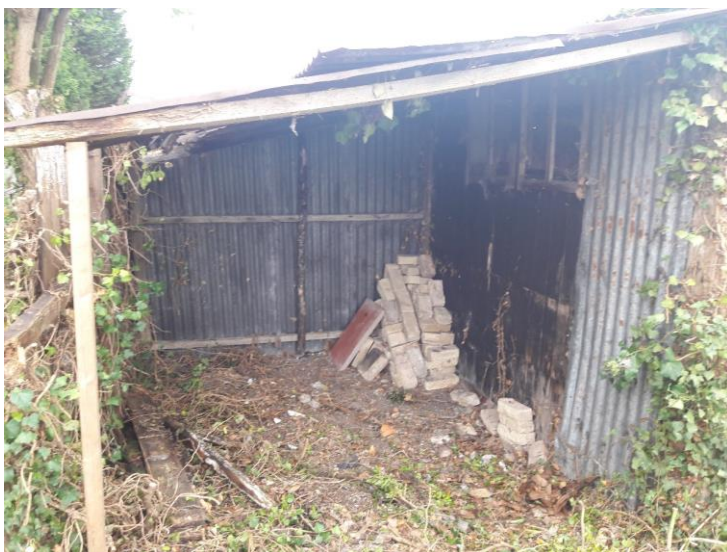
Inside the lean-to

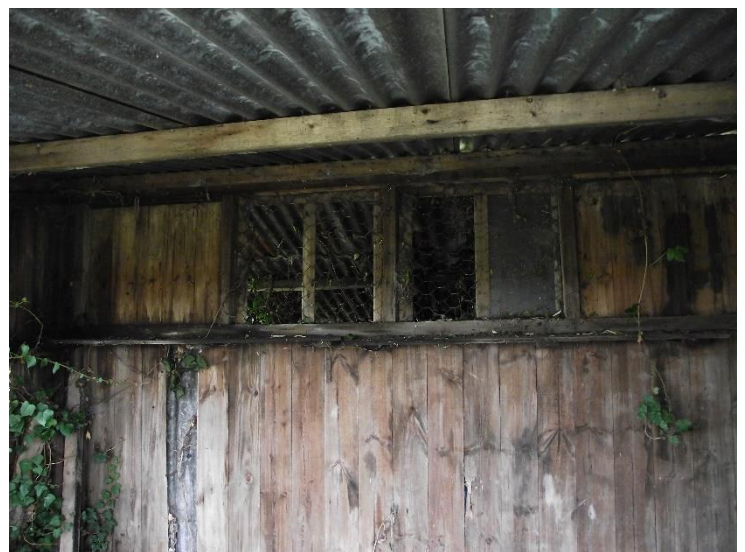
Mesh windows between the lean-to and main room

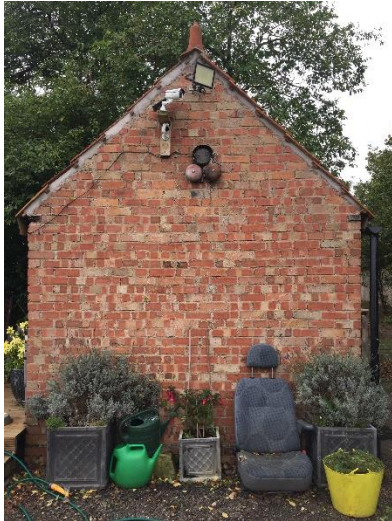
East side

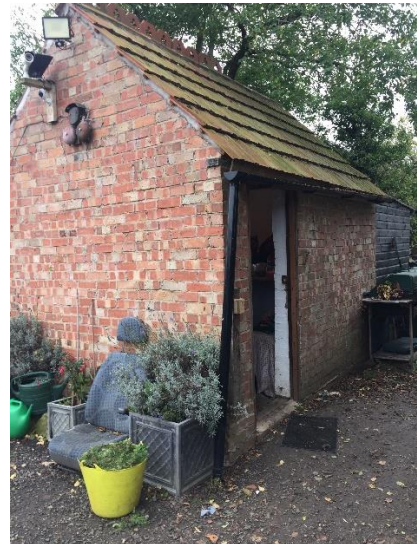
West and north sides

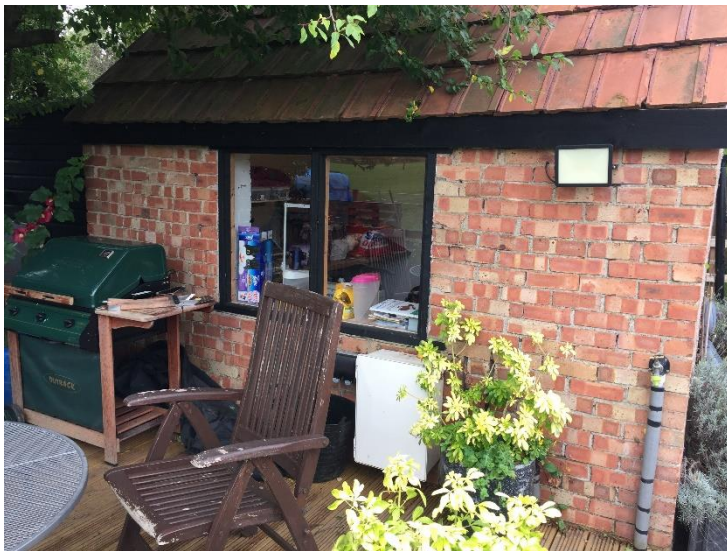
South side

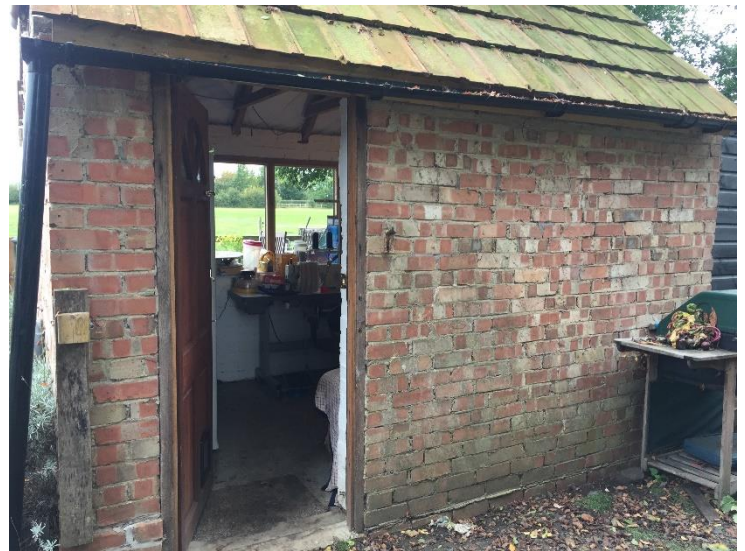
North side

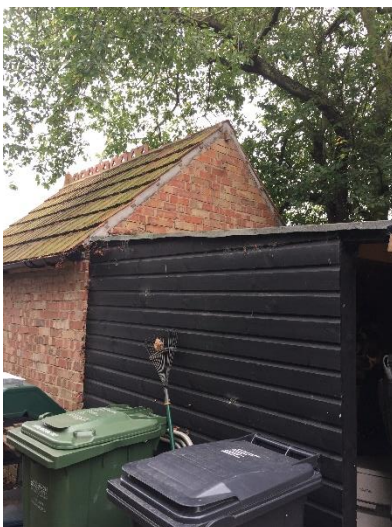
Wooden lean-to on west side

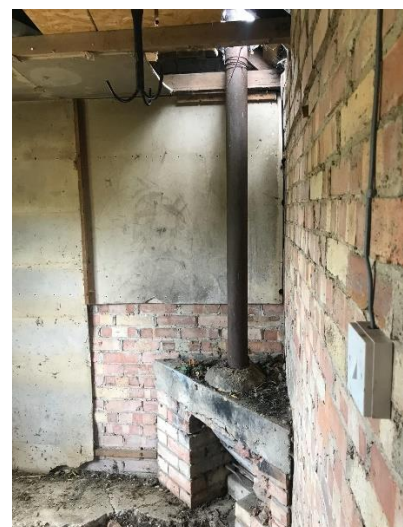
Fireplace and chimney pipe inside hovel

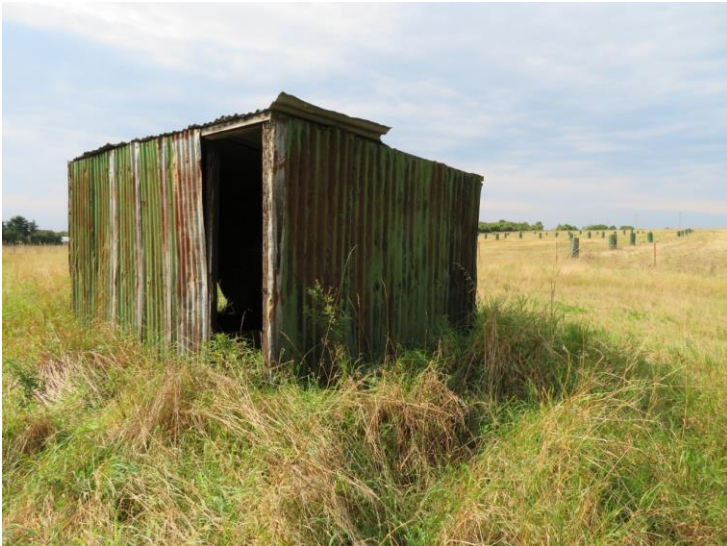
Small, corrugated tin hovel (door missing)
