Market Gardenhovels of the Vale of Evesham, Worcestershire

MARKET GARDENING HERITAGE PROJECT: 2021

WRITTEN BY NINA O'HARE, PROJECT OFFICER AND GILL PAWSON, VOLUNTEER

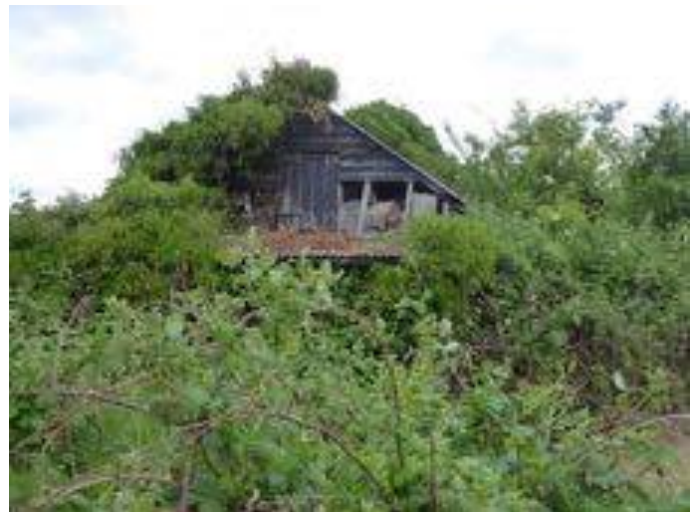
Photo 10: Overgrown hovel

Most extant hovels are also in a state of decay, often covered or surrounded by brambles, ivy and other dense vegetation. A few hovels do continue to be used, often for storage, but the vast majority appear to have been abandoned.

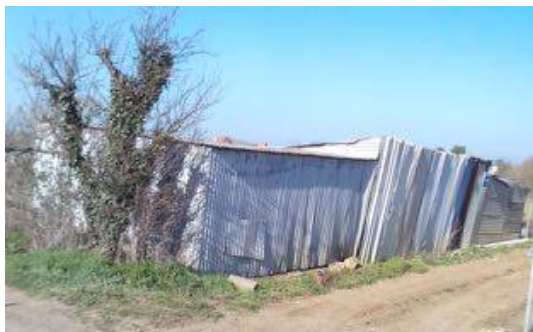
WSM 71074 Series of joined hovels

The surviving hovels demonstrate a diversity of construction and size. Small, medium and large, the large ones either extended or built as a series of separate but adjoining hovels. Mostly mono-pitched roofs, but a few with pitched roofs. Usually timber framed structures, clad with corrugated iron, although a few clad in timber. A few more solid structures have block walls. One surviving hovel comprises an old van (railway?) with sliding doors on the side adjoining a larger conventional structure; produce trays still inside. About half of the surviving hovels appear to be in some modern, storage use; for example, one contains bales of hay. The other half are probably unused as they are in varying degrees of deterioration, with brambles, ivy and other vegetation beginning to take over.

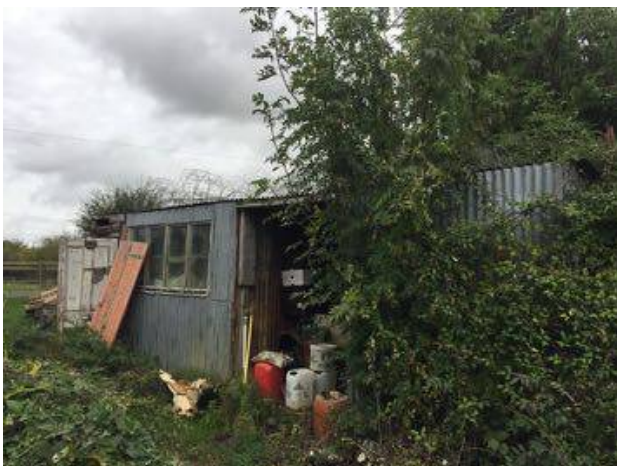
WSM 71080 West elevation

The surviving hovels are mostly small, with a mono-pitch roof, constructed of timber with corrugated sheet cladding. Some have timber cladding to the walls. Two brick hovels remain, one of which has recently been converted into an office. It is a small rectangular building with a pitched roof. A number contain a collection of contents, indicating recent or current use, although most are in very poor condition. One small brick hovel has been maintained in good condition and is now used as a shop for the selling of asparagus. One surviving hovel is constructed of concrete blocks, which is unusual. Other than the brick hovels, the remaining ones all have varying degrees of vegetation growth alongside or encroaching on the structure, which is likely in due course to lead to the collapse of the structure. Surveyors found one hovel with a well and one with a water pump; water was a definite asset if it was available; most hovels had no obvious source of water.

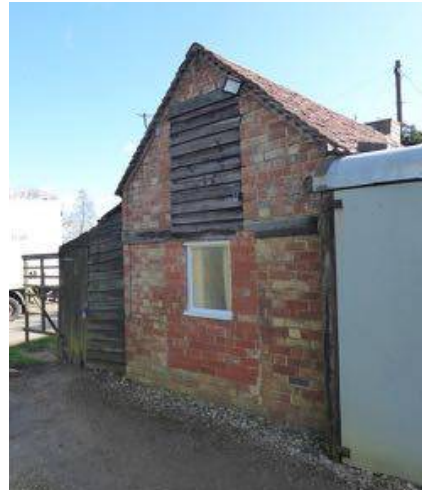
WSM 71410 Hovel used for selling asparagus
(Gill & Ken Pawson)

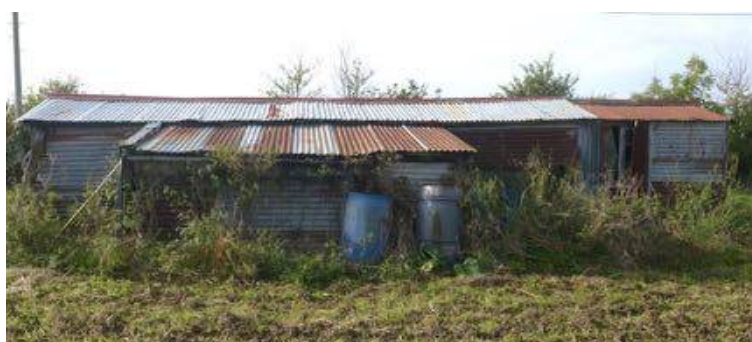
WSM 72841 North elevation with extension

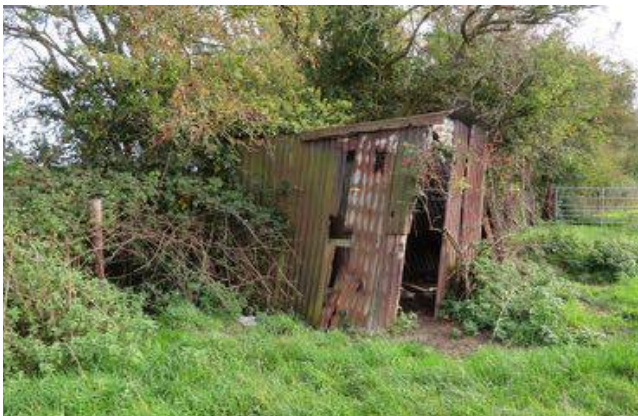
WSM 73504 North West elevation
(Terry Woodfield)

The two remaining hovels are of basic construction; timber frame, with mono-pitch roofs of corrugated sheeting and walls of corrugated sheets or timber panels. Both are overgrown with brambles and partially collapsed making it very difficult to identify size.

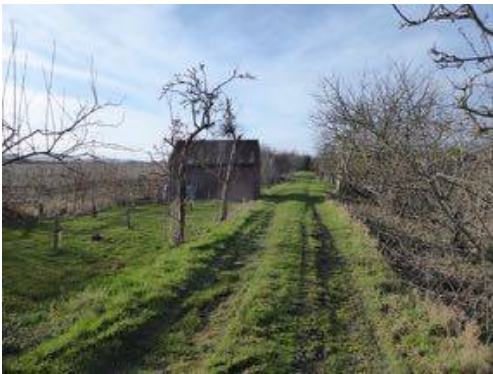
WSM 72550 East elevation

The recorded hovels are aligned along the length of the parish; three south of the B4084, four north of the B4084 and one close to the village. The hovel near the village is unusually large, comprising three 3m wide bays and it has a water tank alongside. All are timber framed with corrugated sheeting roofs. Other than the large one which has walling of timber plants and panels, the others have walls covered with corrugated sheeting. Two hovels have pitched roofs, otherwise the roofs are mono-pitched. Five of the 8 surviving hovels are in good condition and appear to be in use.

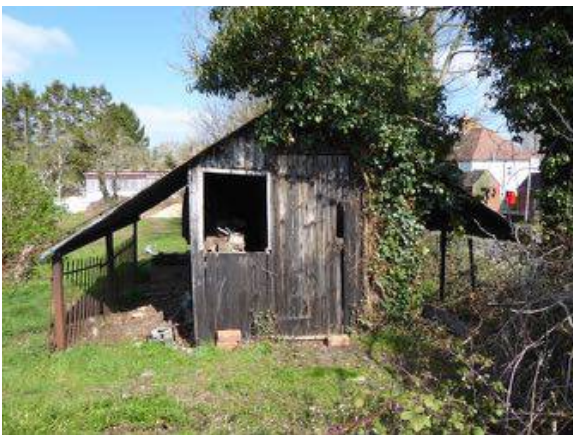
WSM 71124 Before restoration

The parish contains one of the three hovels that are being restored by the project, but it is the most significant of all hovels surveyed. Not only is it largely intact structurally, when found, it contained a large collection of items that had been used by the owner; a veritable time capsule. The full story can be found on the project website <http://www.cleevepriorchroniclers.com/wp-content/uploads/2021/04/230-Edit-Vale-Hovels-Market-Gardening-Heritage-NO-ADS-SMALL-1.pdf>. And information about visiting the restored hovel can be found online: www.explorethepast.co.uk/project/market-gardening-heritage.

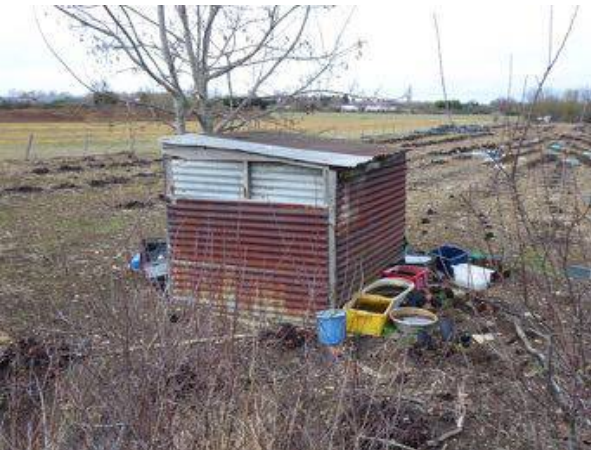
Still in use at a rhubarb field
WSM 71421 East elevation

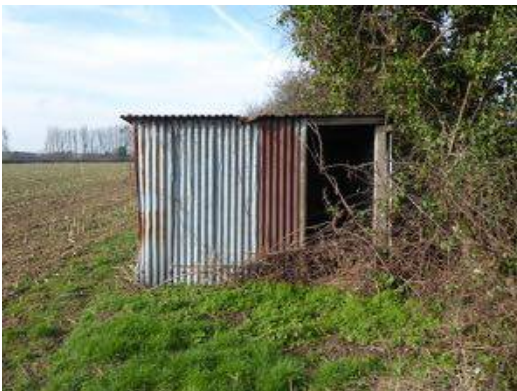
WSM 72548 East elevation
(Ken & Gill Pawson)

A single hovel was found south of the Evesham to Pershore Road, on Smokey Lane. It is the best-preserved building within the parish, being constructed of brick, with a pitched roof. It has been well maintained and retains its old water boiler in one corner. The building appears to be used for storage. Apparently, it was lived in by a German ex-prisoner of war after the war, as he did not wish to return to Germany. He worked on the associated land.

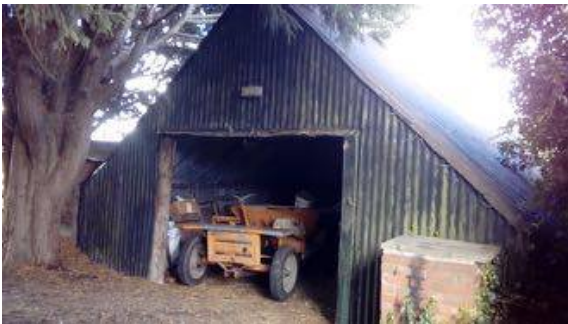
WSM 73455 South West elevation

The one extant hovel is situated in what is now a garden of a house, but on an allotment/market garden sized plot. It is large, with a pitched roof extending down to a height of about 1m at the sides. It is covered with corrugated sheeting. It is used for storage. The two ruined hovels are overgrown with vegetation, but the structure remains visible. One is a small unit, clad in timber and sheeting with a mono-pitched roof and the other one is small but with a pitched roof, also of corrugated sheeting.

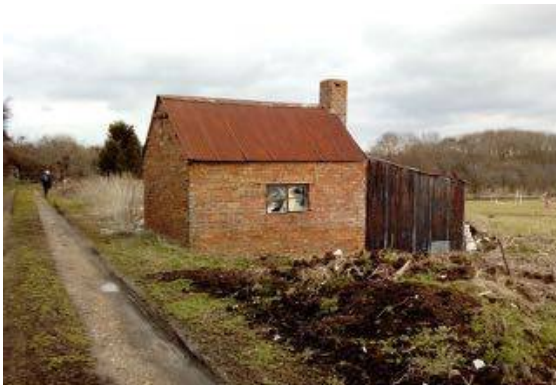
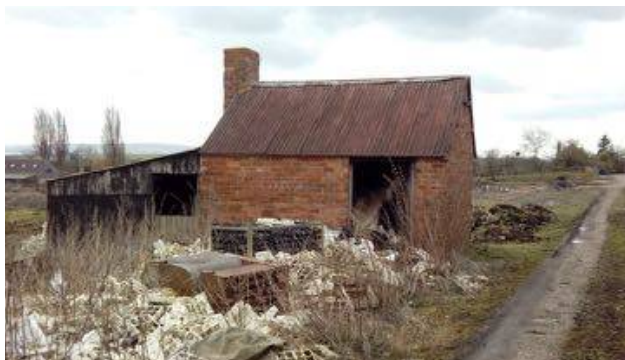
WSM 71093 South West Elevation
(Terry Woodfield & Jane Mason)

There is a wide variety of styles of construction in the few extant hovels. Those best preserved are generally built of brick, with tiled roofs. A few surviving hovels are two-storey, but most are single-storey. The most common building type is of timber frame, with corrugated sheet cladding, on the walls and roof. Most of the

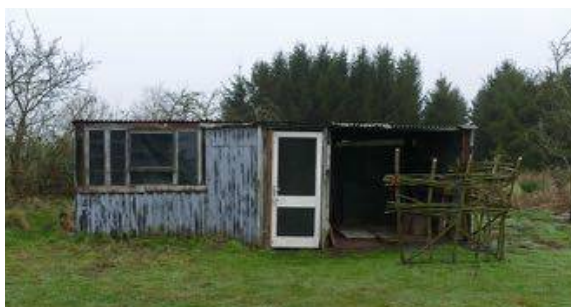
WSM 72533 East Elevation

The two extant hovels are both small, single-storied, with a timber frame and corrugated sheeting cladding.

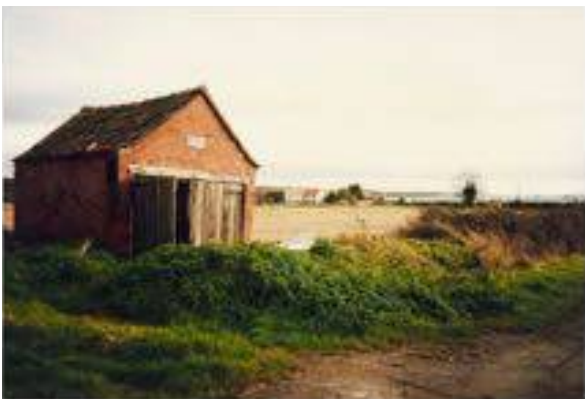
The now demolished hovel of which a photograph survives was also typical of hovels, but of the more solid, permanent type. It was single-storey, brick built with a pitched, tiled roof. It had a timber lean-to on the side, which may have been for a toilet. It was demolished to make way for the Norton-Lenchwick by-pass, which was opened in 1995.

Photograph from Anchor Lane, looking towards Longlands (c. late 1980's – early 1990s). Demolished during the construction of the Norton – Lenchwick Bypass, which opened in 1995.

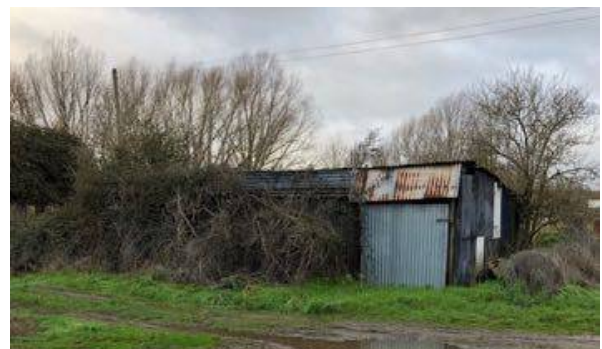
WSM 71100

Only one hovel survives in the parish. It is typical of the hovels associated with market gardening, being single storey and clad with corrugated sheeting. It is however large and this is probably the reason that it has survived, as it is of a sufficient size to make it useful for storage in connection with commercial scale farming. It is however partly overgrown with bramble and other vegetation, indicating that it is not being maintained today as a useful structure on the farm.

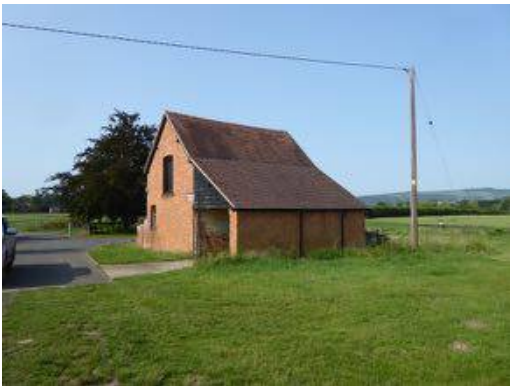
WSM 73079 North-East elevation

The other extant hovels are of timber framed construction with corrugated cladding. They vary in size and are largely overgrown with vegetation.

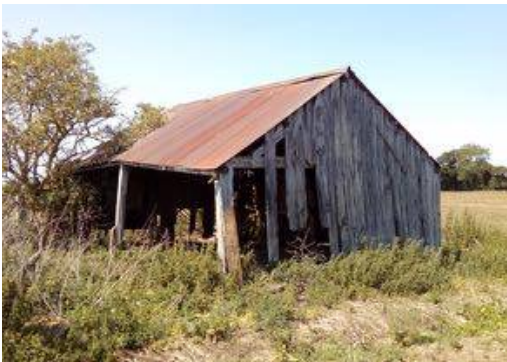
WSM 73301 South East Elevation

None of the surviving hovels remain in use. All of the surviving hovels were simple structures; timber-framed with corrugated sheeting or timber planking cladding and are now overgrown to some extent.

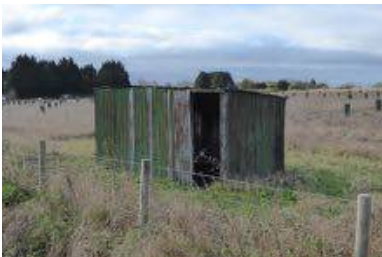
WSM 71126 Northeast elevation
(all photos - Gill and Ken Pawson)

The extant hovels are generally in a good condition and of a range of sizes, from small to large. Of the latter, these were sub-divided into separate sections, or they were built in stages, with extra sections added as necessary. Three of the hovels have evidence of separate toilet rooms attached. No brick buildings were found.

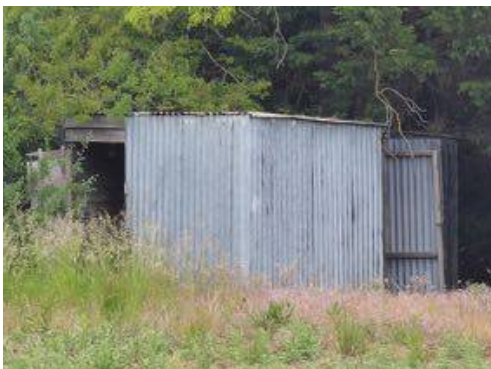
WSM 73078 South East Elevation
(Ken & Gill Pawson)

Of the surviving hovels, two appear to still be in use for storage. The other 5 are either ruined or in a very poor condition, either with cladding missing or overgrown.

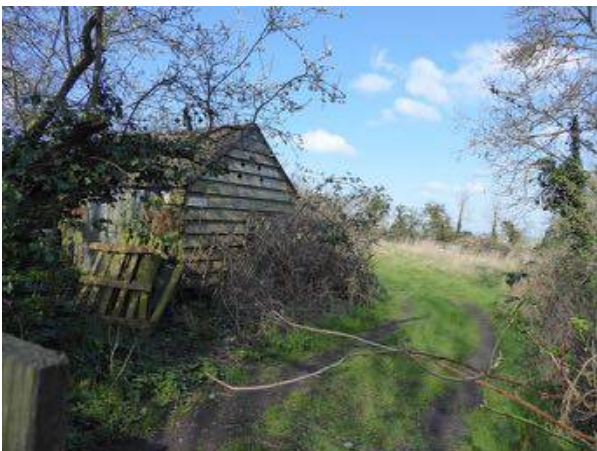
WSM 73533 South East corner
(Ken & Gill Pawson)

The extant hovels are of simple design. One is single storey, clad with corrugated sheeting on a timber frame and the neighbouring one is larger, double height, clad in a mixture of timber boards and corrugated sheeting. Openings are not obvious, due to overgrowth with vegetation and as a result of limited visibility from the public footpath from which the survey was conducted. They are accompanied on the site by 2 old static caravans, so it is possible that the site and its structures are still in some use.

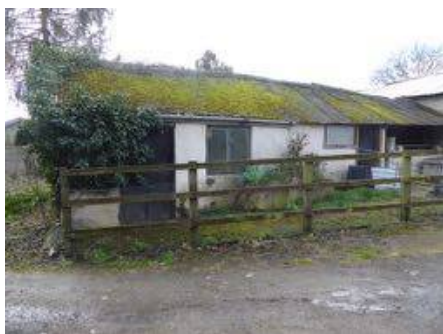
WSM 72665 North Elevation

One of the extant hovels is of unusual construction, comprising rendered stone walls with a timber and corrugated sheeting roof. It is largely intact, although becoming overgrown with ivy. Its internal partitions remain, but it appears not to be in current use. The other extant hovel is of standard timber framed construction, single storey, clad with corrugated sheeting. It is not obviously in use. The third surviving hovel is now completely overgrown and largely collapsed.

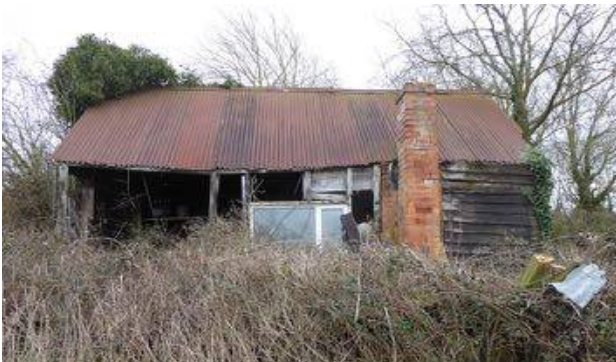
WSM 77465 West Elevation

The two surviving hovels are both located close to a village road, on the north side of the village. Both are on land shown as orchards on the 1884 and 1905 OS maps, so are the exceptions to the local situation. Both are large, by hovel standards, being equivalent to about 3 times the area of the small hovels in the core market gardening area. One has a pitched roof, with a brick chimney, the other has a mono-pitch roof. Both are constructed of timber, mostly with timber cladding and corrugated sheet roofs. Both are partially overgrown, but are still intact and one is used for storage.

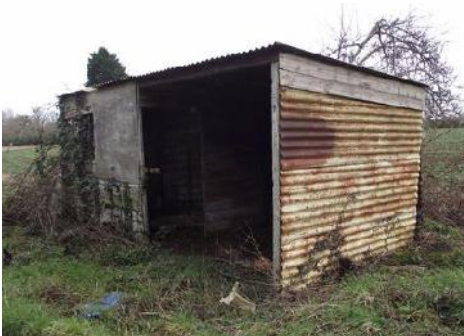
WSM 71120 North and West Elevations

Three of the surviving hovels are located close to the present village edge, but these were only recorded during the walkover survey. They are located on an area shown on the 1921 map as in allotment use. It is possible that these have survived because they have been put to a modern use such as storage in association with a nearby property. The other surviving hovels are located either close to the parish boundary, as in the north and west or near a parish road. All of the surviving hovels are of small or modest size, generally with a mono-pitch roof. All are constructed of timber and corrugated sheets in varying proportions. None have any features of particular interest. Where it was possible to look inside, it appears that some of the hovels are still being used and thus have been retained in a usable condition.
