Hovels Survey Summary

AN OVERVIEW OF MARKET GARDEN HOVELS
IN THE VALE OF EVESHAM

MARKET GARDENING HERITAGE PROJECT
2021

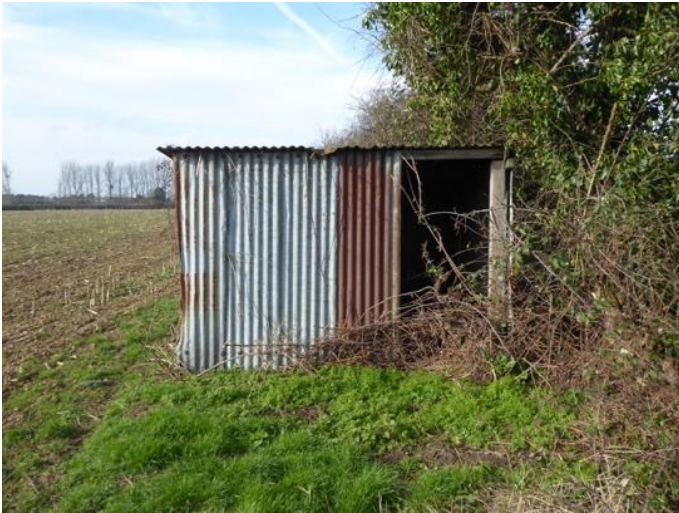
Photo 1: Basic design

The most common building type is a timber frame, with corrugated metal sheets on the walls and roof. A mix of corrugated metal and wooden cladding is also frequently seen. The basic design is a rectangular structure with a single door and window, often on the same elevation, with the other three elevations fully clad. The roof is often mono-pitch, higher over the door and sloping slightly to the rear. The inability to survey inside hovels meant that there is a limited record of the interiors. However, where visible, the floor is typically compacted earth and most did not contain any internal features, although shelves and a work bench are the most common fixtures encountered.

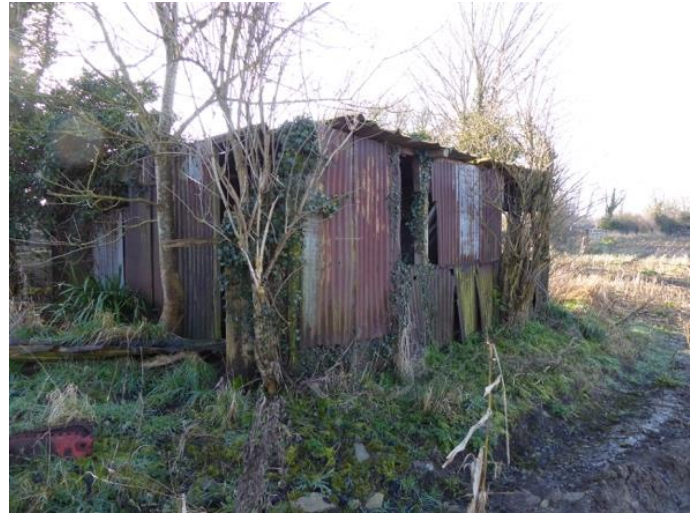
Photo 2: Extended version

There is a wide variety of construction styles seen in the few extant hovels. These buildings are as varied as the individuals who built and used them, as they were typically built with whatever materials were to hand and to meet the grower's own purposes. In many cases, it appears that the hovel started off small, but as the needs of the owner changed extensions were added until the structure became quite large. Photographs of various types and conditions of hovels are shown below.

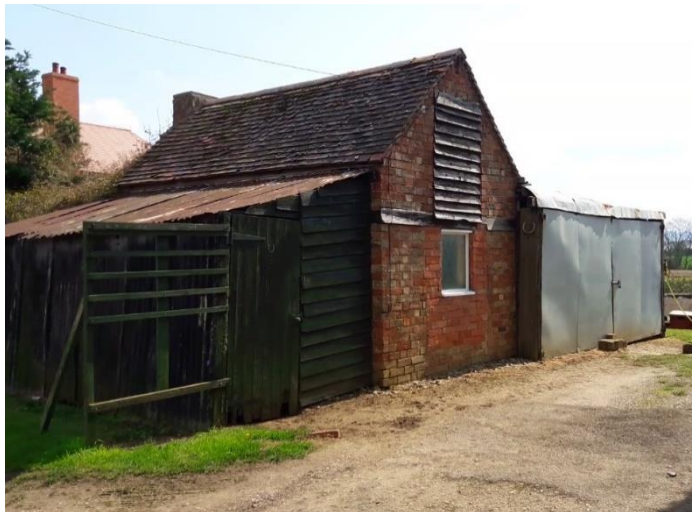
Photo 4: Brick construction with additional lean-tos

Those best preserved are generally built of brick with tiled roofs and are sometimes two-storeys high. A few still have evidence of a brick chimney and are likely to have been used as accommodation for seasonal or temporary workers.

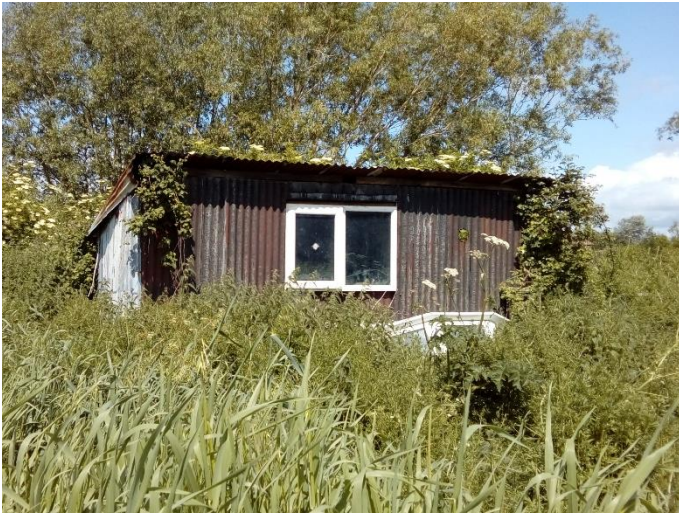
Photo 7: Extant hovel

Extant	Building walls and roof intact: does not have to be used for original purpose
Ruined	Substantial remains of building visible above ground, but walls and roof not intact
Demolished	Site of building visible, but only low walls or floor surviving
Absent	No evidence of building above ground

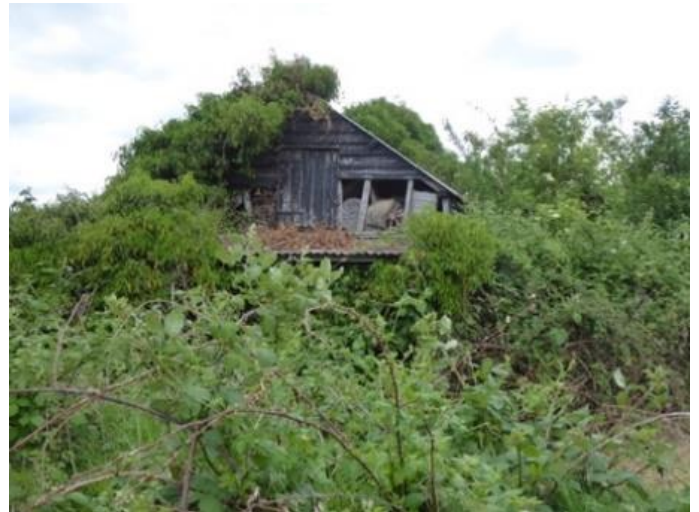
Photo 10: Overgrown hovel

Most extant hovels are also in a state of decay, often covered or surrounded by brambles, ivy and other dense vegetation. A few hovels do continue to be used, often for storage, but the vast majority appear to have been abandoned.
