Worcestershire Archaeology Research Report No.12

Historic Building Non-technical Record Report

THE FORMER WORCESTER ROYAL INFIRMARY, CASTLE STREET, WORCESTER

Part 1: Report, Appendices 1–3, Figures

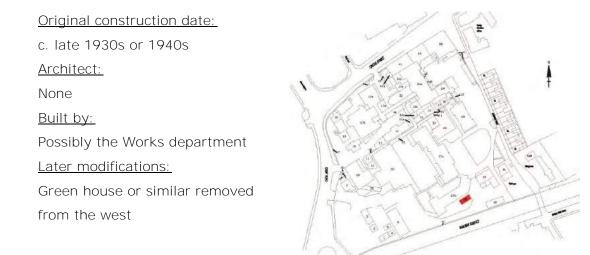
Stores (Building 28)

5.202 Building 28 formed a single storey concrete framed brick and blockwork shed with infill panels of ventilation tile and had a pitched roof covered with corrugated mineral board (Plate 28.1). The western end of the building was painted white suggesting it had previously been abutted by another structure, possibly a greenhouse (Plate 28.2). Internally, the building contained two rows of concrete bicycle holders taking the form of concrete flags with diagonal grooves in each (Plate 28.3). Consequently the structure was interpreted as a cycle garage.

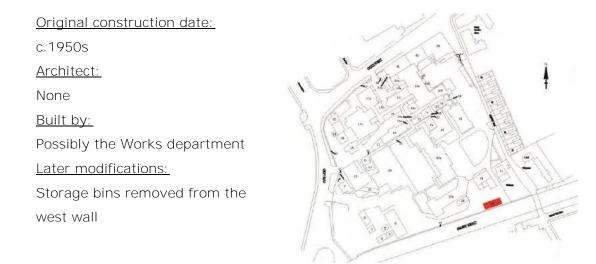
Garage (Building 29)

5.203 This building was built as a garage to the south of Building 30 and in the shadow of the railway viaduct (Building 47). It comprised a single storey brick shed with monopitch roof of steel trusses held on a steel beam with intermediate support (Plates 29.1 – 29.3). The lower part of the west wall was rendered and it is likely that a series of hoppers had been removed from this side, used for storing bulk materials such as road grit, sand and gravel etc. The structure dates to the 1950s as attested to by the light switches on the wall and was of no architectural or historic merit.

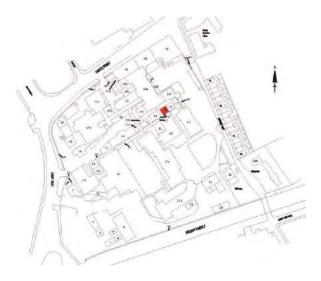
Cleaners Stores and Office (Building 35)

Original construction date:Late 19th centuryArchitect:UnknownBuilt by:UnknownLater modifications:Late 20th century internalrefurbishment (and change of usefrom a possibly domestic function)

- 5.268 This building lies immediately to the east of the corridor to the staff dining room and was formed of two parts (Plate 35.1). The western part (Plate 35.2) was of brick, laid in Flemish bond, and had a flat roof with a wide entrance set to the right of centre in the northern facade, formed beneath a concrete lintel and containing double timber doors. A sign on the left hand door identified this as the Team Cleaners Store. The flat roof was covered in asphalt and featured a square roof lantern fitted with Georgian wired glass (Plate 35.3). To the left of this was a larger brick range with a pitched plain tile covered roof (Plate 35.4) which had a hip at the rear and pedestrian door set centrally in the northern gable. Both buildings were set against the former boundary wall of the hospital (Building 46) and incorporated it into their structure (Plate 35.5). To the right of the door was a pair of timber shelves reminding staff to return keys to porters or supervisors before signing out and consequently these shelves are likely to have held staff registers. Close to the eaves on either side of the north elevation were vents, of which the left hand one was contemporary with the building whilst that to the right was a larger modern vent cover. The doorway to this building comprised a cambered brick head, stone threshold and was fitted with a moulded timber frame but no door (Plate 35.6).

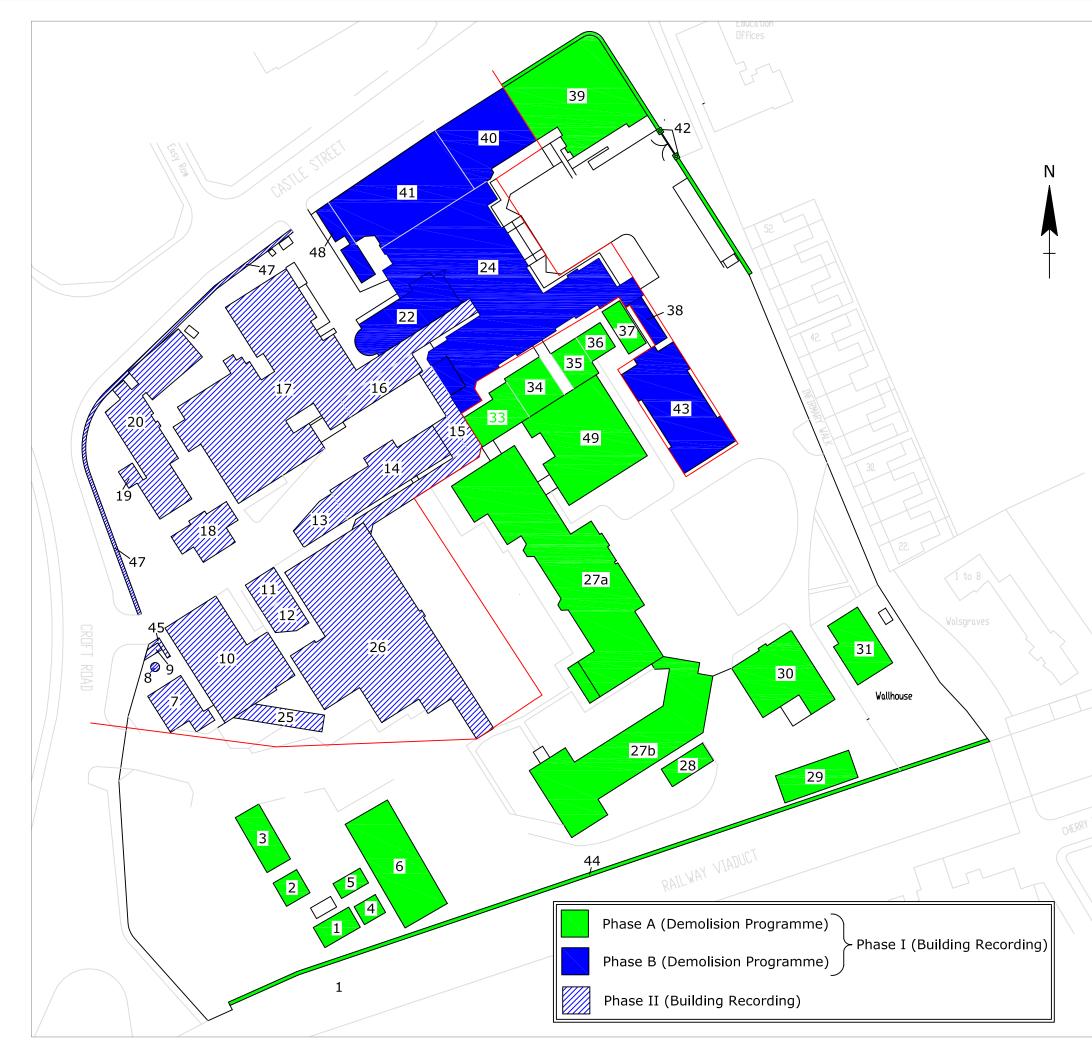
SITE LAYOUT, BUILDING IDENDIFICATION AND DEMOLITION/ HB RECORDING PHASES

1 - Works Offices
2 - Works Offices
3 - Works Offices
4 - Works Offices
5 - Works Offices
6 - Works Offices
7 - Virus Lab
8 - Chimney
9 - Shed
10 - Boilerhouse
11 - Calorifier
12 - Calorifier
13 - Severn Suite
14 - Medical Secretaries
15 - Medical Secretaries
16 - Medical Secretaries
17 - Bates and Theatre Blocks
18 - Isolation Cottage
19 - Substation?
20 - Sheds
21 - Number not used
22 - Infirmary Chapel
23 - Number not used
24 - Infirmary Block
25 - Boiler House extension
26 - Service Block
27 - Nurses Home
28 - Shed
29 - Shed
30 - Walnut Tree House
31 - Wall House
32 - Shed
33 - Service Block?
34 - Service Block?
35 - Service Block?
36 - Service Block?
37 - Service Block?
38 - Service Block?
39 - Security Block
40 - Edward VII Memorial Annex
41 - Edward VII Memorial Annex
42 - Former Arboretum Gate Piers and Railings
43 - Mulberry House
44- Butts Siding Viaduct
45 - Boundary Wall
46 - Boundary Wall
46 - Boundary Wall 47 - Boundary Wall

- 1.3 The record was carried out in response to the requirements of a condition placed upon the consented planning application (Condition 10 - P07D0193), conservation area application (CE18 - L07D0043) and listed building application (Condition 4 - L07D0044) for demolition of some buildings on site and the refurbishment of those buildings which are to be retained. The redevelopment of the site will provide a new 'City Campus' for the University of Worcester. A plan showing the distribution of buildings and indicating which were retained or demolished can be found at Figure 3.

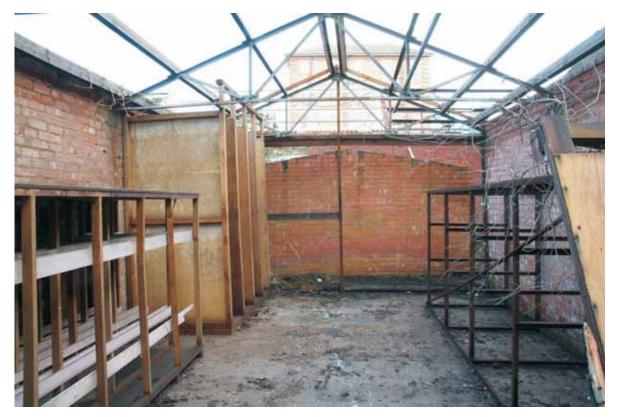
Plate 1.5: Building 1 – interior, view to the southwest

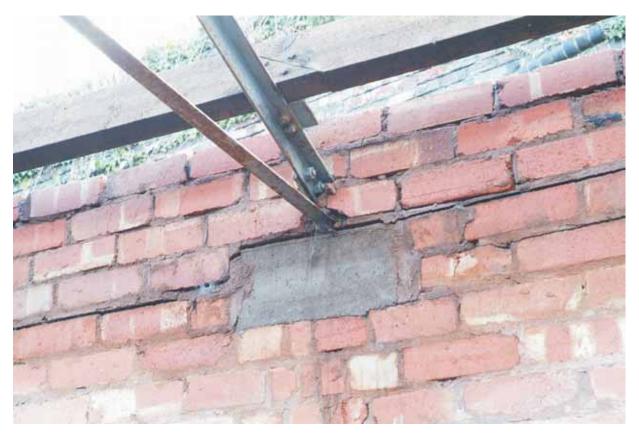
Plate 1.6: Building 1 – detail of pad stone for metal roof truss

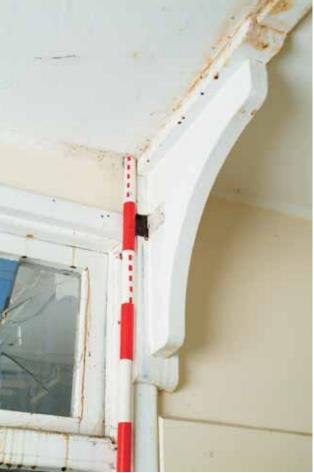
Plate 2.6: Building 2 – detail of roof bracket

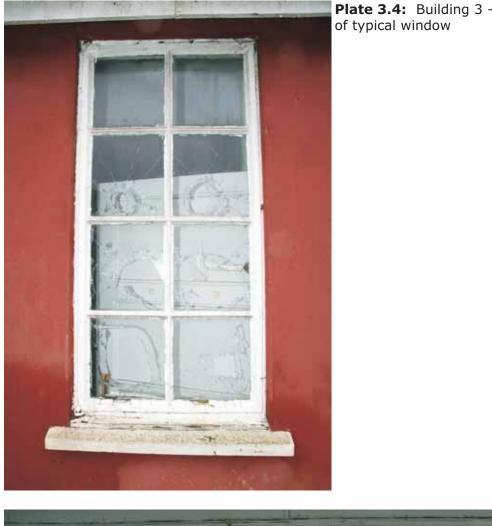
Plate 3.4: Building 3 – detail of typical window

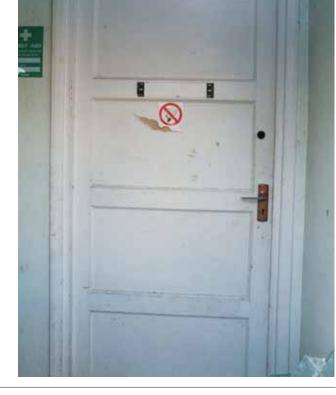
Plate 3.7: Building 3 – detail of internal door

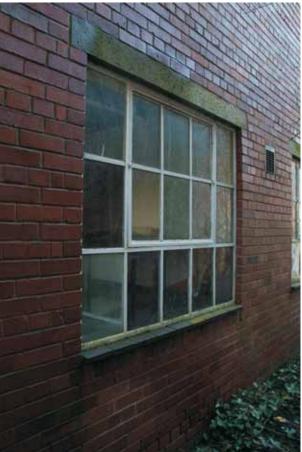
Plate 6.6: Building 6 – detail of typical window

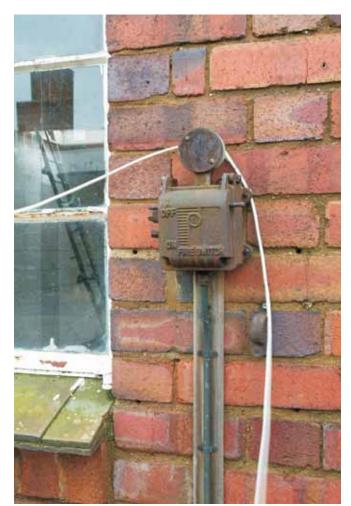
Plate 6.7: Building 6 – detail of emergency electricity isolation switch

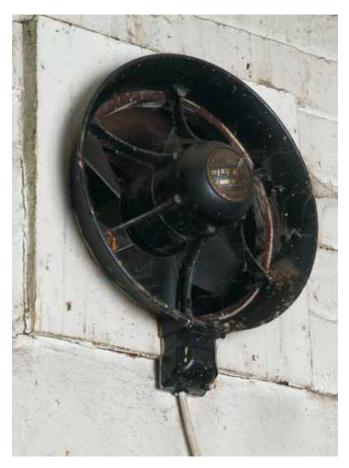
Plate 6.13: Building 6 – detail of 1950 'Vent-Axia' fan, former central workshop

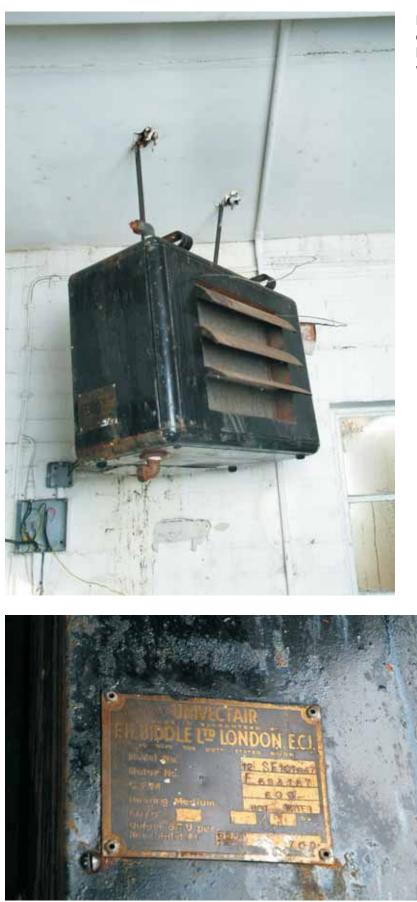
Plate 6.16: Building 6 – detail of makers plate on heater unit, northern workshop

Plate 6.15: Building 6 – detail of 1950s 'Univectair' heater unit, northern workshop

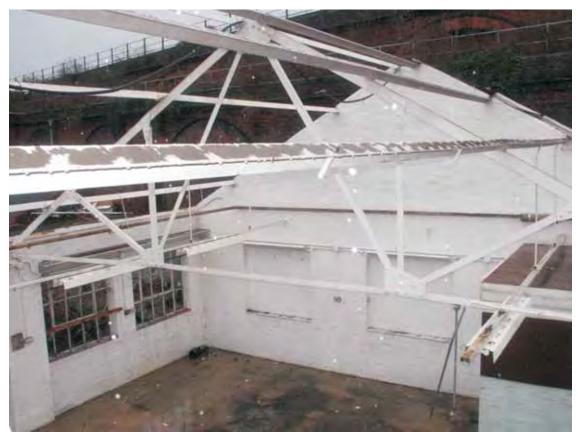
Plate 6.17: Building 6 – roof trusses over former southernmost workshop, view to the southeast

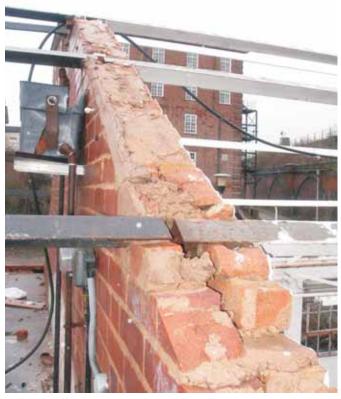
Plate 6.18: Building 6 – detail showing original metal purlins (right) and later purlins over central and northern workshops, view to the east

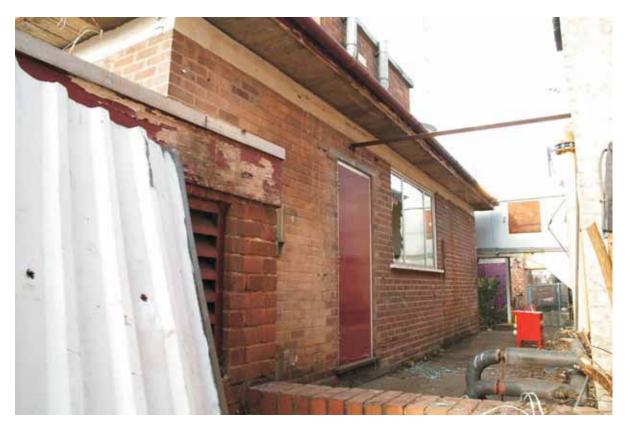
Plate 7.1: Building 7 – eastern elevation

- 5.3 The Virus Laboratories were contained within a single storey brick built block with associated generator room abutting the south side. Both elements had flat felted roofs and was built in three phases from the early 1960s to the 1970s. The only entrance to the building was on the northern side with all other elevations containing modern, metal framed casement or fixed light windows (Plates 7.1 7.4).

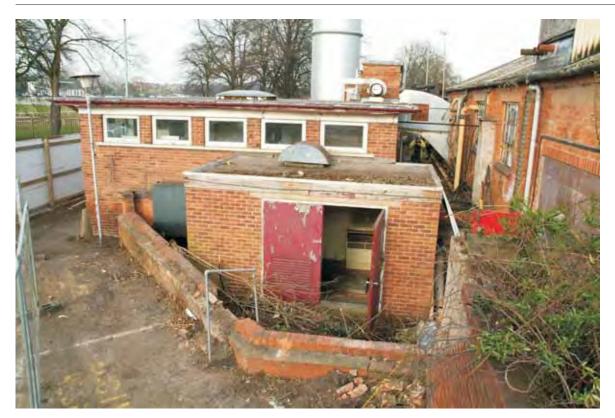
Plate 7.4: Building 7 – southern elevation showing generator room

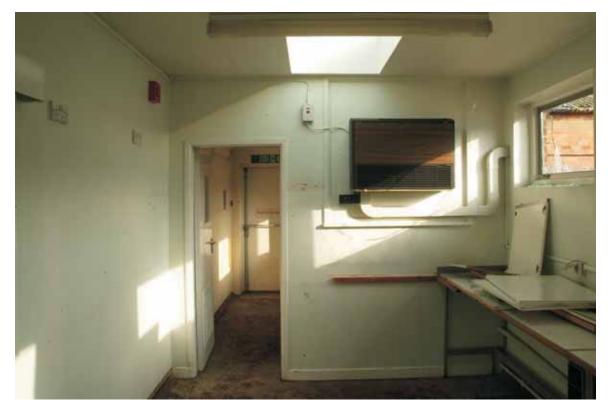
Plate 7.5: Building 7 – Interior of southern lab showing air con unit, view to the east

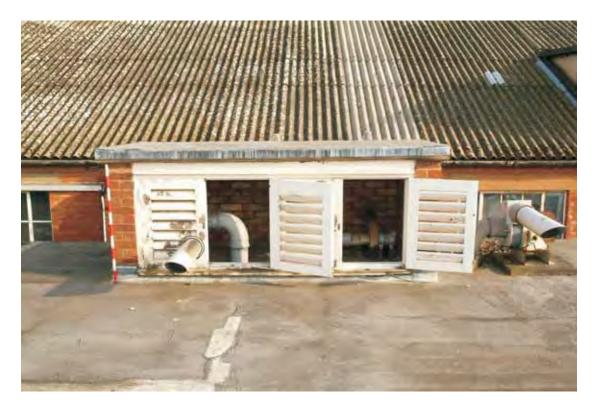
Plate 7.7: Building 7 – plant room on roof, view to the east

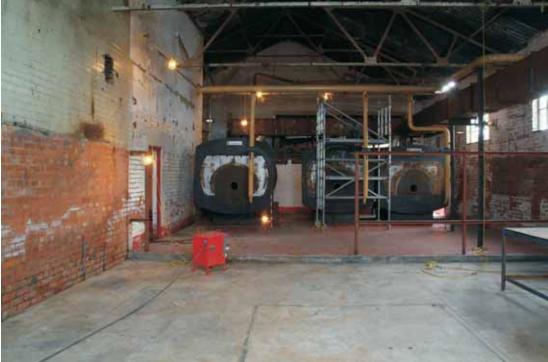
Plate 10.13: Building 10 – interior of main shed, view to the south

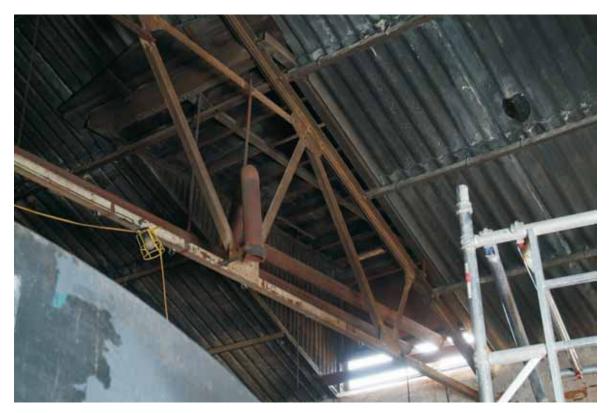
Plate 10.16: Building 10 – detail of roof trusses

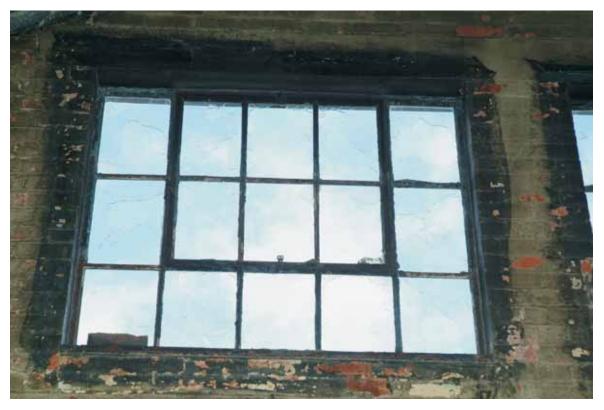
Plate 10.17: Building 10 – detail of high level window in main shed, view to the west

and the building was lit by a series of high level metal framed windows (Plate 10.17) in the north and west walls.

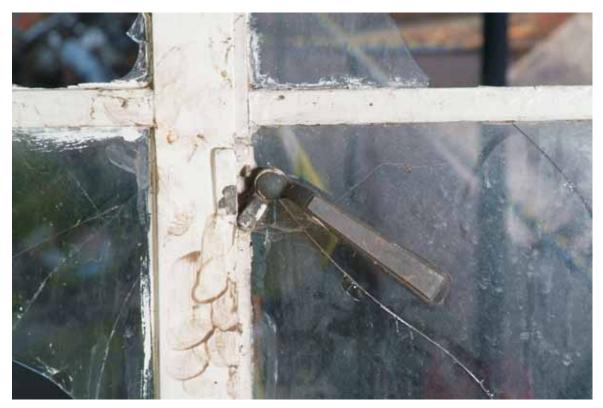
Plate 10.21: Building 10 – detail of window handle in eastern range, view to the north

- 5.10 The eastern range was also contemporary with the original structure and contained a workshop to the north and a mess room with shower and kitchen to the south. The range was lit by metal framed windows in the north and south end and analysis of the window fittings (Plate 10.21) confirmed that the range dated to the late 1940s.

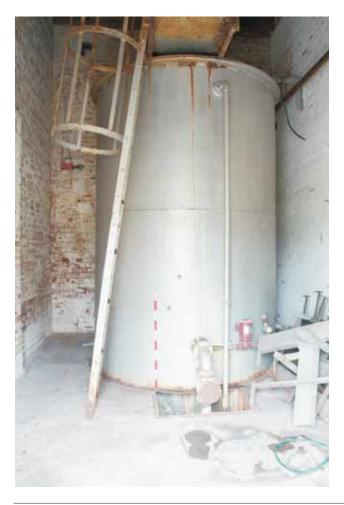
Plate 11.4: Building 11 – interior showing water softener, view to the east

softening plant was renewed.
- 5.11 These two buildings (Plate 11.1) were situated to the west of the boiler house and comprised two elements. At the north end was a two storey high softening plant^{Ψ} (Building 11) containing a tall cylindrical softening tank (Plate 11.2 – 11.4) whilst the southern part formed a calorifier^{Ψ} block (Building 12) comprising a single storey range containing switchroom, viewing room/ oil store and a three storey high tower at its northern end (Plate 12.1 and 12.2). The tower formerly contained the calorifier itself (Plate 12.3) along with an associated water tank.

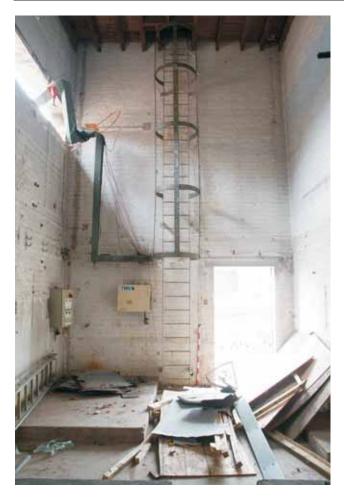
Plate 12.3: Building 12 – interior showing ladder to water tank, view to the south

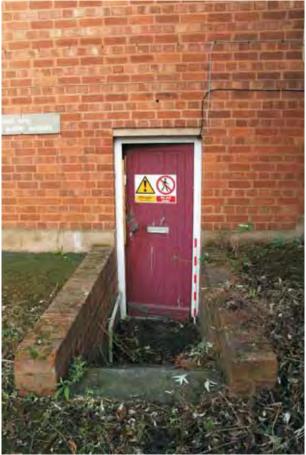
Plate 13.3: Building 13 – basement door in western elevation, view to the east

- 5.13 This building comprised a brick built range (Plate 13.1) added to the western elevation of the former Laundry Block (Building 5). The principal entrance was situated at the eastern end of the north elevation and was accessed by a flight of steps (Plate 13.2). The principal floor was set above ground level so as to marry with that of the adjacent building with which it was internally connected. Due to the fall in the external ground surface the western end contained a part basement accessed from the exterior via a separate door in the western elevation (Plate 13.3).

- 5.16 The eastern elevation contained a blocked oculus which is now partly obscured by the flat roof of Building 15a (Plate 14.7). A similar arrangement was observed on the western elevation which was largely obscured by Building 13 (see Plate 13.3) but which was exposed during the demolition of this range

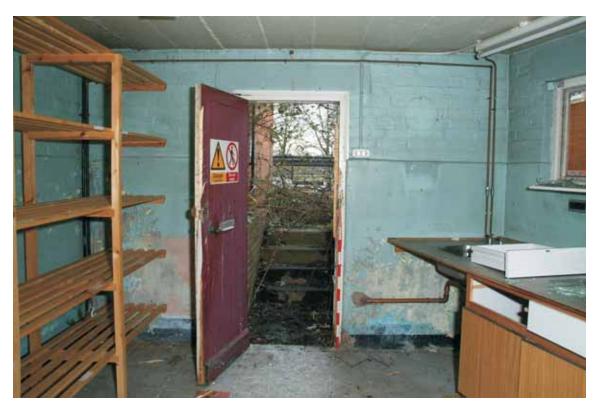
Plate 13.5: Building 13 – interior of basement, view to the west

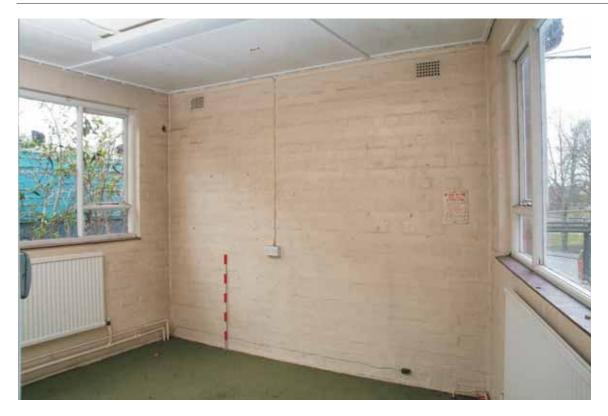
Plate 13.6: Building 13 – interior of westernmost ground floor room, view to the west

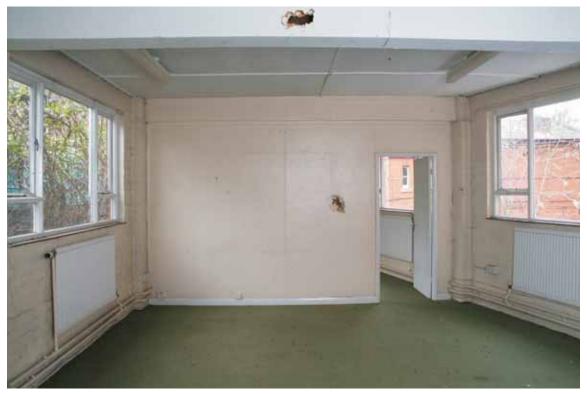
Plate 13.7: Building 13 – interior of eastern ground floor room showing later partition, view to the west

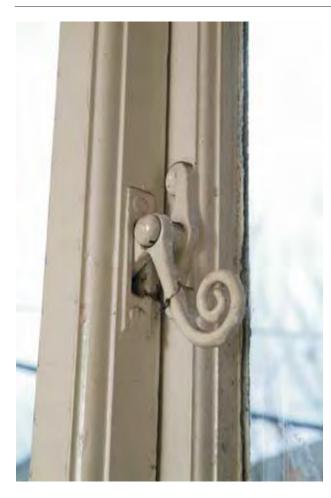
Plate 13.8: Building 13 – detail of window handle in eastern room, view to the northwest

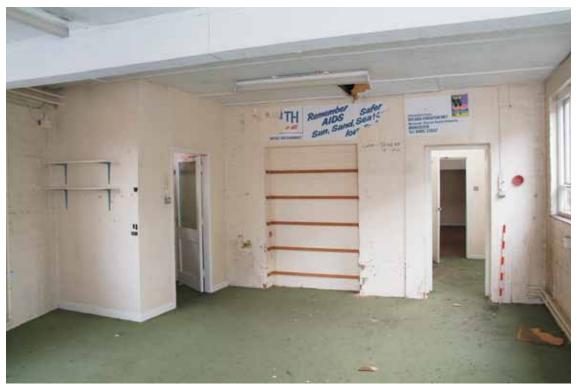
Plate 13.9: Building 13 – Interior of ground floor showing connecting door to Building 14, view to the east

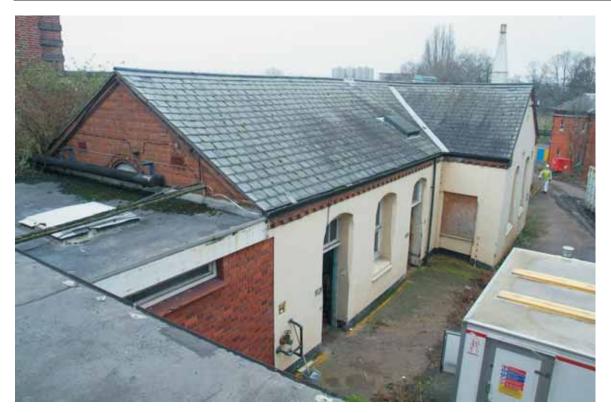
Plate 14.1: Building 14 – northern and eastern elevations

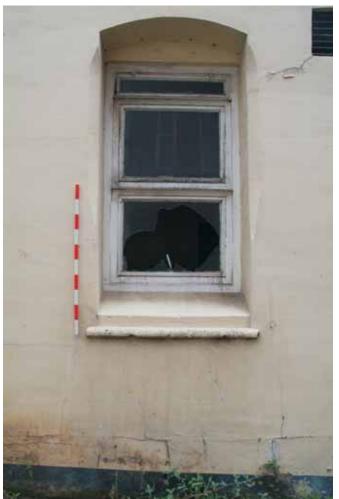
Plate 14.3: Building 14 – detail of typical original window, view to the south

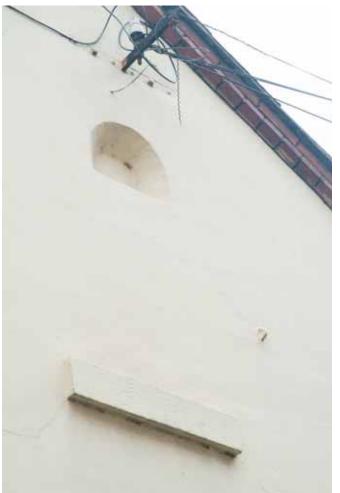
Plate 14.5: Building 14 – detail of rebate and drip moulding in central gable, view to the southwest

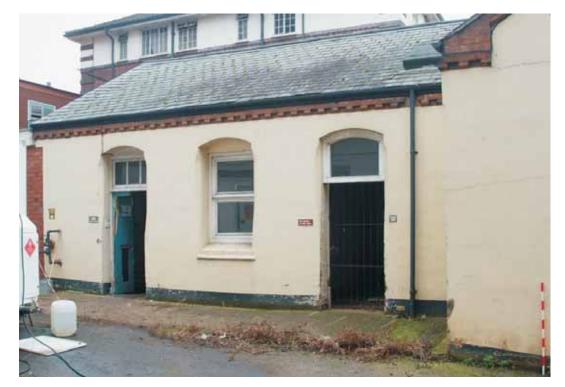
Plate 14.6: Building 14 – eastern wing showing modified windows, view to the southeast

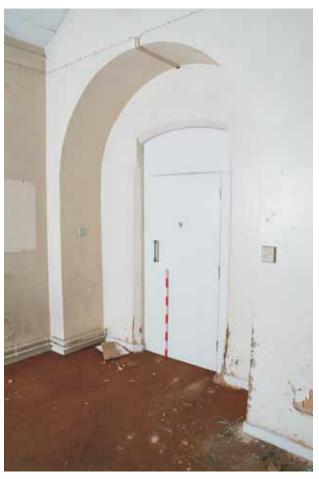
Plate 14.14: Building 14 – detail of original doorway in partition between west wing and central range, view t0 the northeast

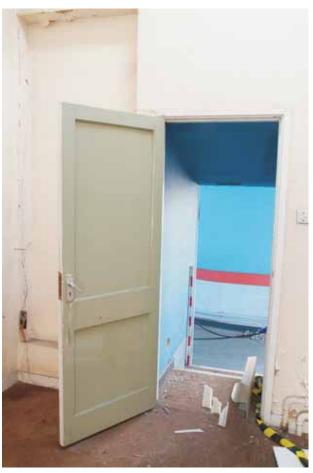
Plate 14.16: Building 14 – two inserted doorways in south elevation looking through to Building 15, view to the southeast

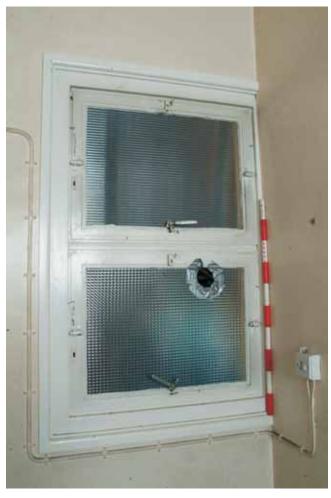
Plate 14.17: Building 14 – detail of metal framed pivoting window in north elevation, view to the north

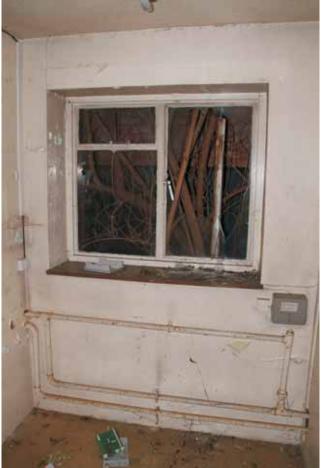
Plate 14.18: Building 14 – detail of metal framed casement in south elevation, view to the southeast

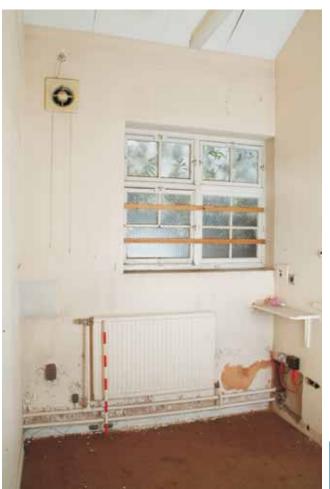
Plate 14.19: Building 14 – detail showing timber framed window in southern elevation, view to the southwest

panes formed by rather heavy shaped glazing bars, all indicative of the 1930s (Plate 14.19).

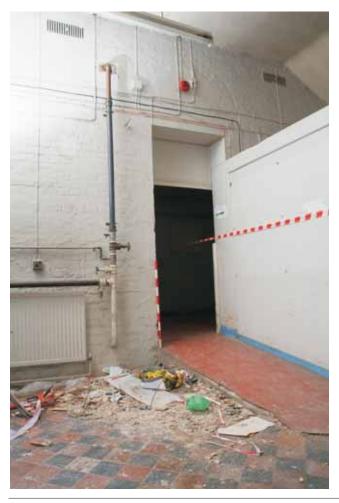
Plate 14.22: Building 14 – interior of eastern wall showing inserted doorway, view to the southeast

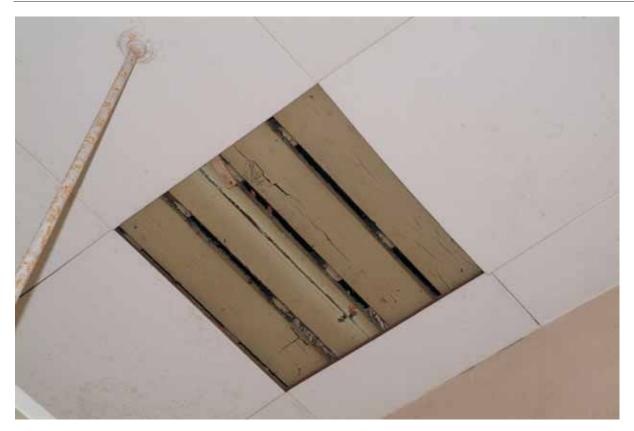
Plate 14.23: Building 14 – detail of original ceiling boarding, view up

- 5.21 The ceiling throughout the building had been lined out in modern polystyrene tiles which in places had fallen away to reveal an earlier ceiling covering of widely spaced boards (Plate 14.23). Both the north and south pitches were pierced by roof lights but whilst some of those in the southern pitch appeared to be original (Plate 14.24), both pitches had smaller lights which appeared to be newly formed (Plate 14.25).

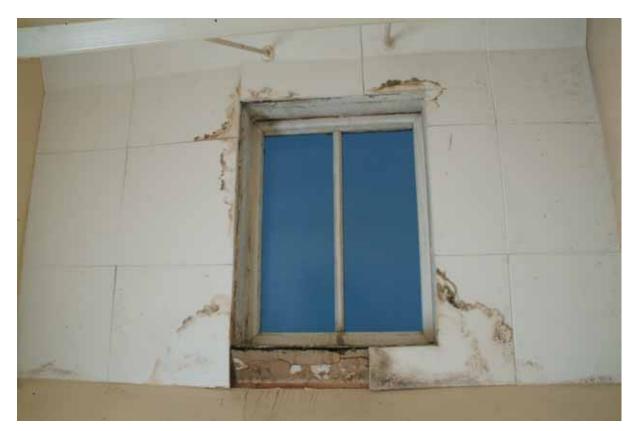
Plate 14.24: Building 14 – detail of historic roof light, view up

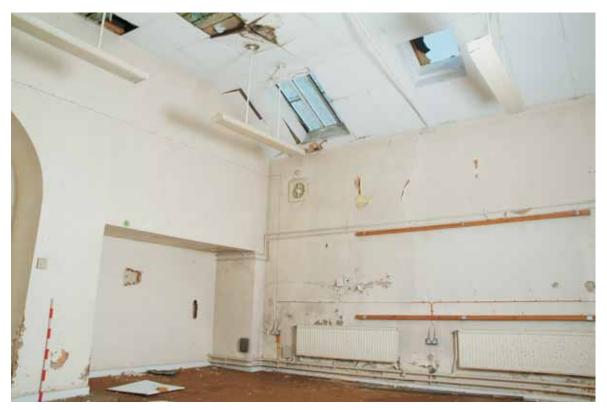
Plate 14.25: Building 14 – detail demonstrating difference between original and later roof lights, view to the southeast

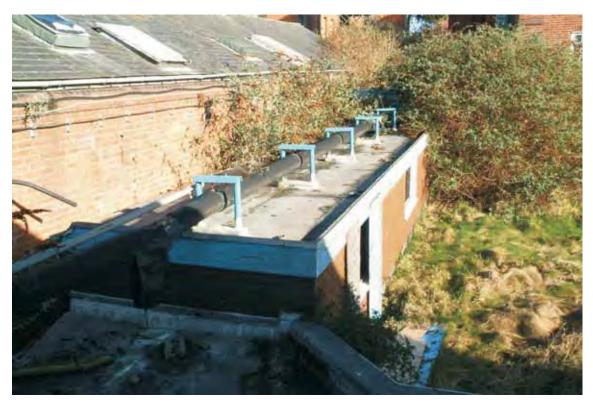
Plate 15.1: Building 15 – roof and south elevation against rear of Building 14

- 5.25 This largely freestanding corridor (Plate 15.1) dates to the construction of the Accident and Emergency Department (Building 26) in 1967. The corridor is constructed of brick set on a thick concrete slab and has a flat roof (Plate 15.2). It is lit by metal framed casement windows along the exposed sides and ran from the southern side of the corridor linking the Bates Block (Building 17) with the A & E Department (Building 26) with entrances from the southern access road (Plate 15.3) and the kitchens in Building 24c (Plate 15.4). Internally the building is painted with colour coded stripes to assist patients in finding their way around the labyrinthine corridors (Plate 15.5).

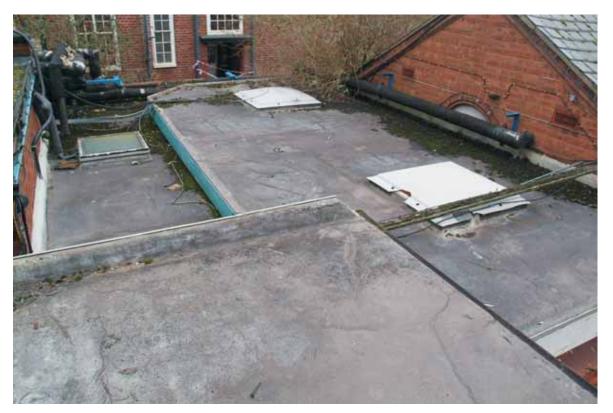
Plate 15.2: Building 15 and 15a – roof, view to the south

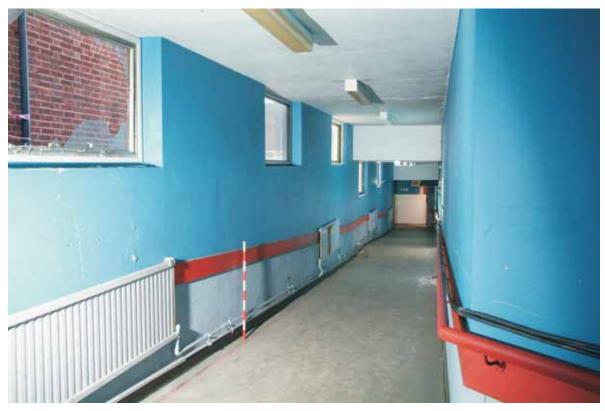
Plate 15.5: Building 15 – interior of east-west section, view to the west

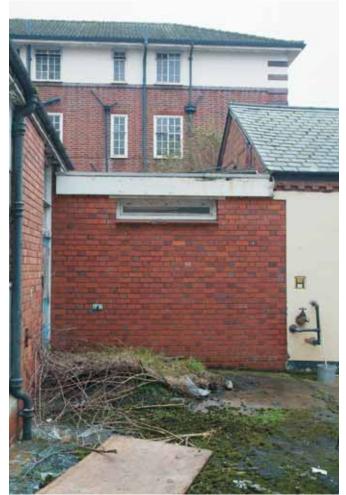
Plate 15.6: Building 15a –northern elevation

- 5.26 A contemporary flat roofed extension to the former laundry formed Building 15a (Plate 15.6) and was exposed only on the north side which contained a long, high level window. This building formed a through room (Plates 15.7 and 15.8) connecting the south side of Building (corridor) 15 with the east side of Building 14 (Figure 26) and was used as additional linen storage prior to the hospitals closure.

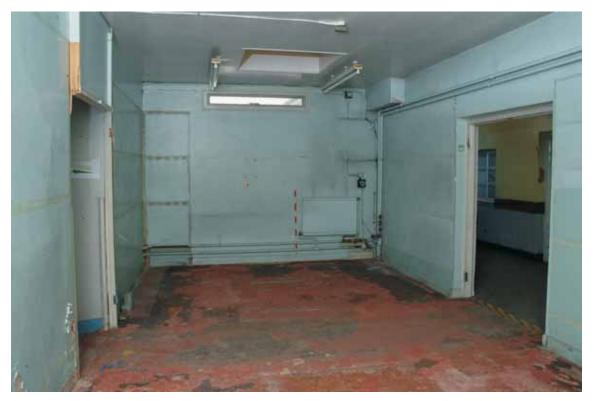
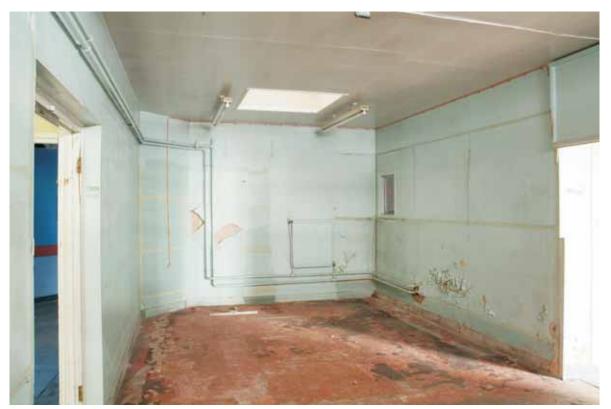
Plate 15.7: Building 15a – interior, view to the south

Plate 15.8: Building 15a – interior, view to the north

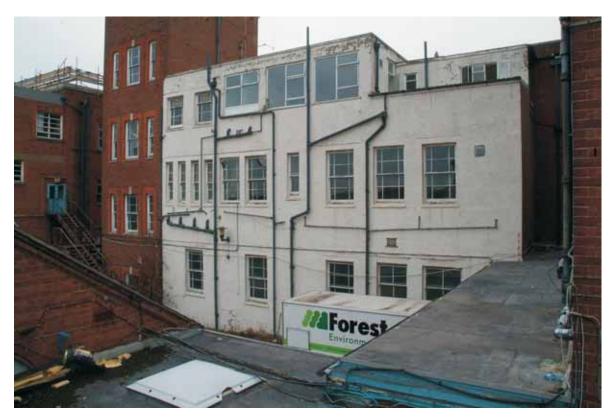
Plate 16.1: Building 16 – southern elevation, view to the northeast

- 5.27 This three storey range was added to the south side of the access corridor linking the Bates Block (Building 17a) to the main Infirmary building in 1947. The principal elevation was to the south (Plates 16.1 and 16.2) which comprised a fairly regular fenestration of large metal framed, margin-light windows. These were varied on the first floor at the west end where a series of narrow windows mark the location of lavatories inside. The change in fenestration on the third floor to larger paned metal framed windows marks the extent of an extension to that floor during the late 1950s. The evidence of this extension is also visible on the roof (Plate 16.3) and internally. The north elevation is blind and only exposed above the roofs of Building 15 (Plate 16.4) which abuts it at ground floor level. The western and northern elevations are abutted by the stair tower and corridor of Building 17a.

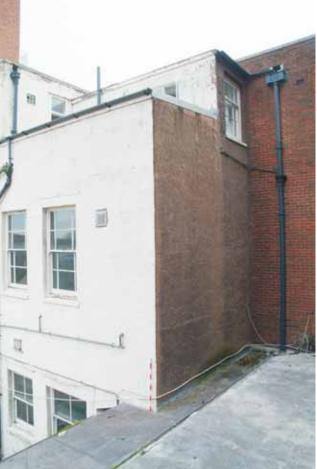
Plate 16.3: Building 16 – eastern elevation above Building 15

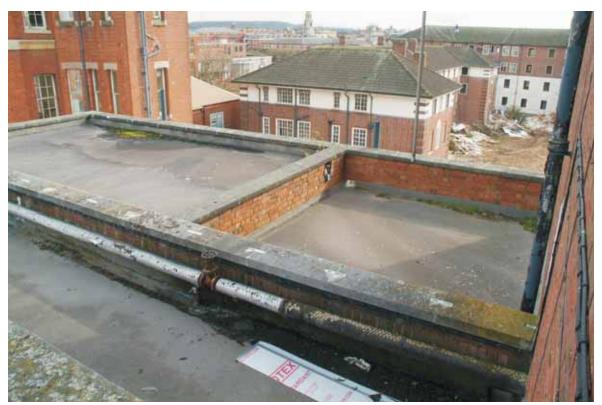
Plate 16.4: Building 16 – roof showing later extension to the left, view to the southeast

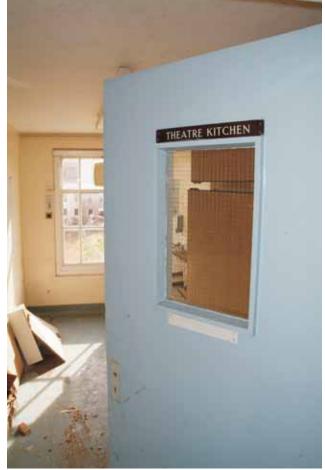
Plate 16.9: Building 16 – detail of original door with viewing panel and Bakelite signage, view to the south

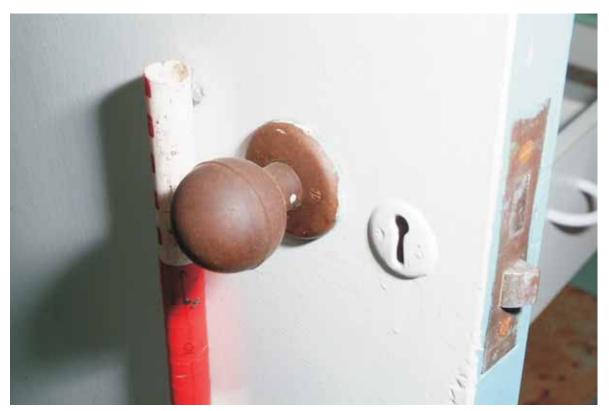
Plate 16.10: Building 16 -detail of original door handle

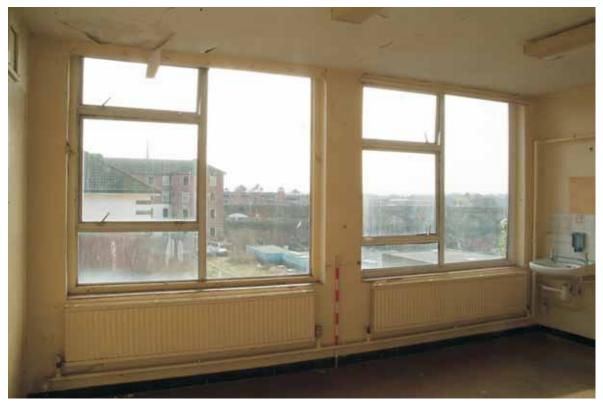
Plate 16.11: Building 16 -interior of third floor extension, view to the southwest

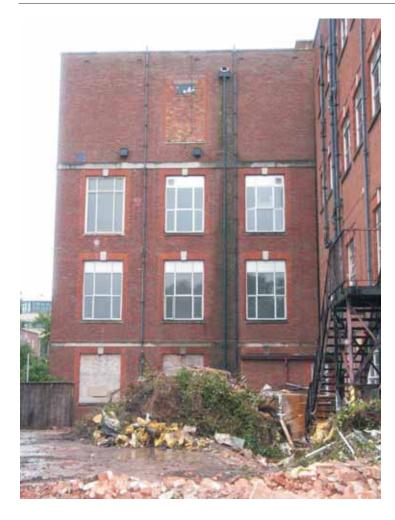
Plate 17.3: Building 17a – west elevation

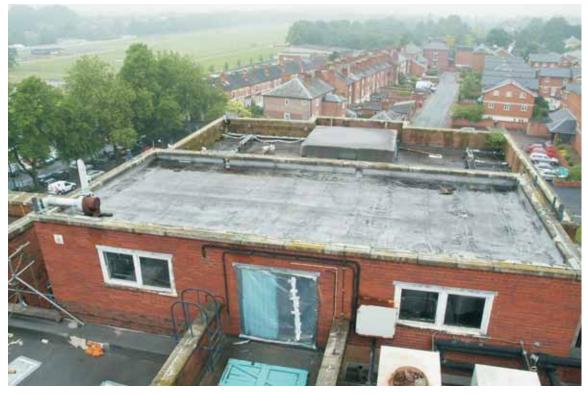
Plate 17.4: Building 17a – roof, view to the northwest

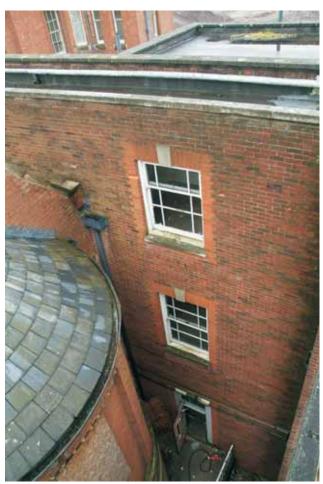
Plate 17.5: Building 17a – exposed north wall of E – W link corridor, view to the southeast

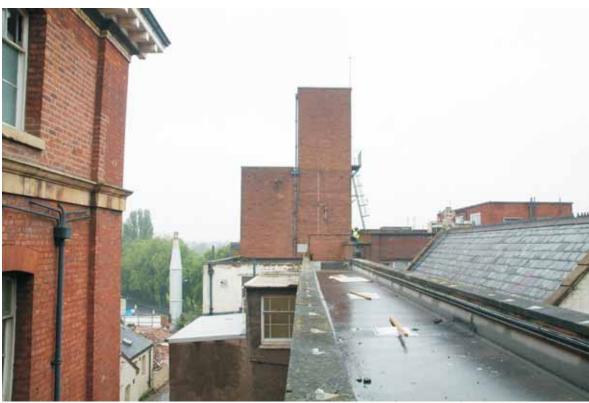
Plate 17.6: Building 17a – flat roof of E – W link corridor with stair/ lift tower in background, view to the west

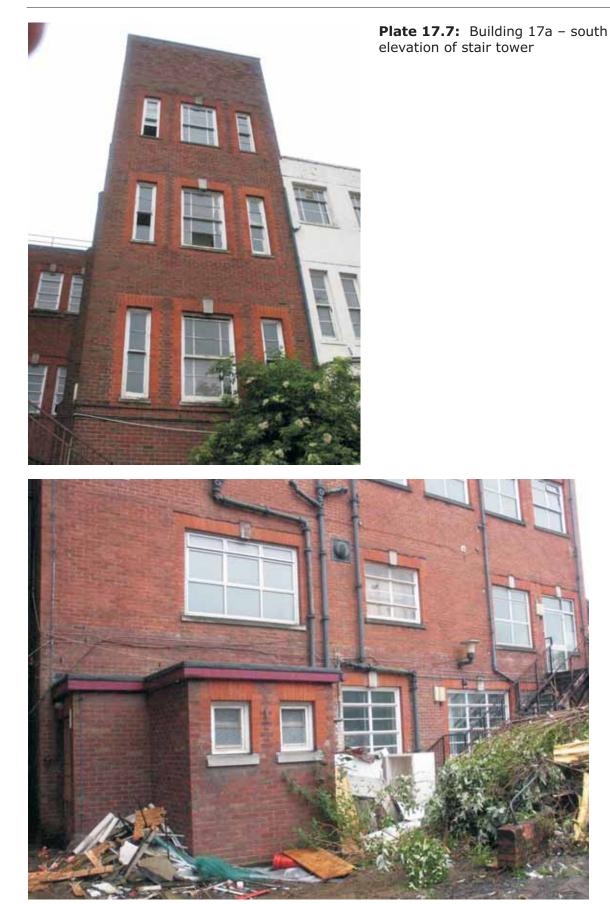
Plate 17.8: Building 17b – visible remnants of the VD Clinic showing northern lavatory wing and change in brickwork above ground floor, view to the southwest

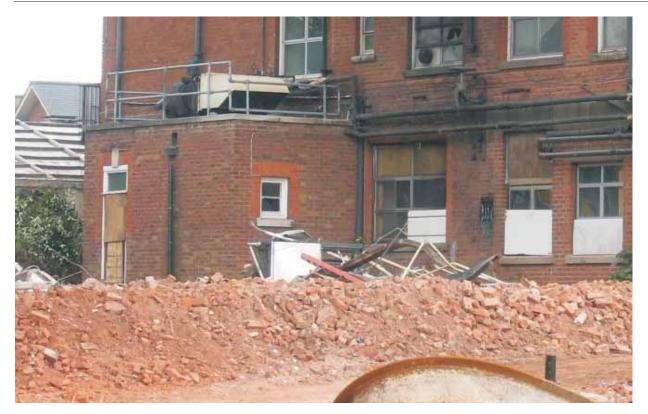
Plate 17.9: Building 17b – visible remnants of the VD Clinic showing western lavatory wing and change in brickwork above ground floor, view to the southeast

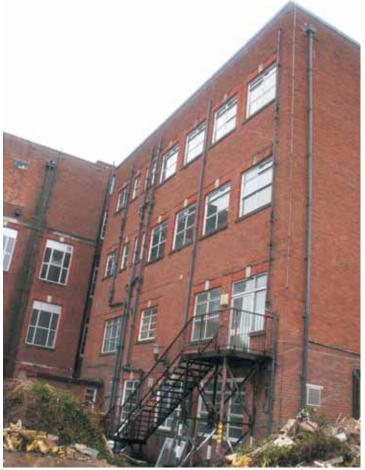
Plate 17.10: Building 17b – visible remnants of the VD Clinic showing western lavatory wing change in brickwork above ground floor and between ground floor extension, view to the northeast

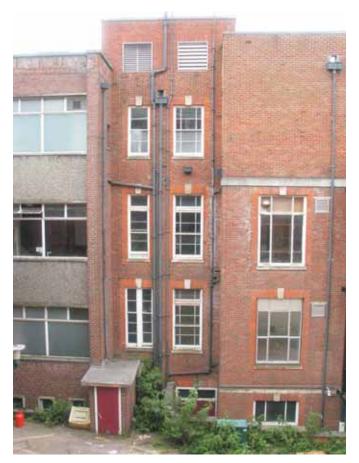
Plate 17.11: Building 17b – northern elevation of post 1938 building, view to the east

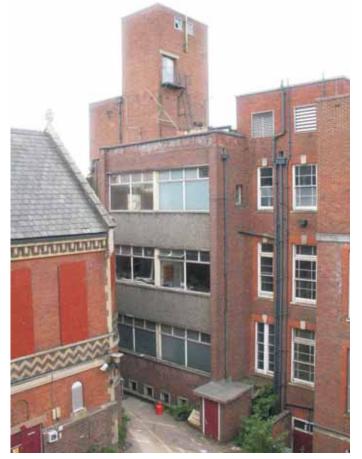
Plate 17.12: Building 17b - c.1960s infill block against the east side of the N - S link corridor, view to the southwest

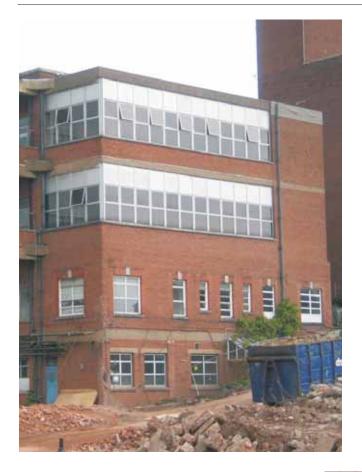
Plate 17.13: Building 17b – half glazed extension over two storey flat roofed range, view to the northeast

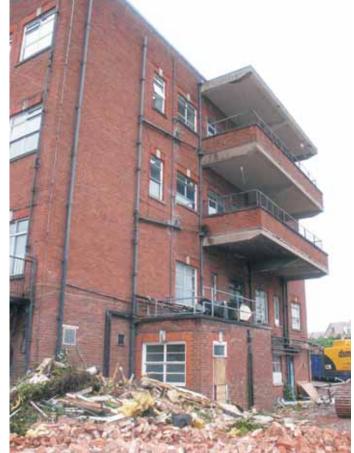
Plate 17.14: Building 17a – c.1960s balconies on southern elevation, view to the southeast

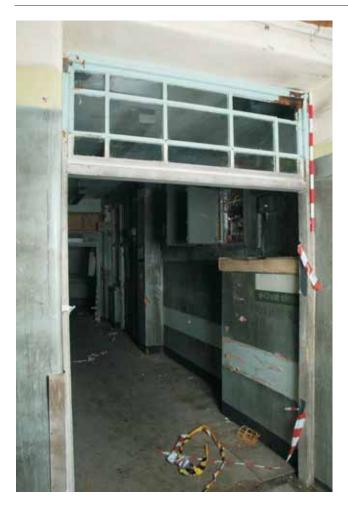
Plate 17.15: Building 17a – basement: 1938 doorcase and overlight at entrance to N-S link corridor, view to the northeast

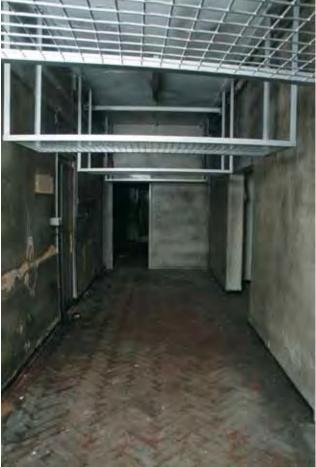
Plate 17.16: Building 17a – basement: 1938 parquet flooring of N-S link corridor, view to the north

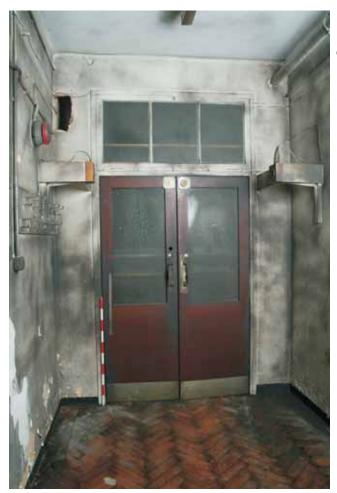
Plate 17.17: Building 17a – basement: 1938 swing doors within the central corridor, view to the south

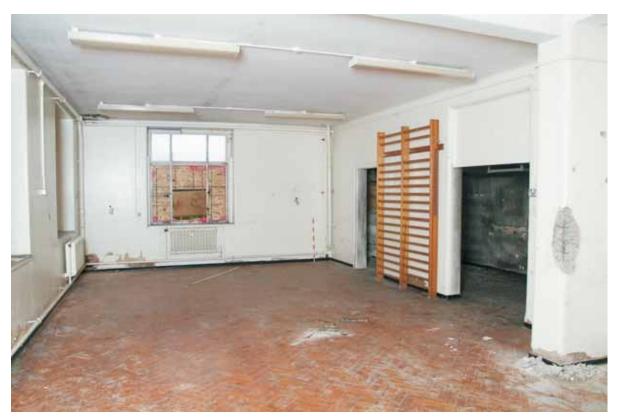
Plate 17.20: Building 17a – basement: physiotherapy department showing wall bars, view to the north

- 5.33 Internally, the building had undergone extensive refurbishment to both the decor, fixtures and fittings. Parts of the basement were artificially smoke blackened from being used, shortly after the closure of the hospital in 2002, as a television set for an episode of the detective drama Dalziel and Pasco (Heads you Lose, BBC, 2005). Despite the widespread alterations, the building retained a number of features dating to the various construction phases along with features relating to the function of the various spaces prior to closure. In the basement these included doorcases (Plate 17.15), parquet flooring (Plate 17.16), corridor doors (Plate 17.17), tiled rooms for the post-mortem theatre (Plate 17.18) and mortuary (Plate 17.19) and the adapted stores, fitted with the wall bars of the physiotherapy department (Plate 17.20).

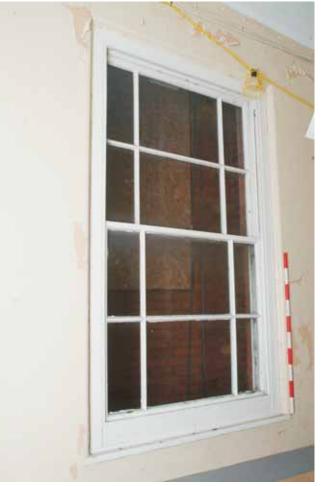
Plate 17.24: Building 17a – ground floor: detail of typical original corridor window, view to the northeast

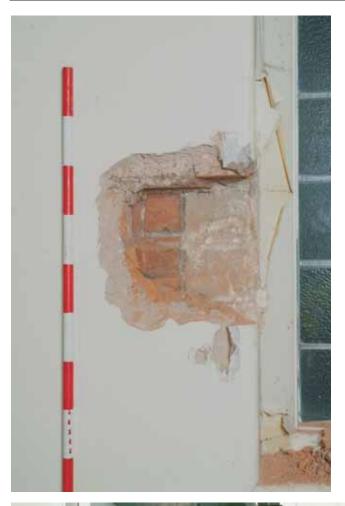
Plate 17.25: Building 17a – ground floor: detail showing original southern chapel facade beneath the brickwork of the corridor, view to the north

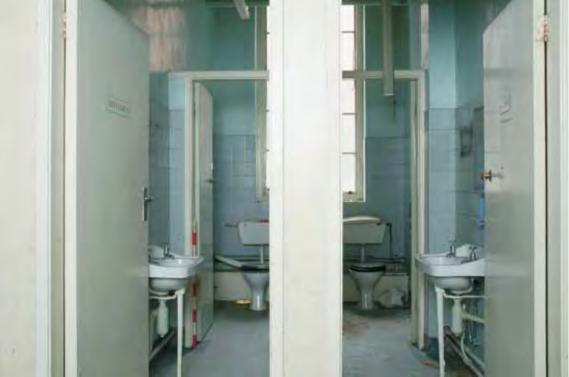
Plate 17.26: Building 17a – ground floor: interior of lavatories showing original period fixtures, fittings and decor, view to the east

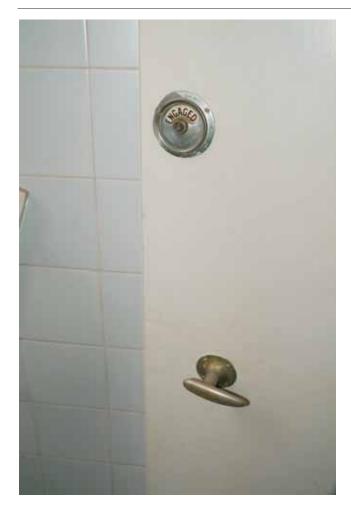
Plate 17.27: Building 17a – ground floor: detail of original door fittings

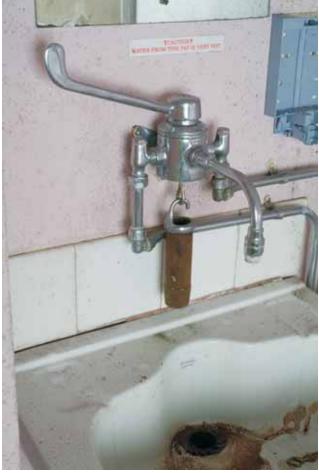
Plate 17.28: Building 17a – ground floor: detail of original sluice sink fittings

- 5.34 On the upper floors of the original theatre block (Building 17a), survival of original or near original features was generally mixed. At ground floor level the opening plaque survived set into the north wall of the corridor, just to the east of the stair tower (Plates 17.21 and 17.22) which was itself screened from the corridor by an original doorcase with overlight. From within the link corridor the former external windows of the Chapel could be seen (Plate 17.23), borrowing light from a corridor lit by the original margin light sashes (Plate 17.24). Investigations to inform the removal of the corridor from the side of the chapel revealed that a single skin of brick had been applied to the southern elevation of the Chapel (Plate 17.25), the original 1850s facade surviving largely intact beneath. Within the main block, specifically designed spaces such as lavatories (Plate 17.26) and sluice rooms have continued to serve as such due to the convenience of the integral plumbing. As a result, survival of original features in these areas was heightened with a number of the lavatory doors retaining their original fittings (Plate 17.27) along with sinks and sluice taps (Plate 17.28). Other rooms with less defined functions had been wholly refurbished,

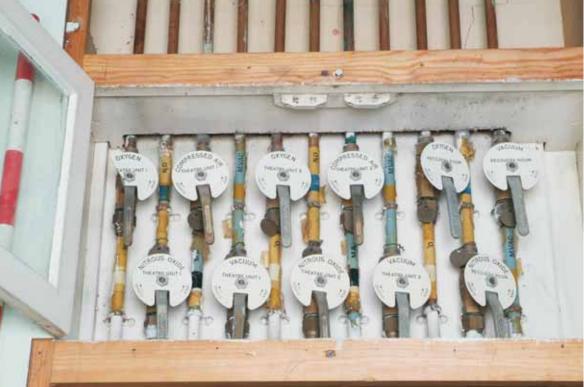
Plate 17.32: Building 17a – second floor: detail of gas supply controls to operating theatres

the flexibility of the space allowing subdivision and reallocation of use (Plate 17.29). Unfortunately, the process of asbestos removal was already under way across much of the upper floors and only limited access was available (Plate 17.30). Despite this, the level of survival appeared to be fairly consistent with that of the basement and ground floors. The uppermost floor was constructed and remained in use as the theatre floor and consequently features on this floor reflected that use (Plates 17.31 – 17.33).

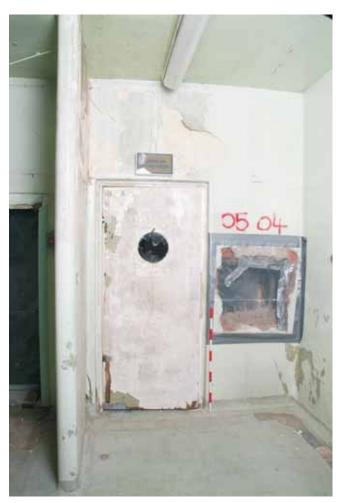
Plate 17.33: Building 17a – second floor: door from the sterilizing room to Theatre 1 with laser warning sign above, view to the west

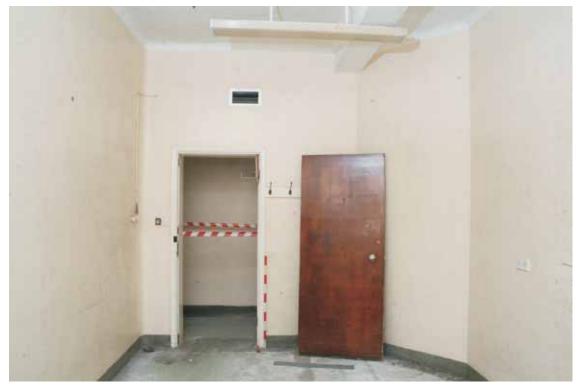
Plate 17.34: Building 17b – basement: interior of original consulting room within the VD clinic showing original door, view to the north
