Worcestershire Archaeology Research Report No.12

Historic Building Non-technical Record Report

THE FORMER WORCESTER ROYAL INFIRMARY, CASTLE STREET, WORCESTER

Part 1: Report, Appendices 1–3, Figures

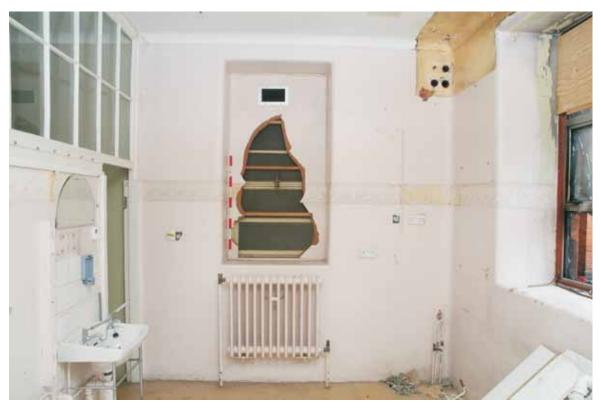
Plate 17.35: Building 17b – basement: original external window on south side of VD Clinic from within former male changing room, view to the south

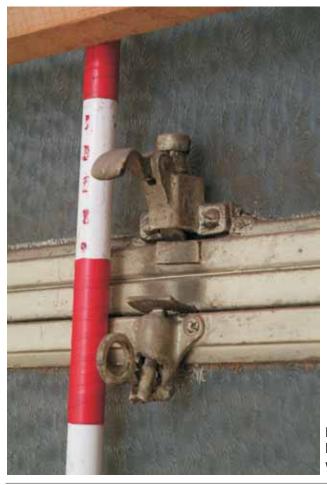
Plate 17.36: Building 17b – basement: detail of original 1936 window catch

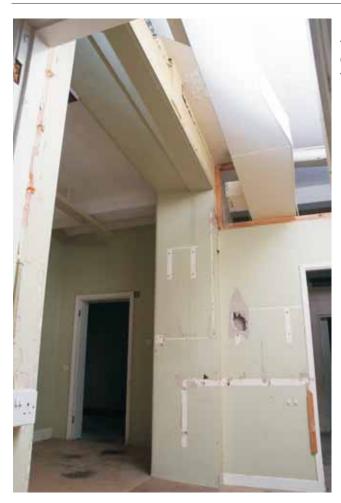
Plate 17.37: Building 17b – basement: former window opening on south side of VD Clinic enlarged to access 1938 extension, view to the northeast

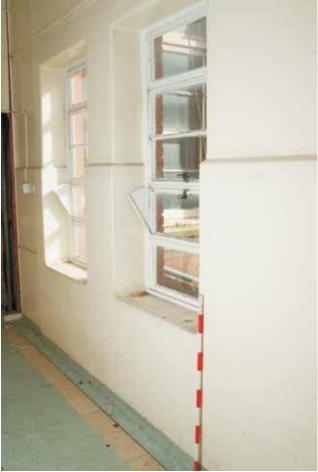
Plate 17.38: Building 17b – ground floor: hopper-light windows on the south side of link corridor between 17a and 1938 extension to 17b, view to the southeast

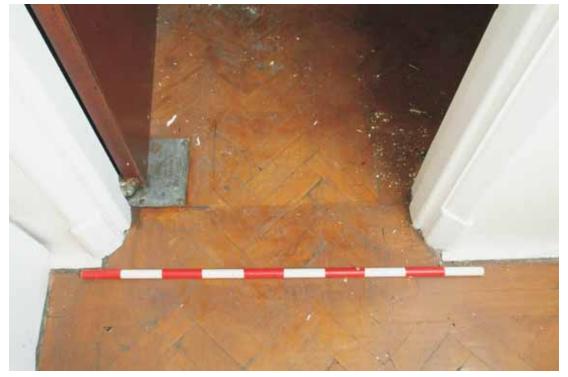
Plate 17.40: Building 17b – ground floor: floor and skirting detail at entrance to office within 1938 extension to 17b, view to the south

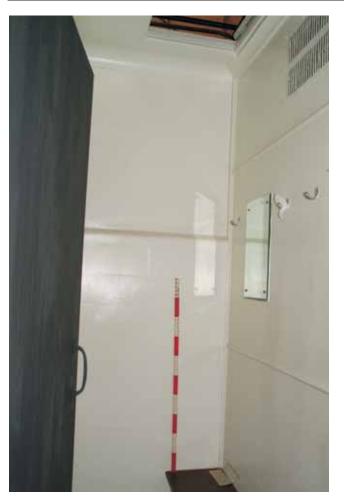
Plate 17.41: Building 17b – ground floor: coved cornice within changing room, view to the north

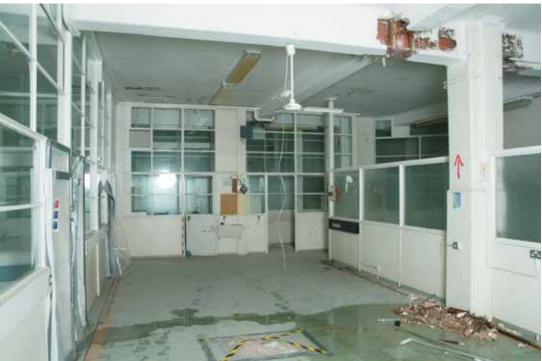
Plate 17.44: Building 17b – second floor: original metal partitions within the children's ward, view to the north

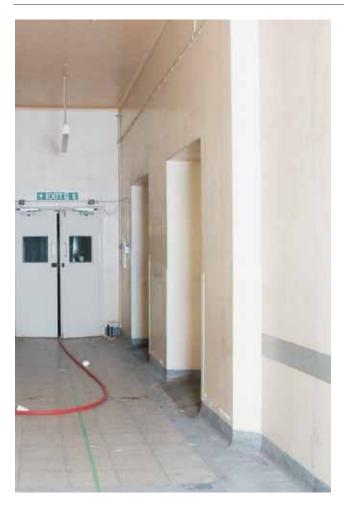
Plate 17.47: Building 17a – second floor: later openings on east side of link corridor accessing 1960s extension (note the change in floor level), view to the northeast

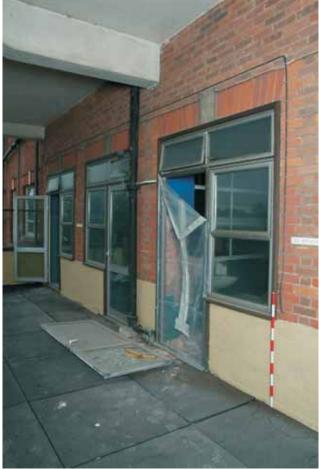
Plate 17.48: Building 17b –first floor: extended window openings on west elevation accessing balcony, view to the northeast

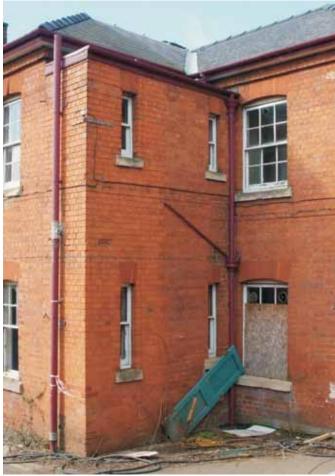
Plate 18.7: Building 18 – detail of eastern closet wing showing vertical joints in brickwork, view to the northwest

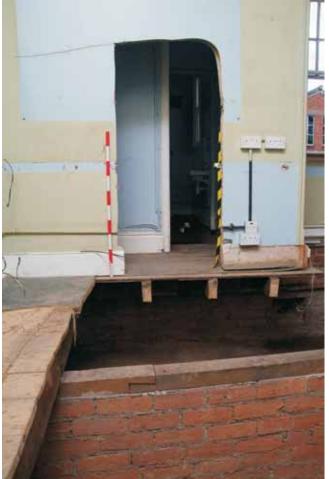
Plate 18.14: Building 18 – corridor inserted into the southeast corner of the west ward, view to the south

- 5.40 Access to the western closet wing had been altered on both floors with that on the ground floor via a short corridor inserted into the corner of the western ward room (Plate 18.14). The west wall of the stairwell had an inserted opening, level with the first half landing of the staircase (Plate 18.15) and the corridor itself was formed of stud and plasterboard partitions. Steps had been added to the west side of the stairwell wall beyond the wall and underneath these, the original skirting board of the west ward could be seen extending into the corner of the original room (Plate 18.16). An original doorway from the west ward into the duty room had also been blocked and rendered, its original location implied by the symmetry of the building and confirmed during the demolition when the brick vousoirs of the head of the opening could be seen (Plate 18.17). On the first floor the original entrance from the west ward through to the closet wing had been blocked (Plate 18.18) and a new opening created from the duty room (Plate 18.19).

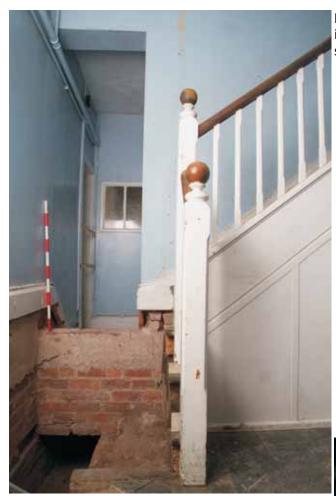
Plate 18.15: Building 18 – ground floor: inserted opening in western wall of the stair well, view to the west

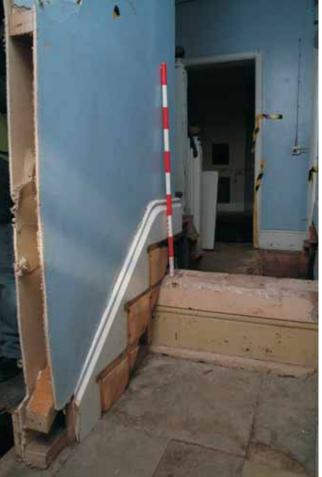
Plate 18.16: Building 18 – ground floor: detail showing original west ward skirting beneath inserted steps, view to the northeast

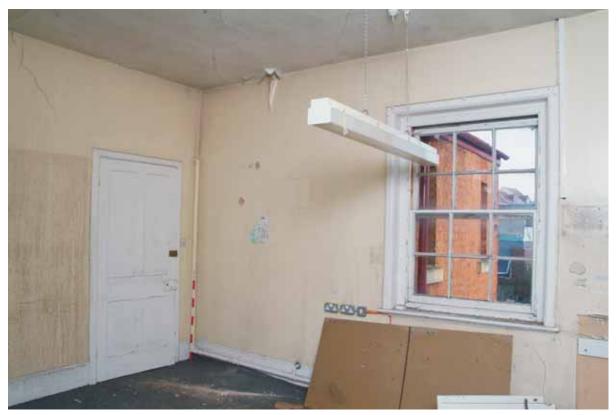
Plate 18.18: Building 18 – first floor: southeast corner of west ward showing location of former openings, view to the southeast

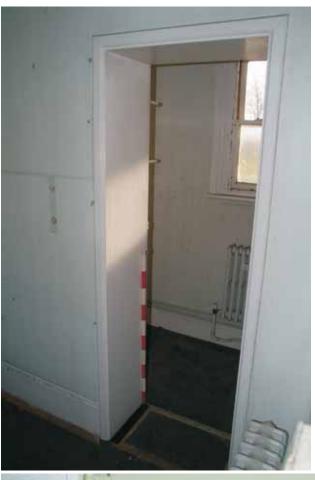
Plate 18.19 Building 18 – first floor: inserted opening from duty room through to western closet wing, view to the southwest

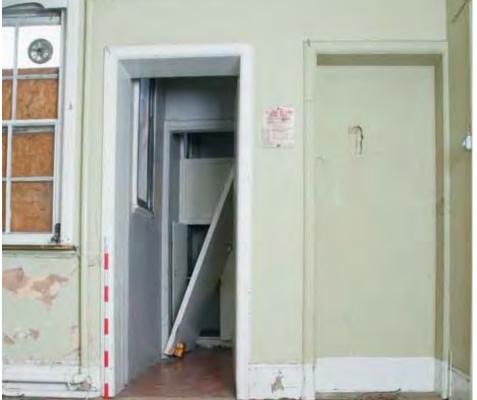
Plate 18.20: Building 18 – ground floor: southwest corner of eastern ward showing door to eastern closet and former entrance to duty room, view to the south

- 5.41 The access to the duty room and closet wing from the eastern wards had survived in close to its original form with a pair of doors set in the southern wall, close to the entrance hall (Plate 18.20) but although the duty room door was present, it had been boarded over on both floors (Plate 18.21).

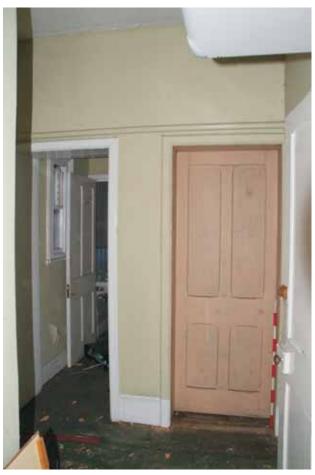
Plate 18.21: Building 18 – first floor: southwest corner of eastern ward showing door to eastern closet and former entrance to duty room, view to the south

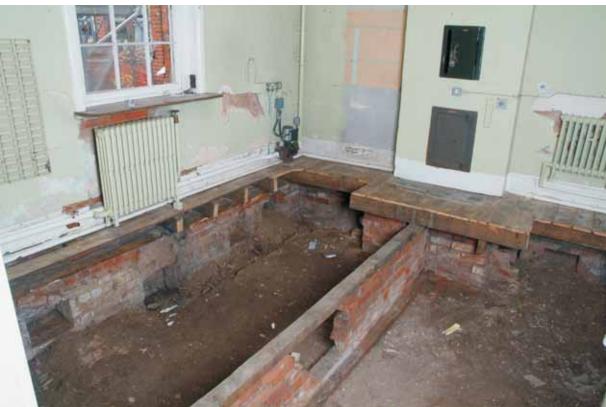
Plate 18.22: Building 18 – ground floor: east ward following removal of the floor showing traces of brick ducting, view to the northeast

- 5.42 Beneath the ground floor (Figure 9), remnants of a forced air ventilation system survived, comprising a series of brick lined ducts which formed a circuit beneath the wards (Plate 18.22) and entrance hall (Plate 18.23). Air was moved around the ducts through convection currents created as it passed beneath the hearths of the fireplaces (Plate 18.24), set centrally in the east and west walls, before passing up vertical shafts set in the external walls of the wards (Plate 18.25). These shafts were plaster lined and could be seen most clearly during the demolition of the building (Plate 18.26). Air was drawn into the building by a similar duct passing beneath the floor of the duty room (Plate 18.27) and the western closet wing.

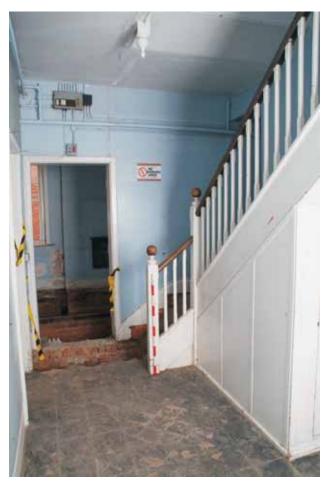
Plate 18.23: Building 18 – ground floor: duct passing beneath the floor of the entrance hall, view to the southwest

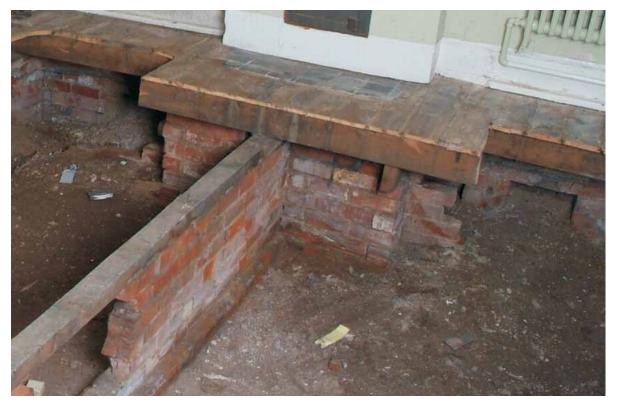
Plate 18.24: Building 18 – ground floor: eastern chimney showing stubs of brick ducting projecting from the chambered hearth plinth, view to the northeast

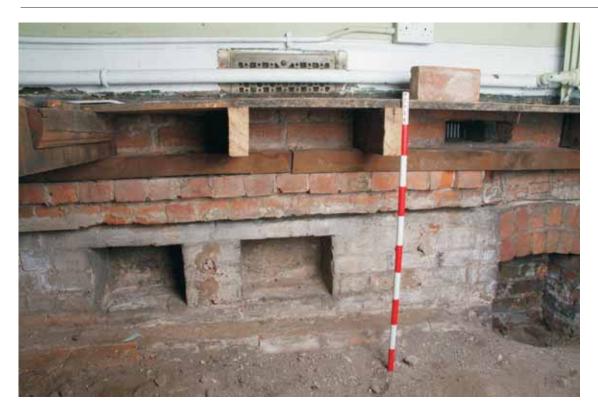
Plate 18.25: Building 18 – ground floor: interior of northern elevation showing openings to vertical shafts below the ground floor, view to the north

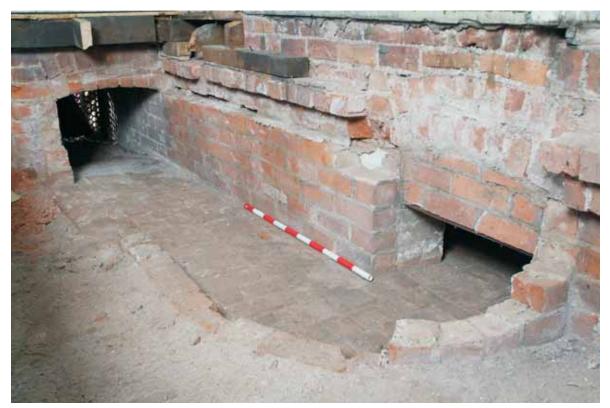
Plate 18.26: Building 18 – demolition of lower storey showing plaster lined shafts within the north and east walls, view to the northwest

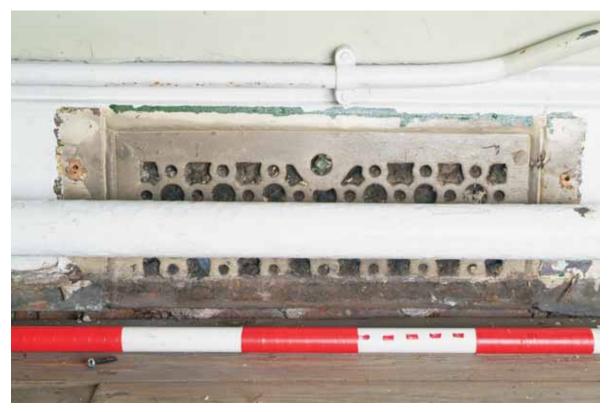
Plate 18.27: Building 18 – ground floor: main air inlet duct beneath duty room floor, view to the northwest

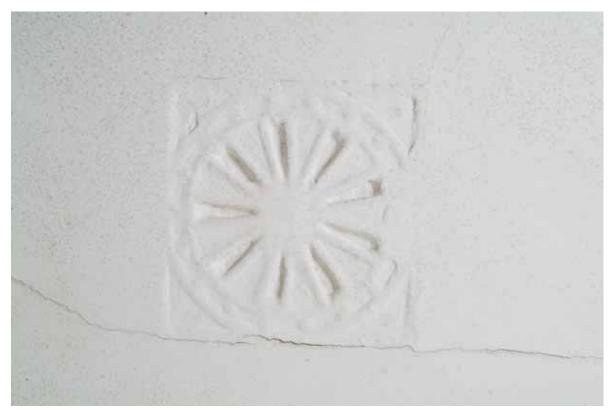
Plate 18.28: Building 18 – ground floor: detail of controllable grill in skirting board

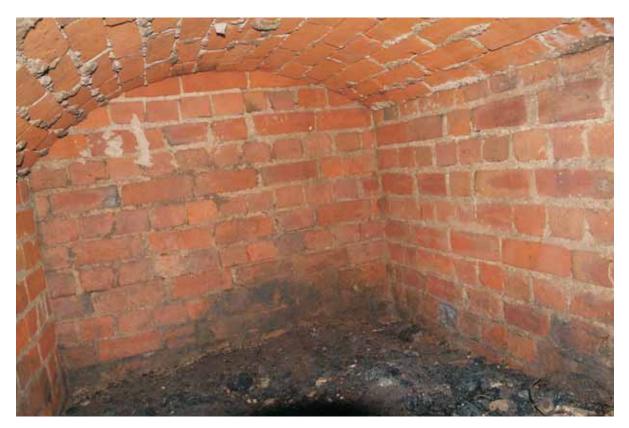
Plate 18.31: Building 18 – basement: exterior of barrel vault, view to the west

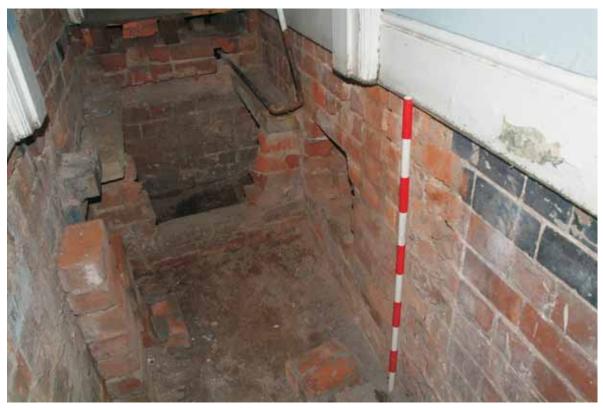
Plate 18.33: Building 18 – basement: interior showing blocked former entrance, view to the west

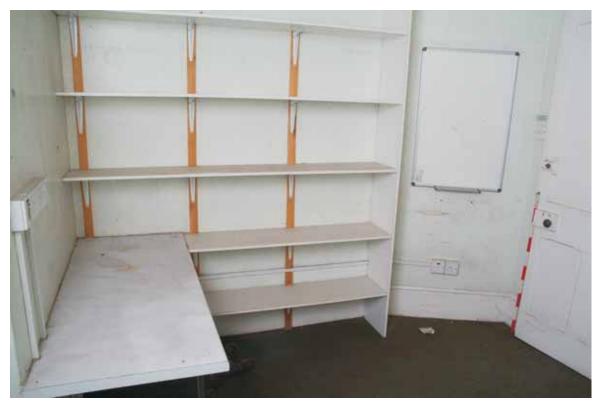
Plate 18.37: Building 18 – first floor: interior of eastern ward showing inserted partition, view to the northwest

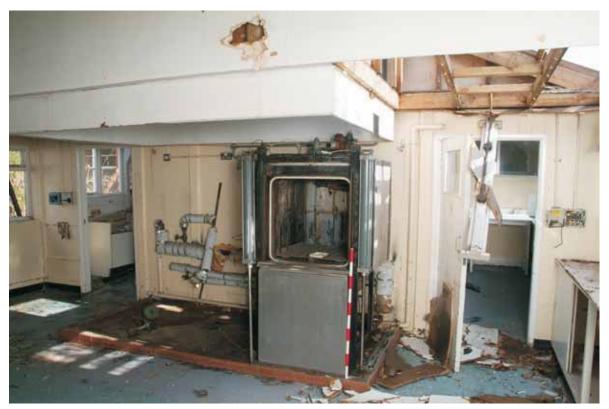
Plate 20.6: Building 20 – detail of effluent scrubber in northern hut, view to the northeast

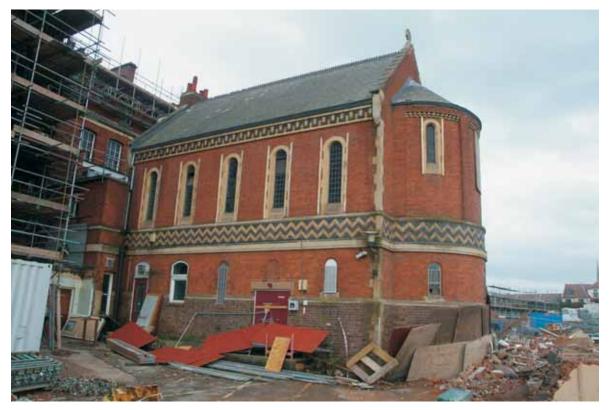
Plate 22.1: Building 22 – general view westwards showing the chapel following the demolition of Building 17

- 5.55 The Chapel comprises a westward projection from the centre of the main Infirmary building (Plate 22.1) and is Romanesque in style. The building stands on a basement and is linked to the main Infirmary building by a two storey block containing consulting rooms and a central corridor at chapel level, linking it with the boardroom. The Chapel consists of a nave and apse, whilst below are store rooms and the main electrical switch room for the Infirmary.

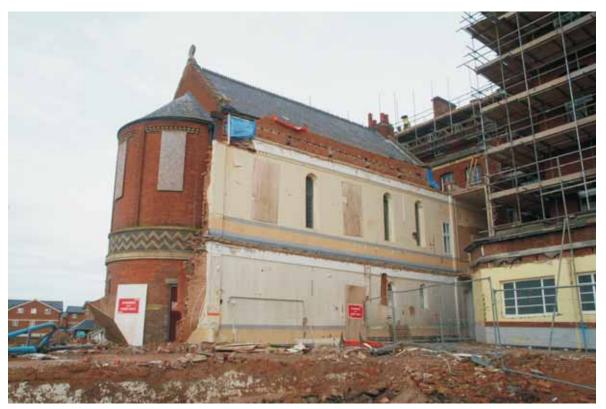
Plate 22.2: Building 22 – northern elevation

- 5.56 The most representative elevation (Figure 11) at the time of this record was that to the north (Plate 22.2) as the whole of the external southern side of the nave had, for the most part been obscured by a brick skin which had formed the north side of the two storey link corridor connecting the main Infirmary with Building 17a. During the course of the recording work however, this corridor was removed (Plate 22.3) and the brick skin carefully stripped away revealing the majority of the original elevation largely intact (Plate 22.4). The exception to this is a series of three later openings at the eastern end of the elevation (Plate 22.5) which are different in proportion to those on the north side of the building and are fitted with timber hopperlight windows (Plate 22.6) and a wide

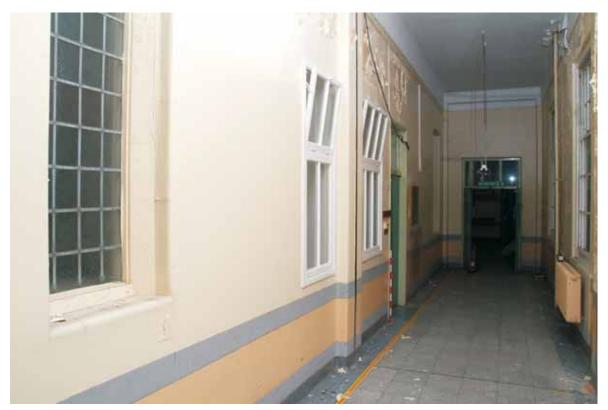
Plate 22.4: Building 22 – detail of southern elevation during removal of brick skin (corridor wall), view to the east

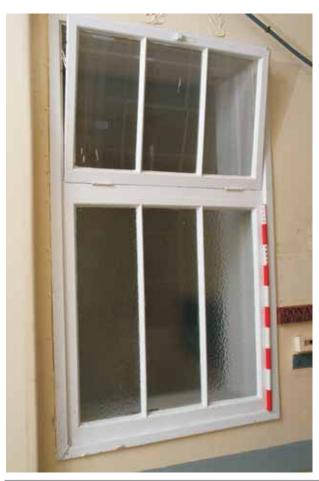
Plate 22.5: Building 22 – upper ground floor: later openings in former external southern elevation, view to the northeast

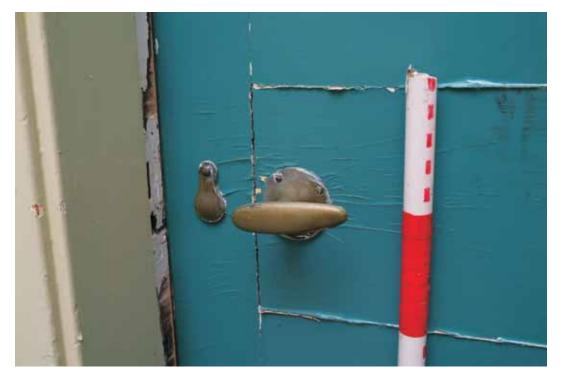
Plate 22.7: Building 22 – upper ground floor: detail of modified original door in formerly external southern elevation, view to the northeast

solid timber door (Plate 22.7). The fittings on the door are typical of the 1920s and early 1930s (Plate 22.8), as is the overlight above, although the width of the door itself suggests that it may be a modified mid 19th century internal door which has had the panels on the outside filled in. The interior of this door retains its recessed panels (Plate 22.9) and closely resembles others inside the connecting range.

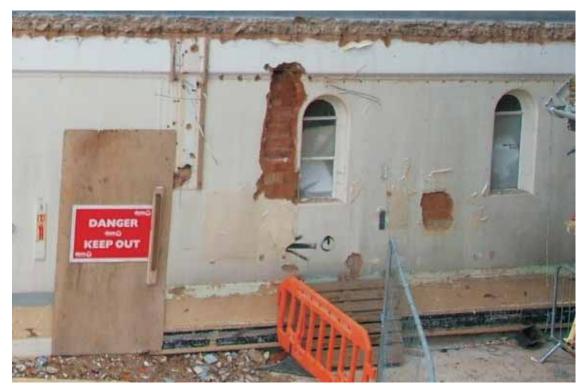
Plate 22.12: Building 22 – original basement windows in southern elevation, view to the northeast

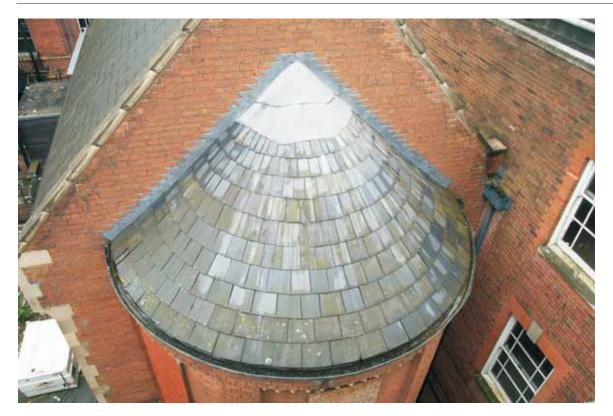
Plate 22.13: Building 22 – half conical roof of apse, view to the east

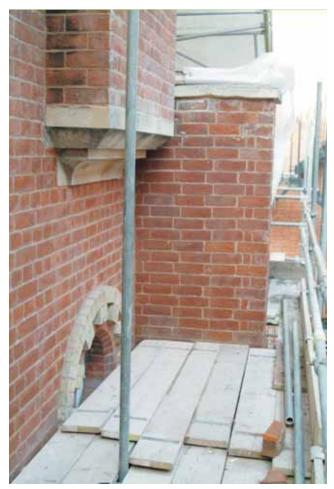
Plate 22.15: Building 22 – oculus in eastern elevation (partly obscured by scaffolding), view to the northwest

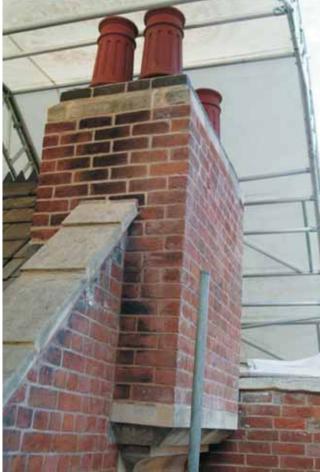
Plate 22.16: Building 22 – chimney stack at apex of east elevation, view to the northwest

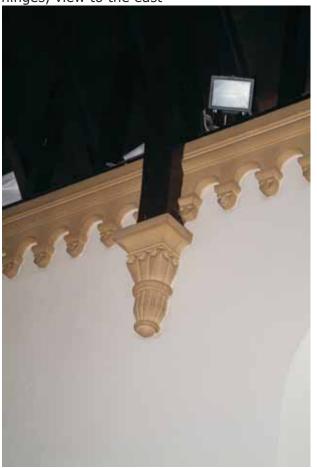
Plate 22.20: Building 22 – nave: detail of moulded corbel cornice and stone corbel block, view to the northwest

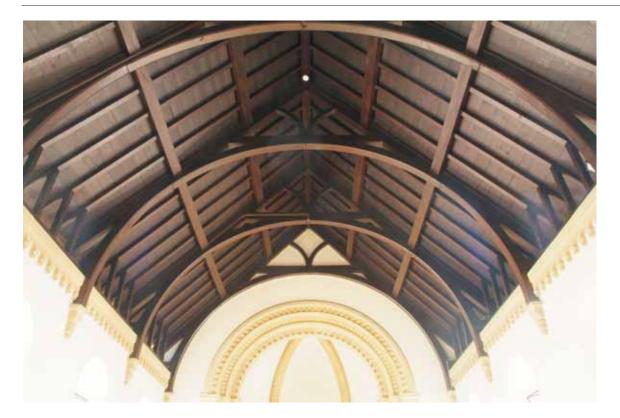
Plate 22.21: Building 22 – nave: roof structure, view to the west

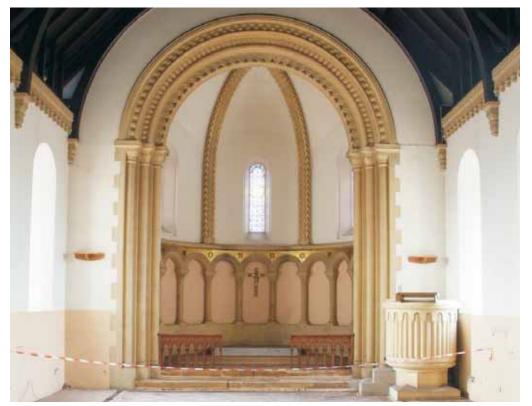
Plate 22.29: Building 22 – nave: interior showing floor detail, view to the west

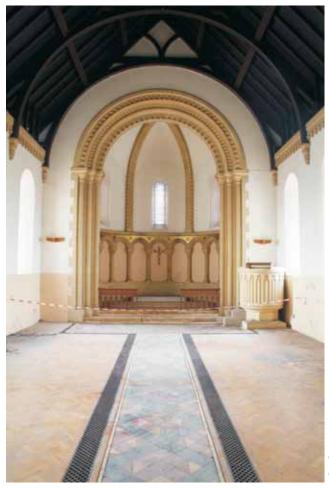
Plate 22.30: Building 22 – nave: chancel arch and pulpit at the west end, view to the west

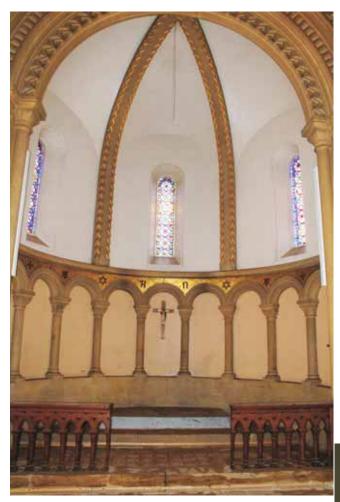
Plate 22.31: Building 22 – chancel: interior showing communion rail, blind arcade and ribs, view to the west

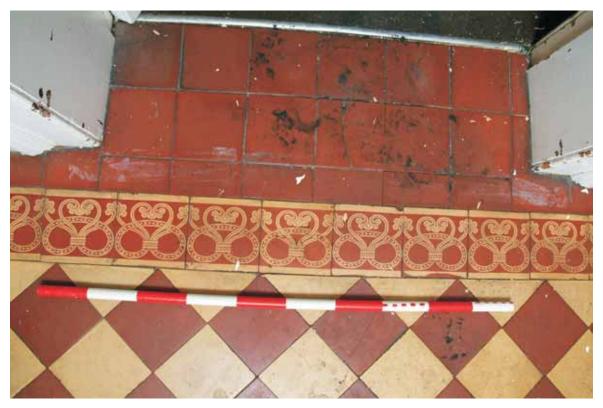
Plate 22.37: Building 22 – connecting range: central corridor on upper ground floor showing detail of floor tiles, view to the north

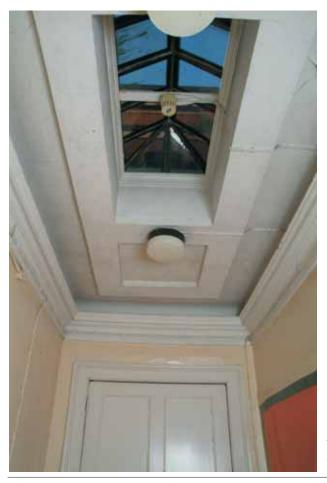
Plate 22.38: Building 22 – connecting range: central corridor on upper ground floor showing ceiling detail, view to the east

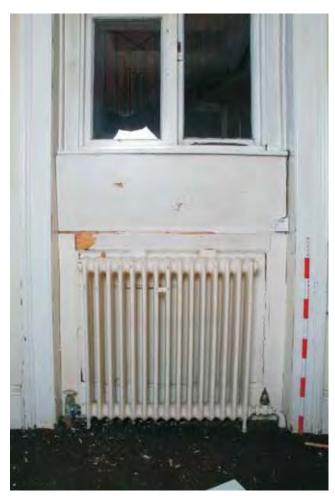
Plate 22.41 : Building 22 – connecting range: medical library on upper ground floor showing detail of original panelling behind radiator, view to the north

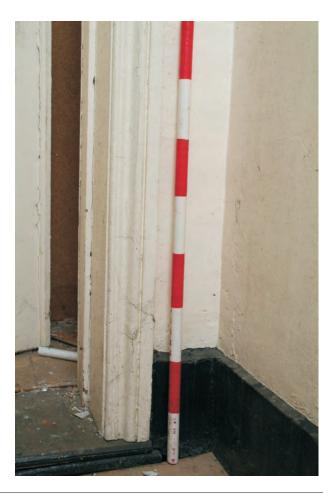
Plate 22.46: Building 22 – connecting range (LGF): detail of skirting within the central corridor and architrave to the contingency store, view to the southwest

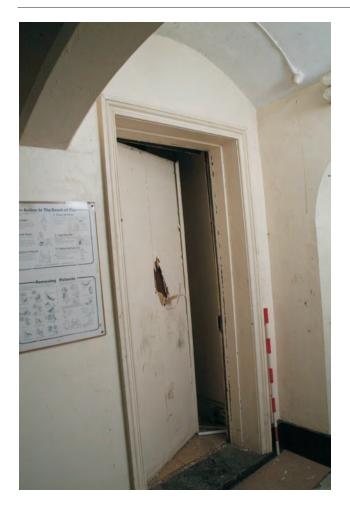
Plate 22.47: Building 22 – connecting range (LGF): door from the central corridor to the 'Contingency Store', view to the southwest

- 5.73 On the south side of the connecting range corridor was a doorway fitted with a narrow moulded architrave indicating that this may not have been an original opening (Plate 22.47). The door had been removed and the opening sealed with a plasterboard panel. Consequently, the room to the south of the corridor was accessed from the Building 17 link corridor and was identified by a sign on **the door as being the 'contingency store' (Plate 22.48).**

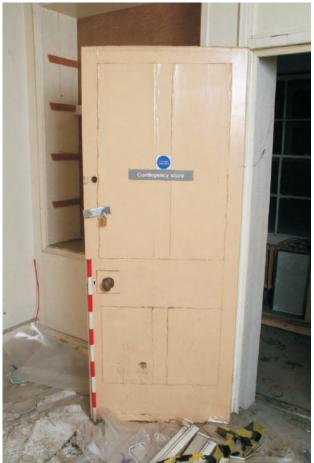
Plate 22.48: Building 22 – connecting range (LGF): door from the Building 17 link corridor to the 'Contingency Store', view to the southeast

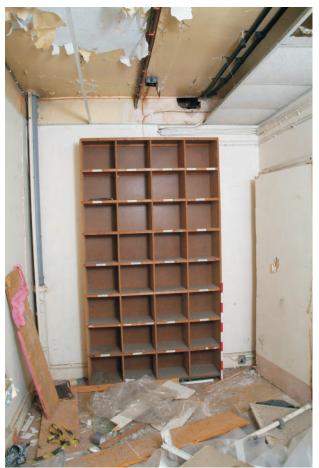
Plate 22.49: Building 22 – connecting range (LGF): interior of the 'Contingency Store', view to the west

- 5.74 Internally (Plate 22.49), the room contains moulded timber skirting (Figure 15) similar in style to those seen in Building 43 (Mulberry House). The room was lit by a window in the south wall, borrowing light from the link corridor. A second opening set at a high level on the northern wall of this room has been blocked, but may have served as a window lending light to the central corridor (Plate 22.50). This wide, short high level opening was mirrored on the northern wall of the central corridor and both had chamfered outer edges suggesting that they were original features of this range.

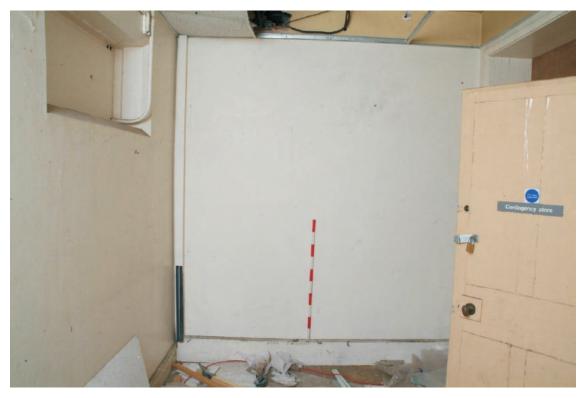
Plate 22.50: Building 22 – connecting range (LGF): interior of the 'Contingency Store' showing high level blocked window (left), view to the east

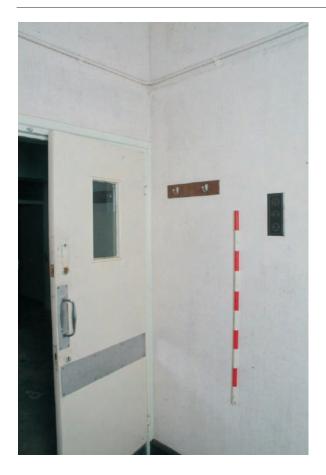
Plate 22.53: Building 22 – connecting range (LGF): interior of the 'ECG Department' showing early 20th century fittings, view to the northeast

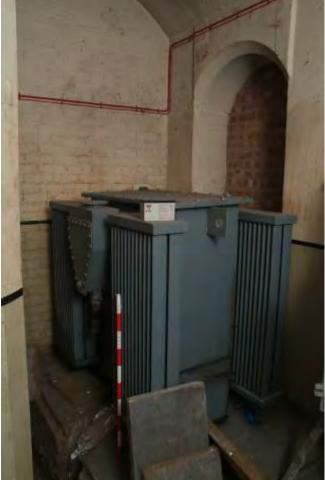
Plate 22.72: Building 22 (LGF): interior of the transformer room showing surviving transformer and brick lined sub floor ducting, view to the southwest

showing surviving transformer and brick lined sub floor ducting, view to
	the southwest
Plate 22.73:	Building 22 – lower ground floor: interior of the transformer room
	showing modified window, view to the north
Plate 22.74:	Building 22 – lower ground floor: interior of the northern side of the
	transformer room showing historic signage, view to the east
Plate 22.75:	Building 22 – lower ground floor: detail of historic sign
Plate 22.76:	Building 22 – lower ground floor: detail of historic sign
Plate 22.77:	Building 22 – lower ground floor: interior of apse showing inserted
	doorway, view to the south
Plate 22.78:	Building 22 – lower ground floor: interior of apse showing surviving
	window opening, view to the north
Plate 22.79:	Building 22 – lower ground floor: interior of apse showing former
	doorway from central aisle, view to the south
Plate 22.80:	Building 22 – lower ground floor: detail of historic floor tiles (re-laid)

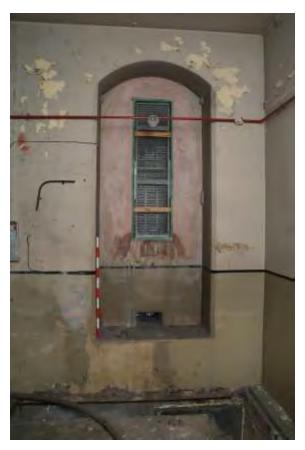
Plate 22.73: Building 22 (LGF): interior of transformer room showing modified window, view to the north

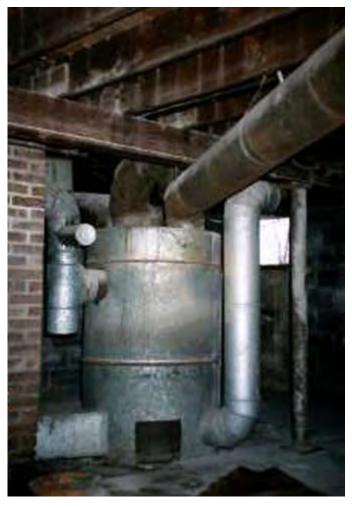
Plate 22.81: Building 22 (LGF): example of an 'Octopus Furnace' (NOT FROM THIS SITE)

Plate 22.81:	Building 22 – lower ground floor: example of an 'Octopus Furnace' (not
	from this site)
Plate 23.1:	Building 23 – eastern elevation of short N – S corridor at the western
	end of the structure, view to the northwest
Plate 23.2:	Building 23 – exposed western elevation of short N – S corridor at the
	western end of the structure, view to the east
Plate 23.3:	Building 23 - exposed southern elevation of the E – W corridor at the
	western end of the structure, view to the north

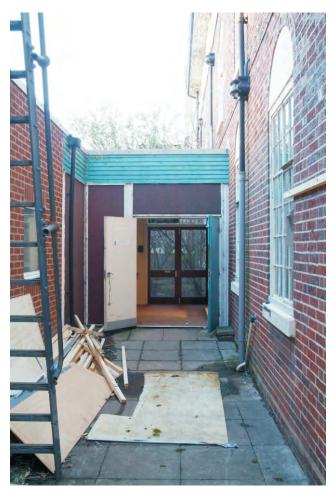
Plate 23.2: Building 23 - exposed western elevation of short N - S corridor at the western end of the structure, view to the east

- 5.91 The short north south corridor at the western end contained glazed double doors facing east and double timber doors facing west (Plate 23.2), both set adjacent to Building 27a. In addition, the exposed part of the east west corridor contained a long timber framed window (Plate 23.3). The short north-south section at the eastern end also contained doors in the sides giving access to the walkway from the western side of the Infirmary building (Plates 23.4 and 23.5) and this part of the structure was partly lit by a small roof light (Plate 23.6).

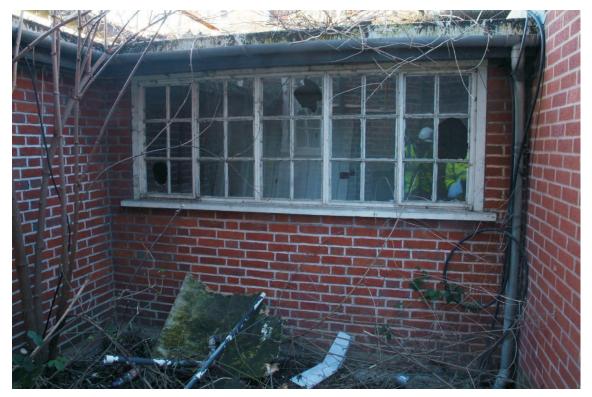
Plate 23.3: Building 23 - exposed southern elevation of the E - W corridor at the western end of the structure, view to the north

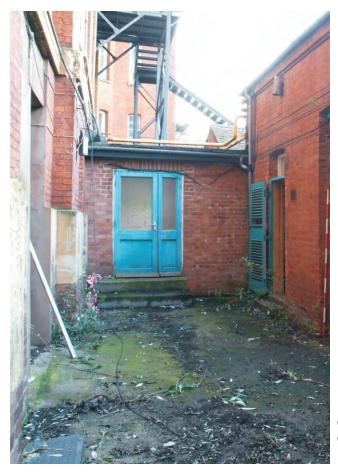
Plate 23.4: Building 23 - exposed western elevation of short N - S corridor at the eastern end of the structure, view to the east

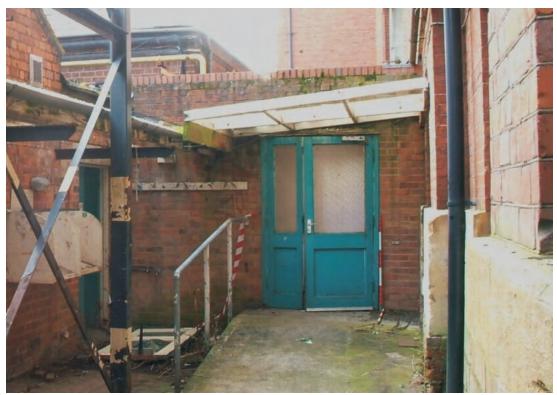
Plate 23.5: Building 23 - exposed eastern elevation of short N - S corridor at the eastern end of the structure, view to the west

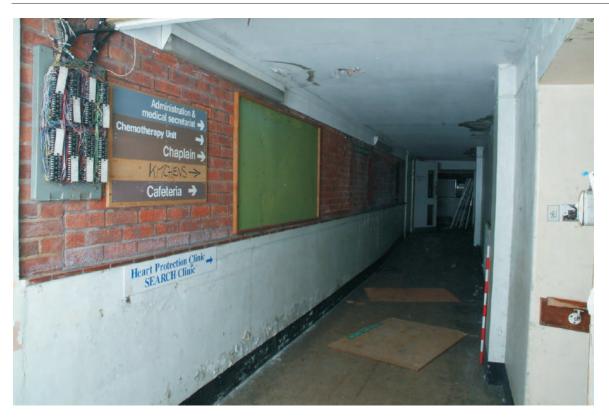
Plate 23.7: Building 23 - interior of the E - W corridor, view to the southwest

- 5.92 Internally, the long east west corridor was rendered and painted white, although the upper part of the southern wall had been left as exposed brick, defined by a red tile sill (Plate 23.7). The brickwork appeared to take the form of a series of regularly spaced brick piers (Plate 23.8) with more recent brick infill between. The space between the piers closely matched the size of the extant window at the west end of this wall and it was concluded that the whole

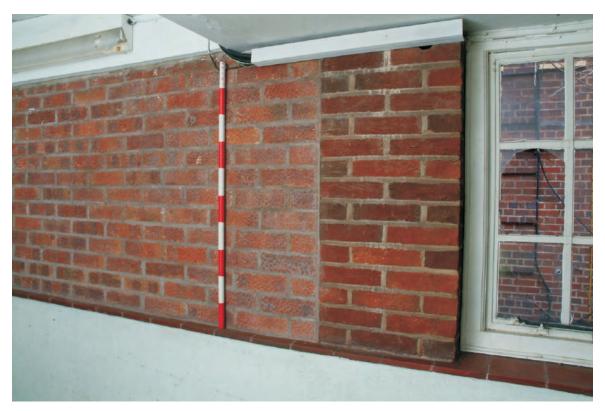
Plate 23.8: Building 23 - internal southern elevation of the E - W corridor at the western end of the structure showing pier and blocked opening, view to the southeast

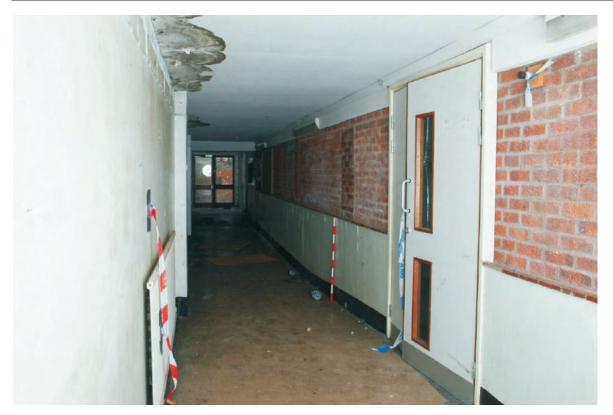
Plate 23.9: Building 23 - internal southern elevation of the E - W corridor showing inserted doorway to Building 32, view to the southeast

of the southern side of the corridor was originally glazed prior to the addition of the staff restaurant and kitchens (Buildings 49 and 32 respectively). Access between this walkway and the later staff restaurant was provided by an inserted pedestrian door in the southern wall (Plate 23.9) along with a wider opening at the east end (Plate 23.10). The walls of the corridor were adorned with staff notice-boards and signage and set on a pilaster on the northern side was a brass plaque (Plates 23.11 and 23.12) which read:

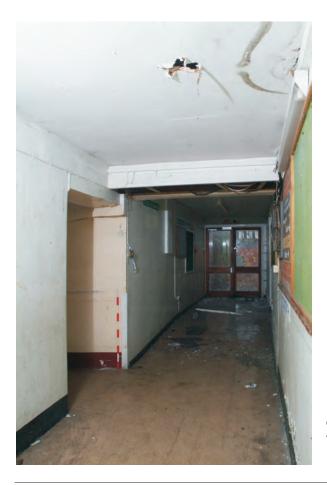
Plate 23.10: Building 23 - inserted opening to staff restaurant at east end of the E - W corridor, view to the northeast

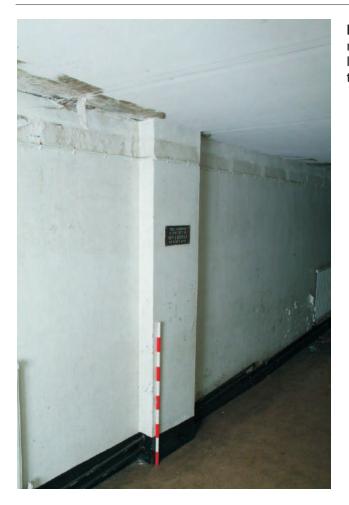
Plate 23.11: Building 23 - pilaster on the north wall of the E - W corridor showing location of commemorative plaque, view to the northeast

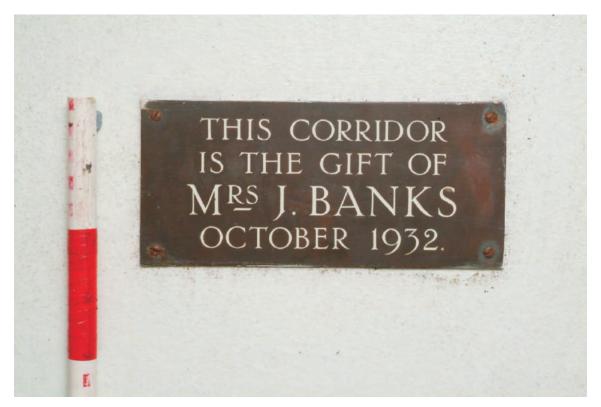
Plate 23.12: Building 23 - detail of commemorative plaque on internal north elevation

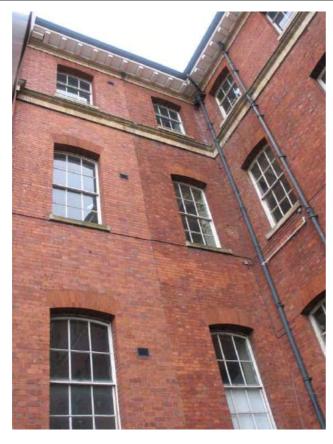
Plate 24.3: Building 24: detail of north facing elevation of SE wing showing point of extension

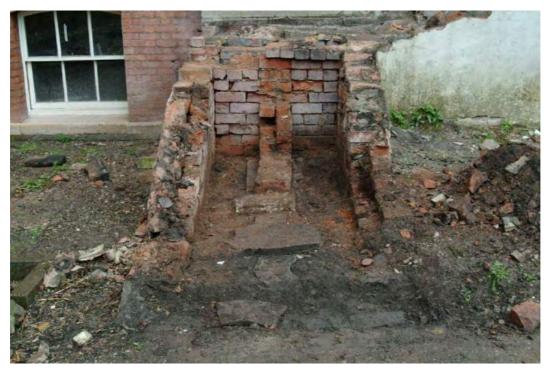
Plate 24.7: Building 24: detail showing structure of tread supports, view to the west

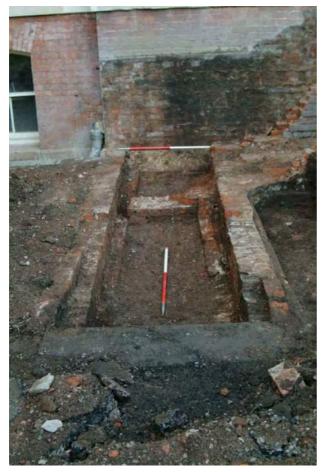
Plate 24.8: Building 24: post excavation shot following removal of central tread supporting wall, view to the west

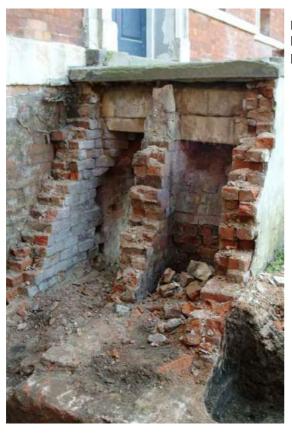
Plate 24.9: Building 24: exterior of barrel vault supporting central platform, view to the northwest

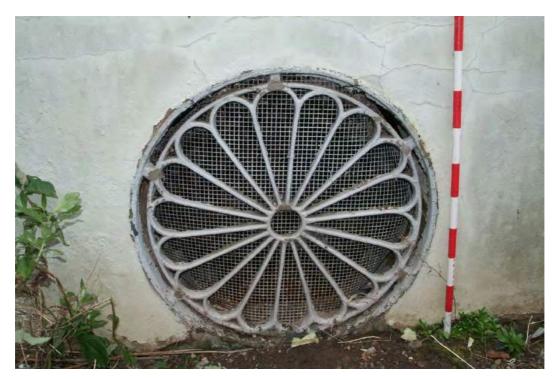
Plate 24.10: Building 24: detail of decorative grill across central oculus, view to the west

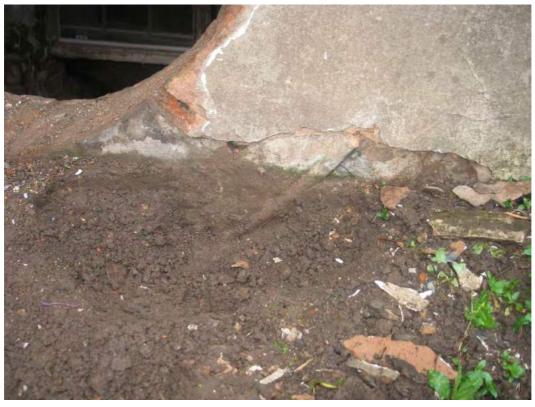
Plate 24.11: Building 24: detail showing surviving bead moulding around base of oculus, view to the southwest

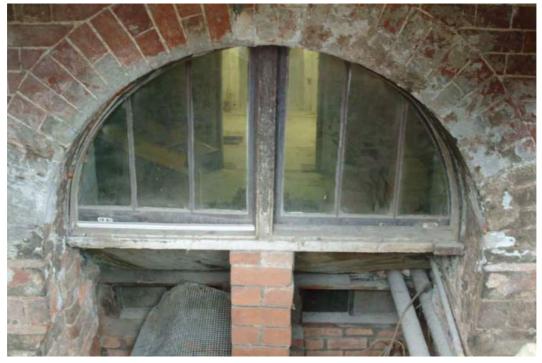
Plate 24.13: Building 24: enlarged opening through the infirmary wall beneath the central platform, view to the west

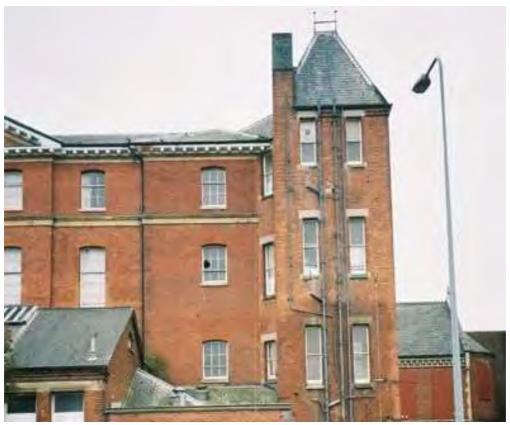
Plate 24.18: Building 24: detail of north western extension (Buildings 24b and 24g) showing vertical and horizontal changes in brickwork

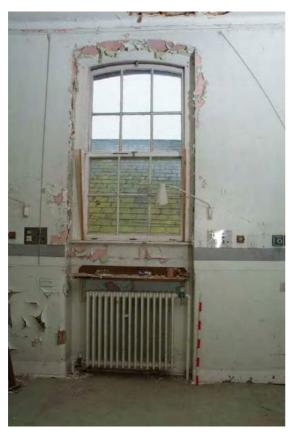
Plate 24.19: Building 24: detail of upper ground floor window in the northern elevation showing hopper light, view to the northwest

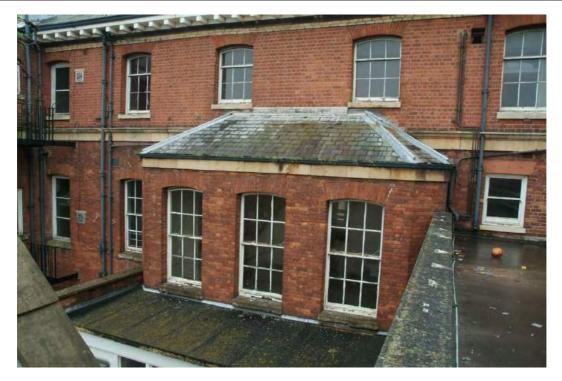
Plate 24.21: Building 24: detail of cental part of western elevation showing canted bay, view to the northeast

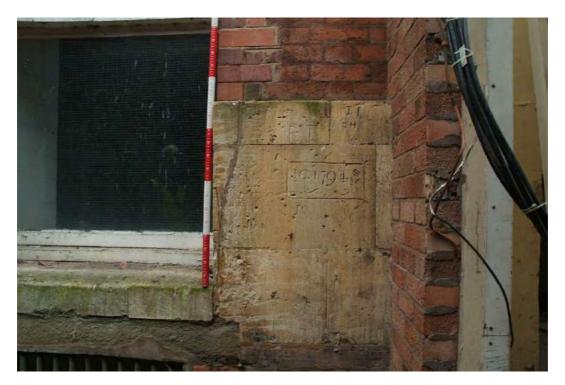
Plate 24.32: Building 24: southern elevation showing detail of graffiti on lower ground floor of original building (Building 24a)

To the west, this extended onto the later part of the building where an inscription dated 1851 was recorded high up on the brickwork (Plate 24.31). The most elaborate of these formed a rectangular frame inside which was **inscribed 'J.C. 1794' with a flower to the side and a scrolled motif below (Plate** 24.32). The letters J.C. were found repeatedly although the 1794 date was the earliest to be recorded. Another inscription was dated 1800 (Plate 24.33) whilst another, carried out by H. Olive? continued the theme of a rectangular border and was dated 189[9] (Plate 24.34). This graffiti was catalogued photographically but much of it was relatively un-informative, comprising undated initials or rather poorly executed characters which were difficult to decipher.

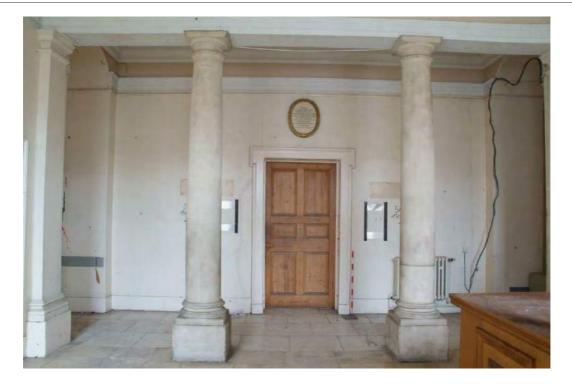
Plate 24.35: Building 24: entrance hall, view to the west

- 5.114 The centre of the upper ground floor (Figure 20) is occupied by the entrance hall [Room 1.31] (Plate 24.35) where the structure of the upper floors is carried on two Doric columns rising to an entablature (Plate 24.36) which frames the

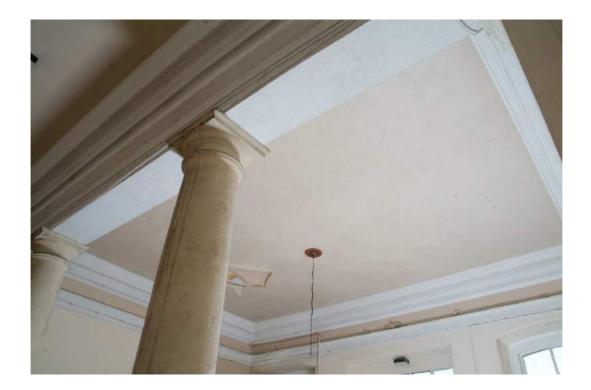
Plate 24.36: Building 24: entrance hall, detail of entablature, view to the northeast

hall ceiling and differentiates it from the cross passage leading to the wards on either side (Plate 24.37). The walls have Doric pilasters and round headed rebates in the east of the north and south walls (Plate 24.38) with that to the north having been historically broken through and re-blocked with a stud partition in which was set a low level fixed viewing panel (Plate 24.39) to the comms room^{Ψ} beyond. On the west side of the north wall is an original door with wide architrave but with a replacement four panelled stable door (Plate 24.40). The doorway is mirrored on the south wall of the entrance hall and this also has a replacement four panelled door. Set between the door and the rebate on this wall is a fireplace (Plate 24.41) with stone surround and brick back dating to the early 19th century. The floor is covered with stone slabs which extend into the cross passage as far as the wards. A modern reception desk has been set to the north of the hall complete with glass screen. The west wall features a single door with wide shouldered architrave and the opening is fitted with a broad six panelled door believed to be original (Plate 24.42). Above the door is a stone tablet with foliate border (Plate 24.43) which reads:

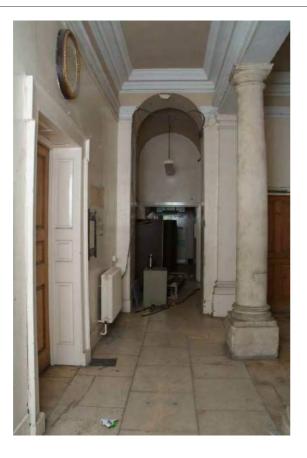
Plate 24.37: Building 24: main north-south corridor, view to the north

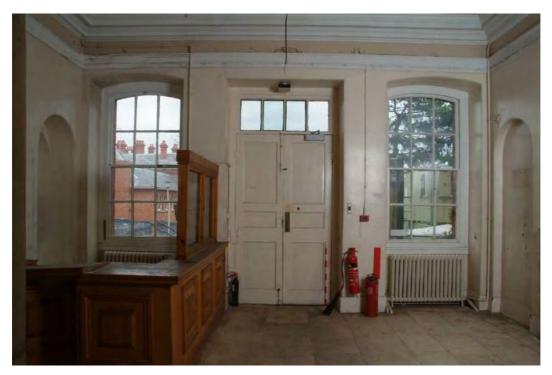
Plate 24.38: Building 24: entrance hall, view to the east

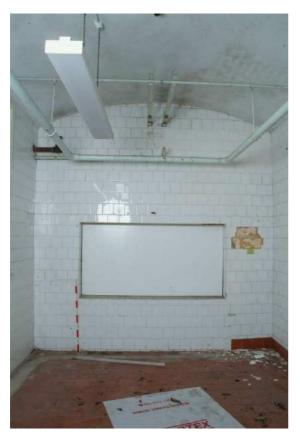
Plate 24.119: Building 24 (LGF): interior of southwest corner tower showing barrel vault, view to the west

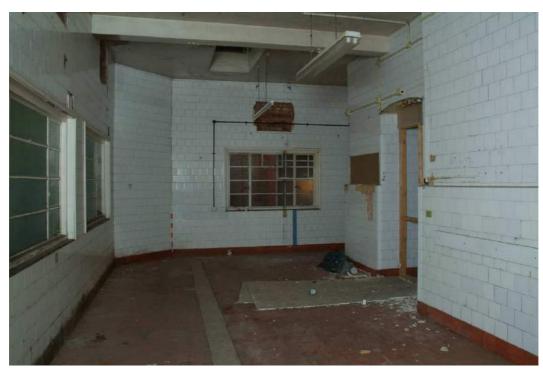
Plate 24.120: Building 24 (LGF): 1920s extension to main kitchens, view to the north

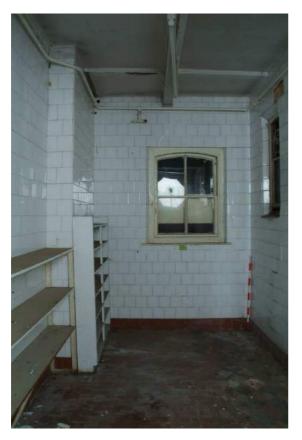
Plate 24.121: Building 24 (LGF): interior of northern annex to kitchens [Rom 105], view to the west

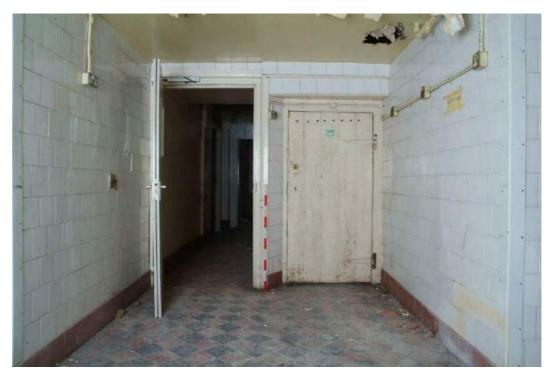
Plate 24.122: Building 24 (LGF): covered entrance to southern stairwell of infirmary and entrance to basement, view to the east

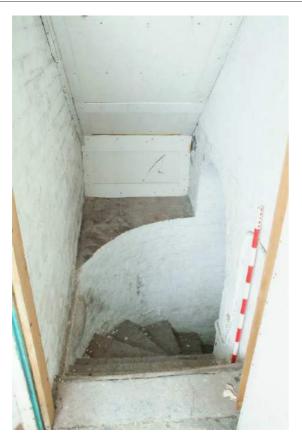
Plate 24.123: Building 24 (LGF): stairs to basement, view to the east

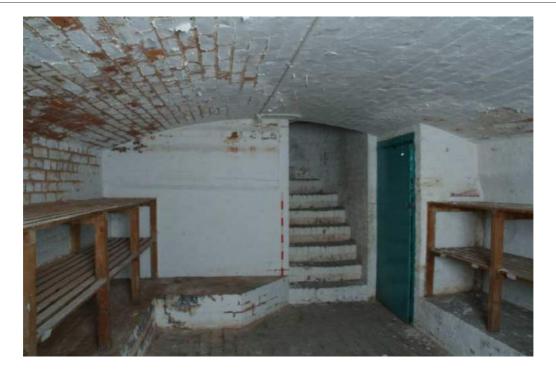
Plate 24.125: Building 24 (basement): interior showing stairs and cupboard

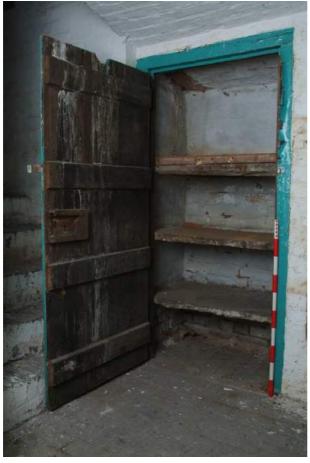
Plate 24.126: Building 24 (basement): detail of cupboard door, view to the northeast

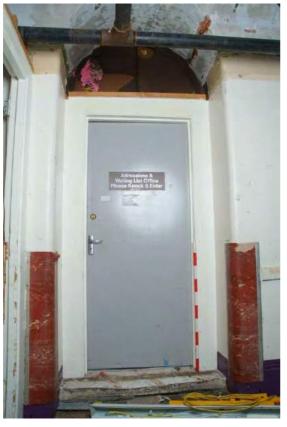
Plate 24.129: Building 24 (LGF): door to central eastern room [Room 102], view to the east

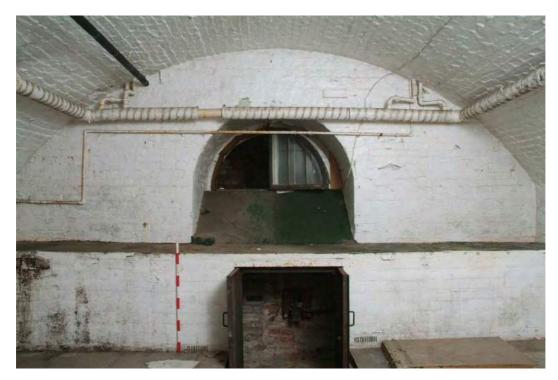
Plate 24.130: Building 24 (LGF): Room 89 showing inner conduit, view to the east
