Worcestershire Archaeology Research Report No.12

Historic Building Non-technical Record Report

THE FORMER WORCESTER ROYAL INFIRMARY, CASTLE STREET, WORCESTER

Part 1: Report, Appendices 1–3, Figures

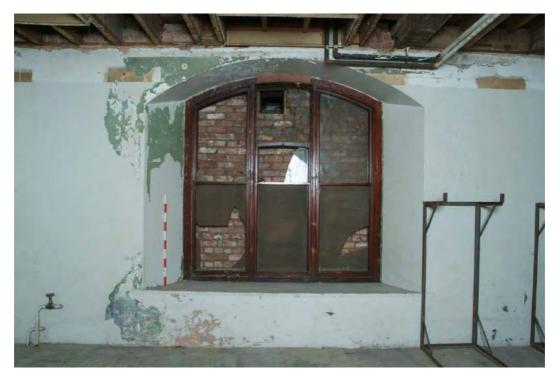
Plate 24.134: Building 24 (LGF): detail of northern original window and blocking of Building 24e [Room 91], view to the north

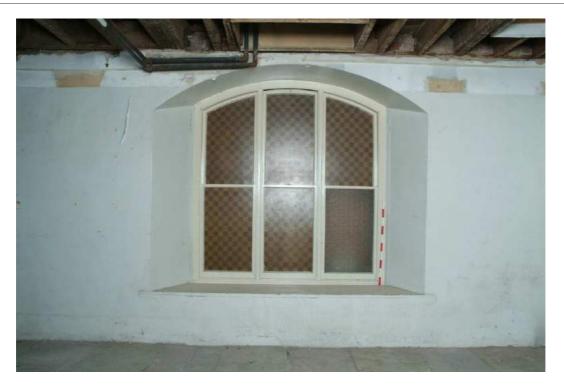
Plate 24.135: Building 24 (LGF): detail of southern original window and blocking of Building 17 link corridor [Room 91], view to the south

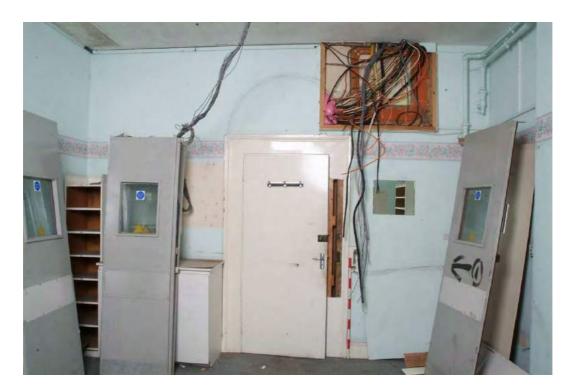
Plate 24.136: Building 24 (LGF): interior of office [Room 88] showing blocked head, view to the west

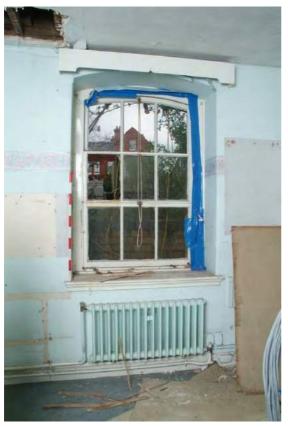
Plate 24.137: Building 24 (LGF): interior of office [Room 88] showing modified original window, view to the west

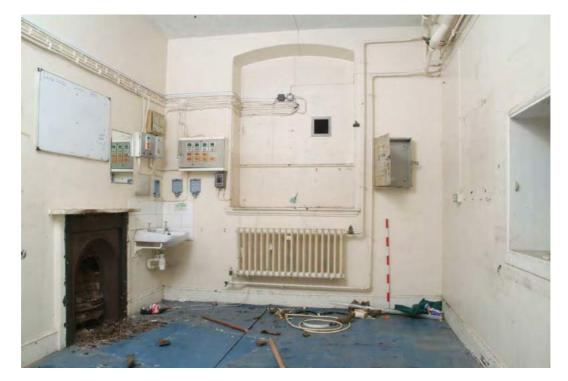
Plate 24.138: Building 24 (LGF): interior of enquiries office [Room 86] showing blocked original window

86] (Plate 24.138) The enquiries office contains an early 19th century cast iron grate (Plate 24.139) and had lost its western window during the construction of Building 24e.

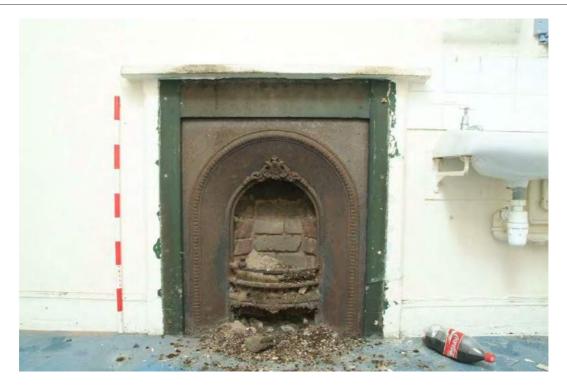
Plate 24.139: Building 24 (LGF): detail of late Victorian chimney piece in enquiries office, view to the south

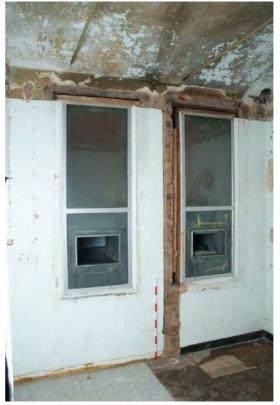
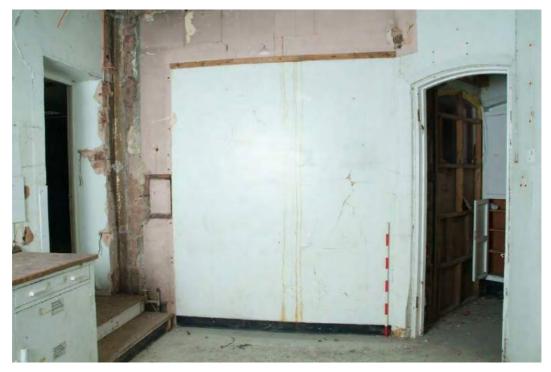
Plate 24.148: Building 24 (LGF): air ducts in modified original window openings, view to the southwest

Plate 24.149: Building 24 (LGF): original (right) and inserted (left) doorways in pharmaceutical store, view to the east

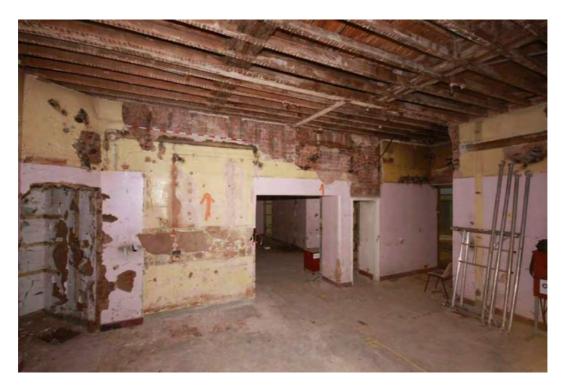
Plate 24.150: Building 24 (LGF): blocked openings in original western elevation of north wing (Building 24a) following soft strip, view to the southeast

- 5.145 Despite the modern finishes to the Spire Suite, during the refurbishment of the building, the blocked window openings and brick heads in the original western elevation of the northern range were observed (Plate 24.150).

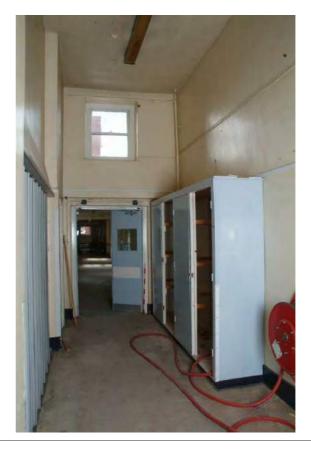
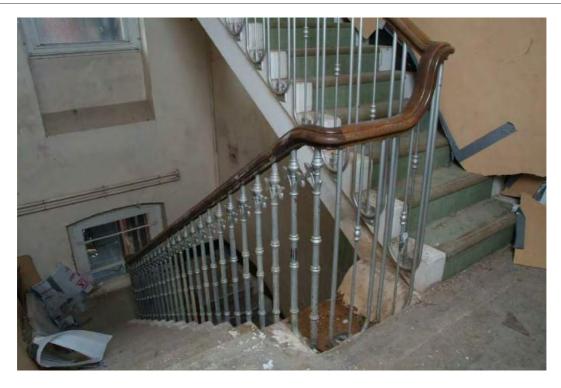
Plate 24.157: Building 24 (FF): change in form of balustrade to northern staircase, view to the northwest

- 5.147 It is at this level that the principal staircase in the north changes in form (Plate 24.157), both in style and quality. The balusters take the paired form of those seen below but comprise simple rods with central embellishment (Plate 24.158). This almost certainly reflects the construction of an additional storey in c1865s, but the existing balustrade is more reminiscent of the 20th century.

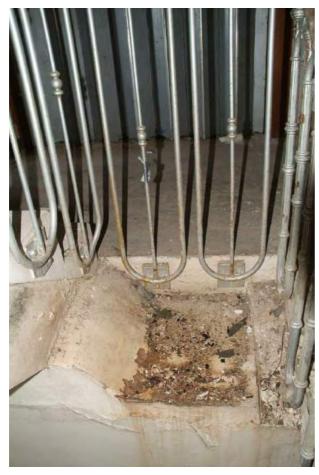
Plate 24.158: Building 24 (FF): detail of balustrade above first floor level

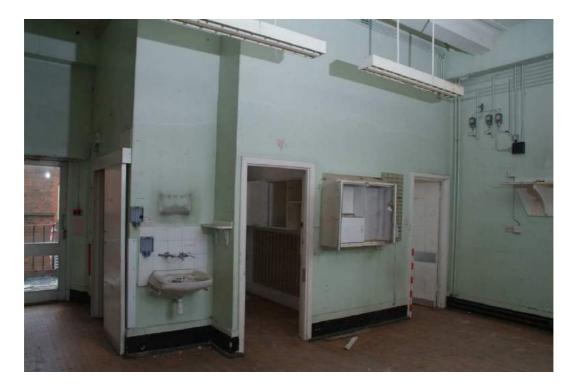
Plate 24.164: Building 24 (FF): inserted 1940s partitions at west of Garlick Ward, view to the southwest

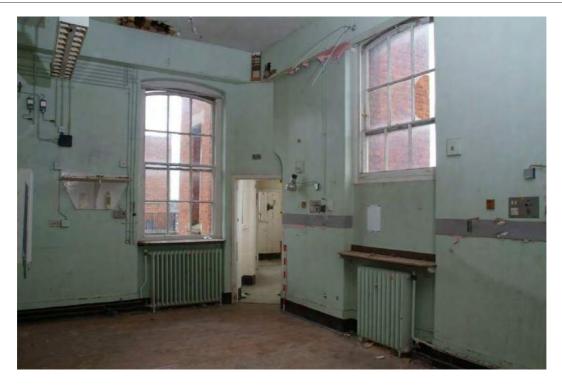
Plate 24.165: Building 24 (FF): west end of Garlick Ward showing short window (right), original window (left) and mis-aligned entrance to tower closet, view to the northwest

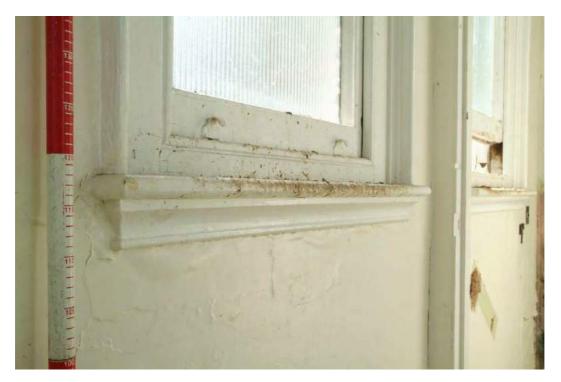
Plate 24.166: Building 24 (FF): detail of typical sill in northwest corner tower

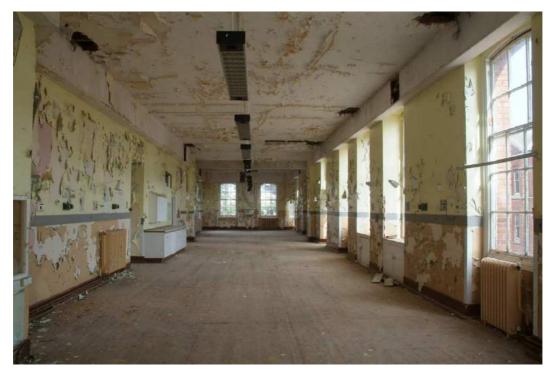
Plate 24.179: Building 24 (FF): Ganderton Ward [Room 2.34], view to the east

- 5.151 The Ganderton ward is the most open of those recorded (Plate 24.179) and has partitions only in the west (Plate 24.180). Set in the floorboards of the ward was a circular plate which unscrewed to reveal the stop cock (Plate 24.181). The high level bressumer in the closet wing is visible (Plate 24.182) and the partitioning has produced two side wards against the north and west walls. Within the southwest corner tower the original ceiling is visible beyond the late 20th century false ceiling. To the east, the ward is wholly open (Plate 24.183).

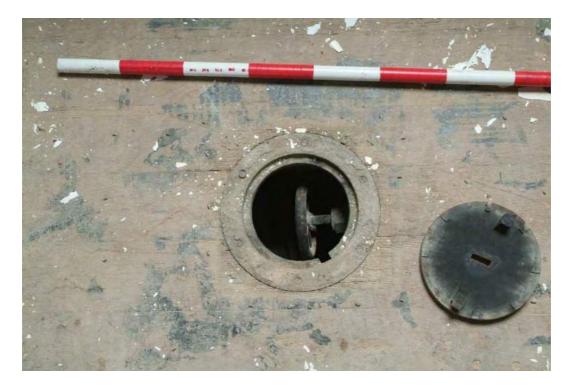
Plate 24.180: Building 24 (FF): detail showing brass stop cock opening in floor

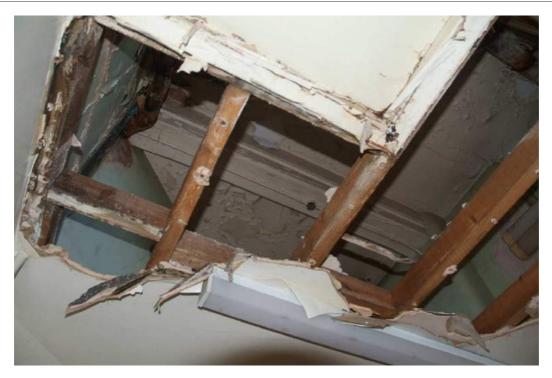
Plate 24.181: Building 24 (FF): exposed joist carrying 3rd floor over closet wing opening, view to the southwest

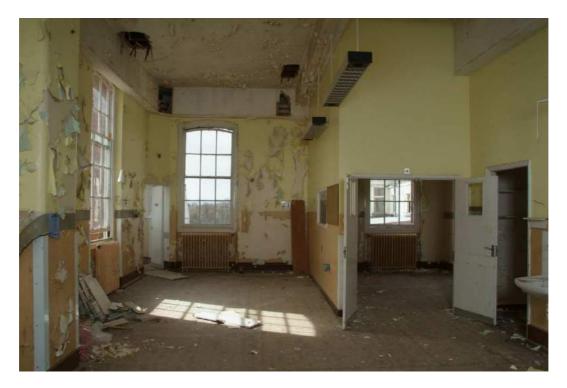
Plate 24.182: Building 24 (FF): western end of Ganderston Ward showing inserted partitions, view to the west

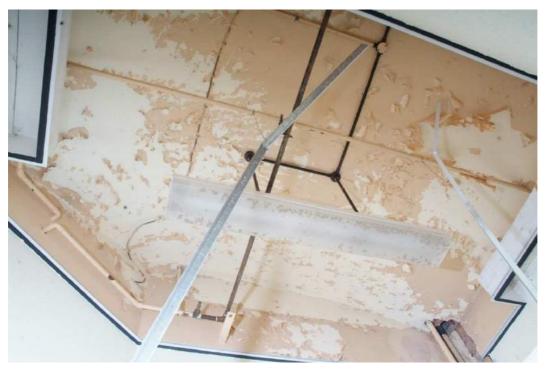
Plate 24.183: Building 24 (FF): exposed original ceiling of the southwest corner tower, view up

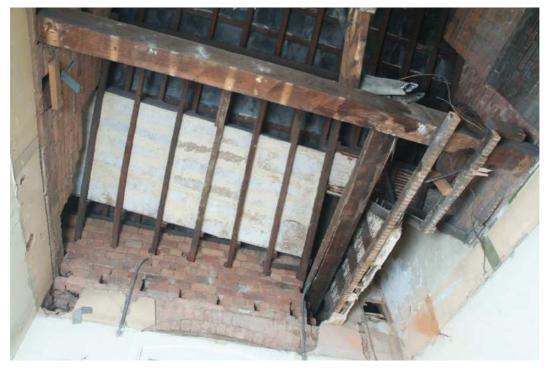
Plate 24.189: Building 24 (SF): historic roof structure following removal of false ceiling over northern stairwell, view to the northwest

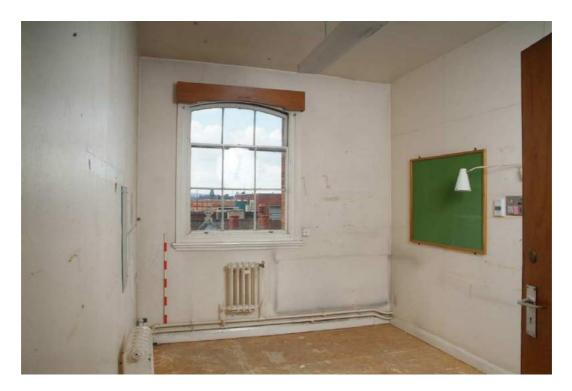
Plate 24.192: Building 24 (SF): central western room showing subdivision, view to the west

does not have the Building 17 link corridor opening out at the west end and instead remains in close to its original form providing a small store room (Plate 24.191). The room above the boardroom had been sub-divided by the insertion of a modern stud wall (Plate 24.192).

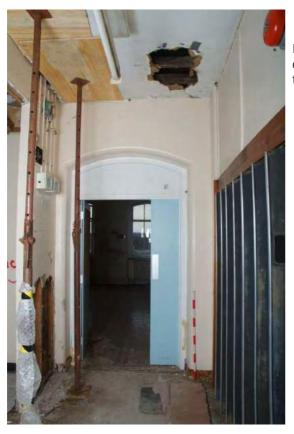
Plate 24.193: Building 24 (SF): entrance to the Maddox Ward, view to the north

- 5.154 The northern opening to the Maddox ward (Plate 24.193) was fitted with an early 20th century screen and door and the interior ward was partitioned in the same way as on the floor below (Plate 24.194). Analysis of the windows revealed that they had been installed during the mid 19th century (Plate 24.195) and the arrangement in the ward (Plate 24.195 and 24.196) was similar to that in the Garlick ward below, including the introduction of a metal framed fire escape into the southern wall (Plate 24.197). However, on this floor the closet wing which had been broken through from the north on all other floors survived in its original arrangement (Plate 24.198), having a doorway in the western side. It was clear that the room had been reused as a plant room. In the roofspace above this room was a ceramic flue held in a timber framework (Plate 24.199) which appeared to be used for the conduction of hot gasses from this room through the east wall of the building and into the area of the stairs. When viewed from outside, this area contains an early 20th century flue cover (Plate 24.200) which was thought more than a coincidence.

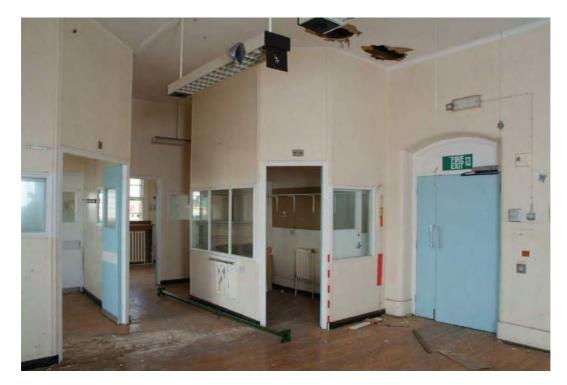
Plate 24.194: Building 24 (SF): subdivision of the eastern part of Maddox Ward, view to the southeast

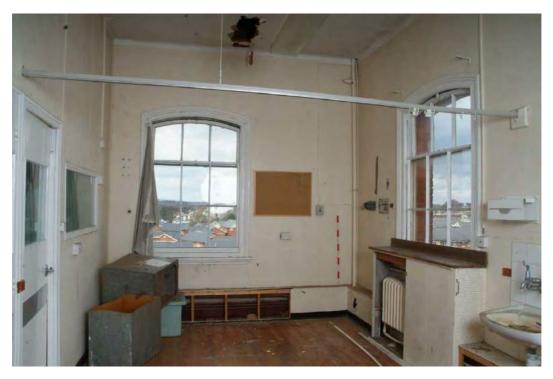
Plate 24.195: Building 24 (SF): easternmost area of Maddox Ward, view to the north

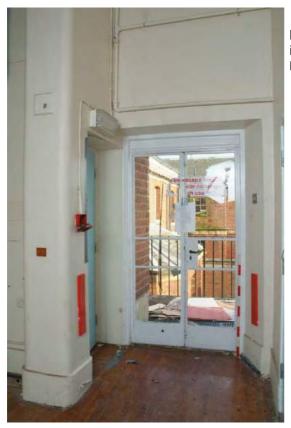
Plate 24.197: Building 24 (SF): inserted fire escape doors in west of Maddox Ward, view to the south

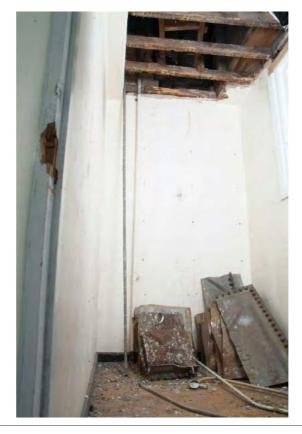
Plate 24.199: Building 24 (SF): ceramic conduit in roof above closet wing, view to the east

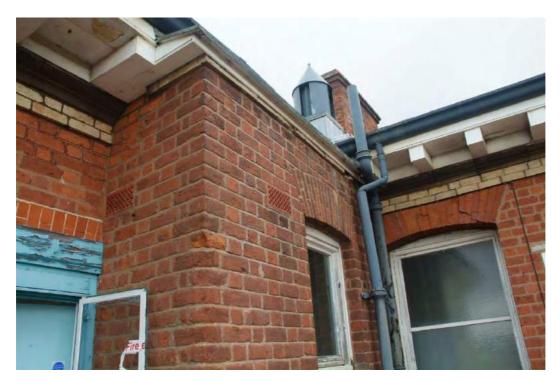
Plate 24.200: Building 24 (SF): cowl on roof above the closet wing, view to the northeast

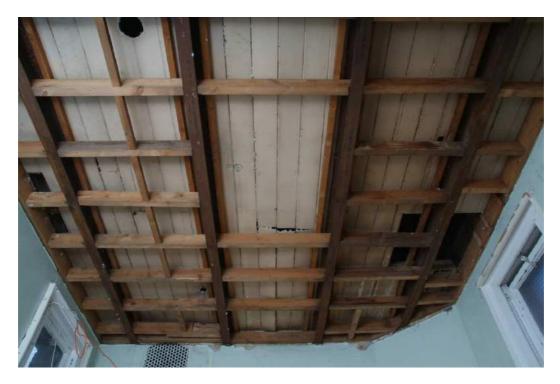
Plate 24.202 Building 24 (SF): ceiling of northwest closet wing showing inserted steel joists, view to the west

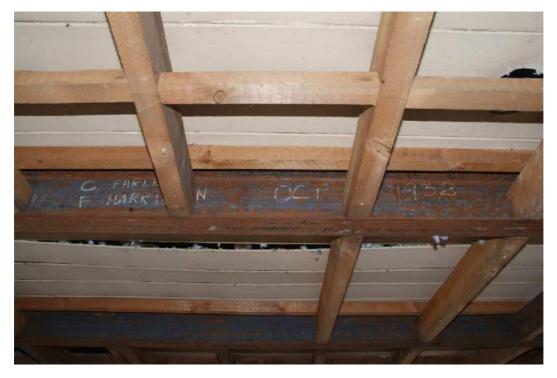
Plate 24.203: Building 24 (SF): detail of chalked inscription on steel joists, view to the south

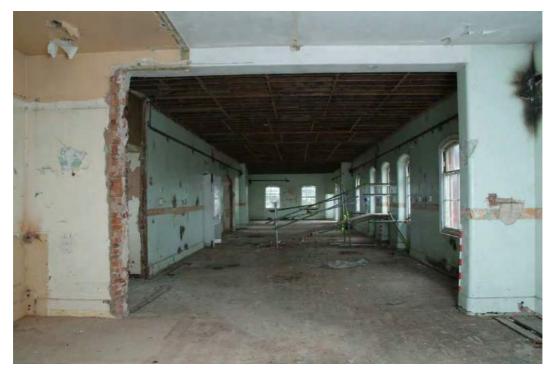
Plate 24.206: Building 24 (SF): general view of Bonaker Ward, view to the east

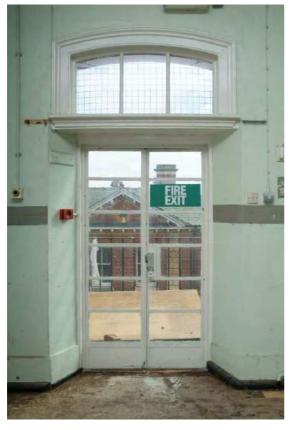
Plate 24.209: Building 24 (SF): inserted fire escape doors in south wall of Bonaker Ward, view to the south

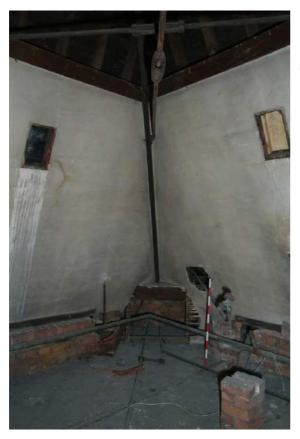
Plate 24.211: Building 24 (SF): lathe and plaster lining to roof of the southeast corner tower, view to the northwest

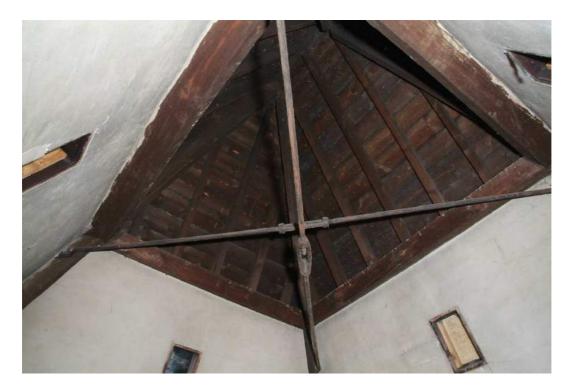
Plate 24.212: Building 24 (SF): structure of roof apex over southeast corner tower

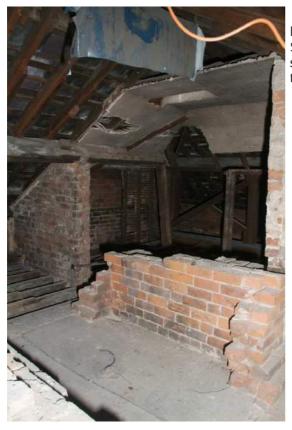
Plate 24.215: Building 24 (Roof Structure): former tank support structure in central part of roof, view to the southwest

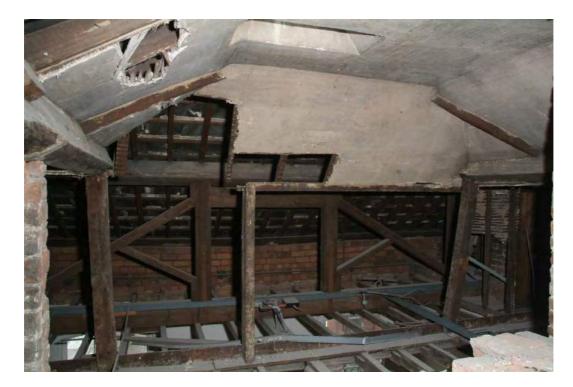
Plate 24.216: Building 24 (Roof Structure): lathe and plaster chamber in roof west of centre

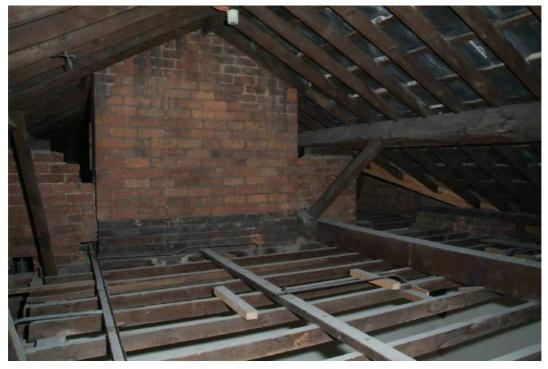
Plate 24.217: Building 24 (Room Structure): chimney showing extension, view to the south

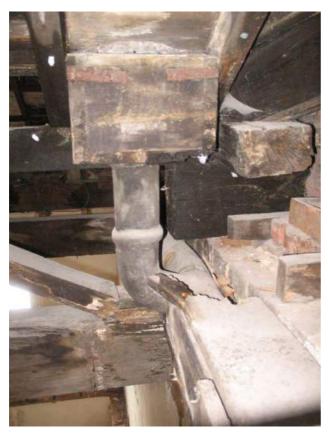
Plate 24.219: Building 24 (Roof Structure): internal lead rainwater hopper and pipe, view to the west

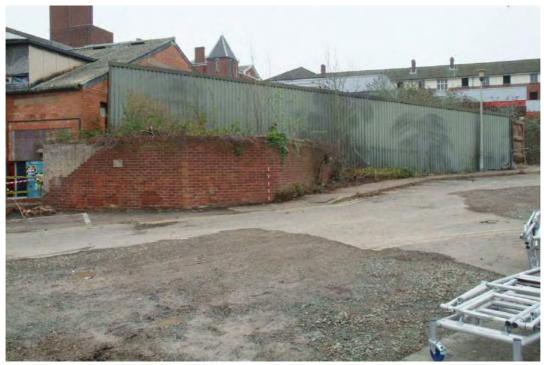
Plate 25.1: Building 25: general view of coal conveyor from the southwest

5.172 The existing coal conveyor was situated at the southern end of the boiler house (Building 10) and set at an angle to it. Comprising a steel framed container with pressed metal sheet cladding (Plate 25.1) and shipping container doors at the southeast end (Plate 25.2), the interior formed a single open space (Plate 25.3). The floor rose to the northwest and comprised a series of thin metal bars with protruding lugs (Plate 25.4) which were moved backwards and forwards by means of hydraulic motors beneath (Plate 25.5). Due to the shape of the lugs, coal placed in the southern end could be moved northwards up a slight gradient until it passed through a long slot in the southern elevation of the boiler house where it fell into hoppers.

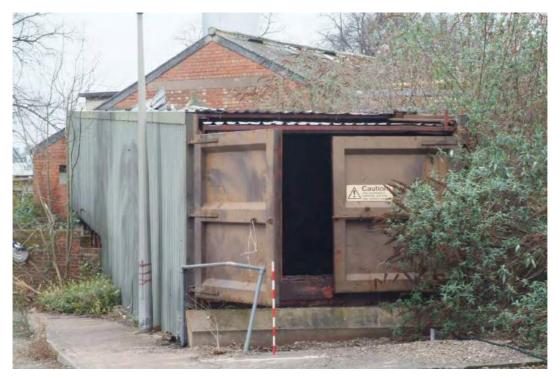
Plate 25.2: Building 25: shipping container doors at the south eastern end

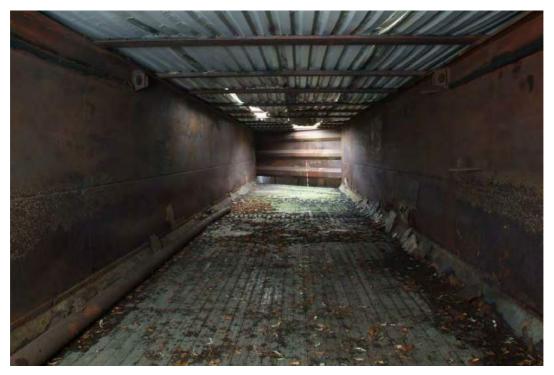
Plate 25.3: Building 25: interior, view to the northwest

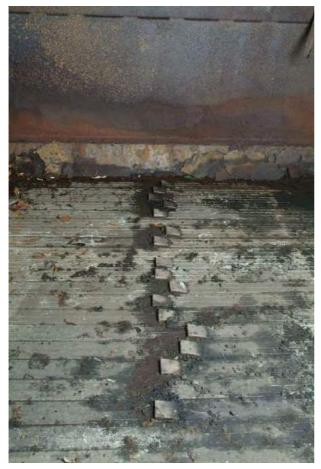
Plate 25.4: Building 25: detail of floor bars and lugs, view to the northwest

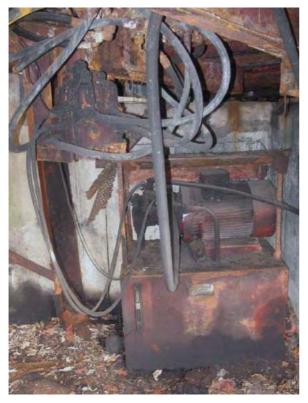
Plate 25.5: Building 25: hydraulic reservoir and pump beneath the conveyor, view to the east

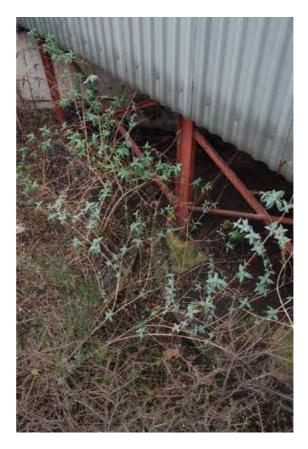
Plate 25.6: Building 25: interior of bunded tank showing conveyor trestles, view to the north

5.173 The structure is supported on metal trestles which allowed it to span a bunded open tank (Plate 25.6) that contained two circular foundations 4.57m in diameter (Plate 25.7). These had formerly supported oil storage tanks which were built when the heating plant for the Infirmary was changed from coal to oil in 1969³². Lying adjacent to these were a number of large metal screws which were associated with circular apertures in the base of the boiler house elevation (Plate 25.8) and it was likely that when the boilers were converted to coal, the bunded enclosure was reused as a coal store with coal being moved into the boiler house using these screws on the Archimedean principal of a screw conveyor.

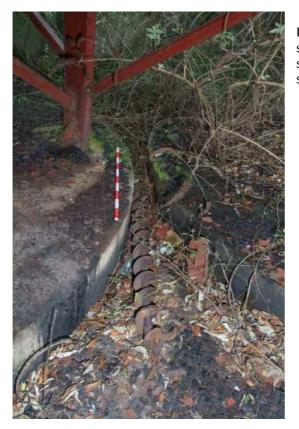
Plate 25.7: Building 25: foundation slabs for former oil storage tanks showing discarded screw, view to the south

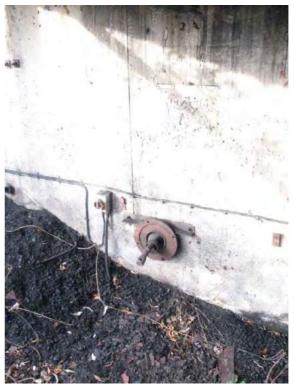
Plate 25.8: Buildings 25: appertures in lower part of boiler house southern elevation, view to the northwest

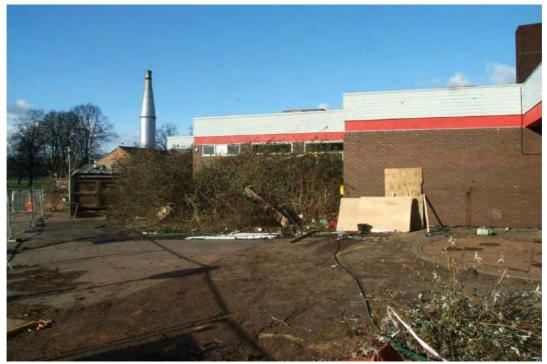
Plate 26.1: Building 26: exposed southern elevation, view to the north

- 5.175 The building was situated to the southwest of the main Infirmary and comprised a brick and concrete built single storey structure (Plate 26.1) with a flat roof (Plate 26.2) which featured a short section of crenellated parapet where the structure wrapped around Building 12 (Plate 26.3). It was terraced into the gardens on the west of Building 27a (Plate 26.4) and was essentially rectangular in plan with a small projection at the southeast corner and in the centre of the east elevation which was heavily overgrown. The projection in the southeast formed an open sided ambulance drop-off lobby (Plate 26.5) complete with turn table (Plate 26.6) so that emergency vehicles could be rotated on arrival allowing the patients to be delivered to the department under cover of the canopy.

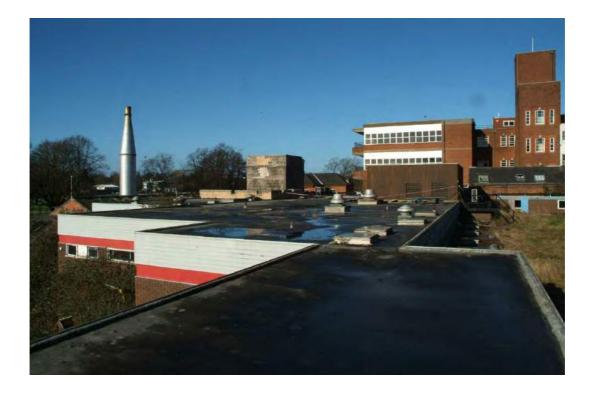
Plate 26.2: Building 26: flat roof, view to the north

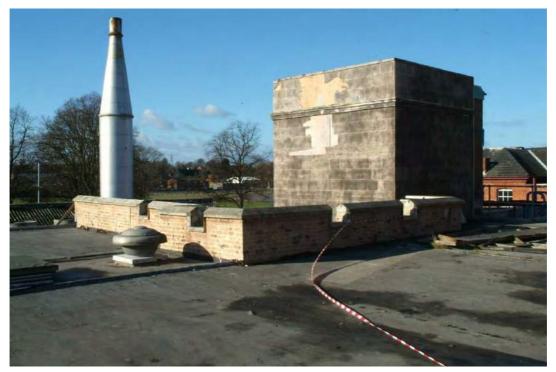
Plate 26.3: Building 26: detail of crenulated parapet, view to the northwest

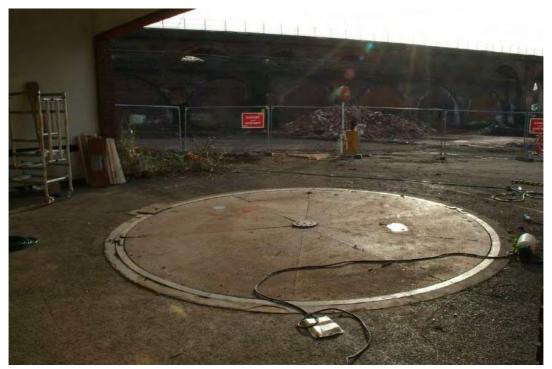
Plate 26.6: Building 26: detail of ambulance turntable, view to southwest

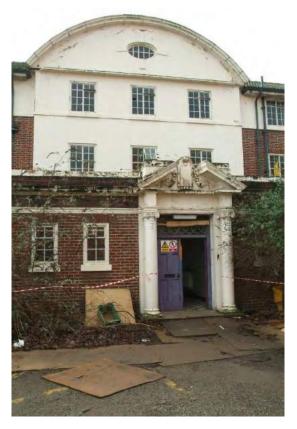
Plate 27.2 : Building 27a – detail of central part of eastern elevation

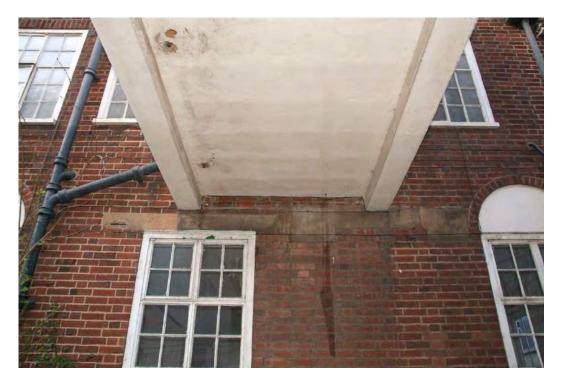
Plate 27.8: Building 27a – detail showing underside of the elevated corridor, view to the north

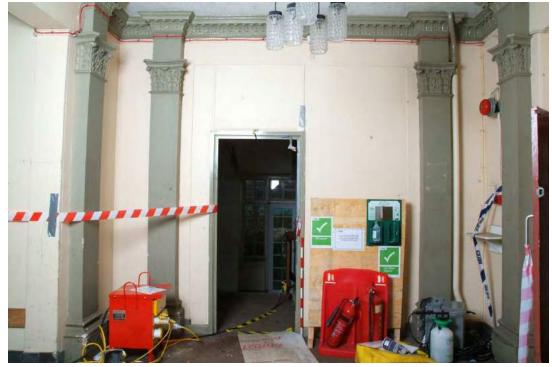
Plate 27.17: Building 27a – eastern side of entrance hall showing reduced opening to stair hall, view to the west

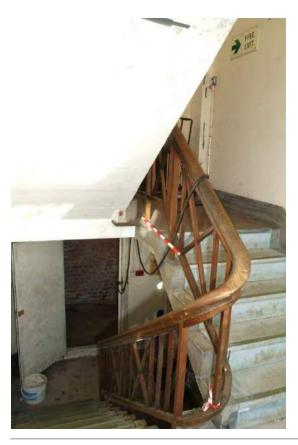
Plate 27.18: Building 27a – ground floor: central staircase, view to the southeast

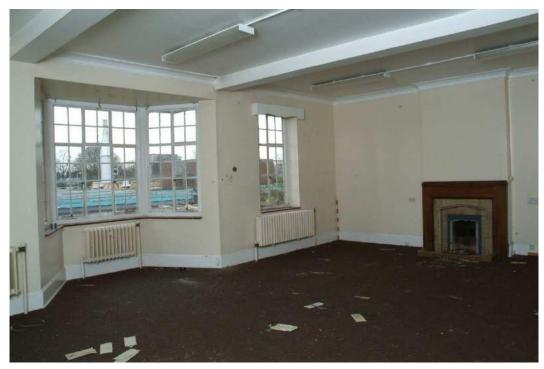
Plate 27.20: Building 27a – ground floor: sister's sitting room, view to the northwest

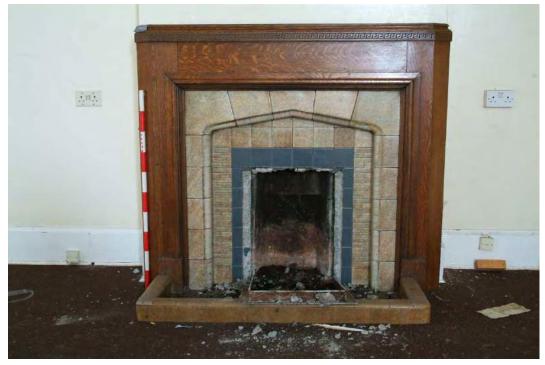
Plate 27.21 : Building 27a – ground floor: detail of 'Wellington' fireplace within sister's sitting room, view to the north

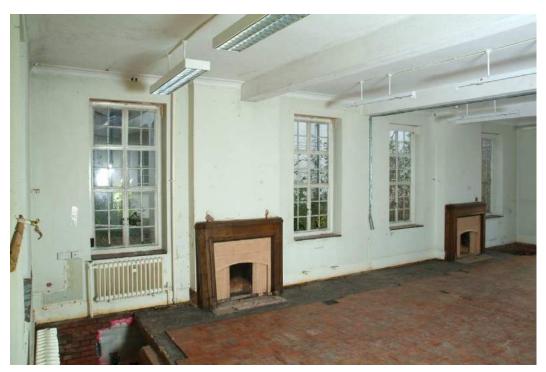
Plate 27.24: Building 27a – ground floor: nurses' sitting room, view to the southwest

- 5.185 The southern wing was given over to the nurses' sitting room (Plate 27.24) which formed a single large space with two fireplaces against the southern wall, suggesting that the room had formerly been divided into two parts. The chimneypieces were comparable but less grand than that in the **sisters'** sitting room and during demolition these also produced a number of paper artefacts of a similar sort.

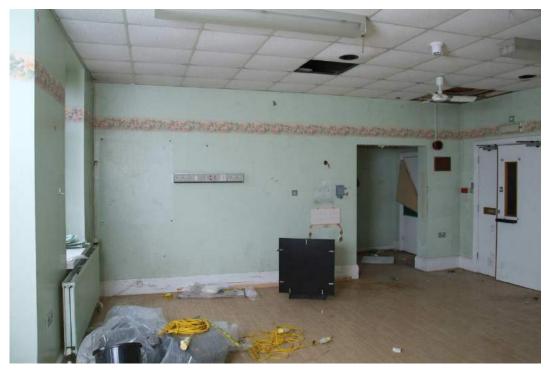
Plate 27.25: Building 27a – ground floor: typical room to the north of the entrance hall, view to the north

- 5.186 To the north of the entrance hall were a series of smaller rooms which had undergone subdivision through the insertion of stud walls. This had resulted in the loss of original features (Plate 27.25) although a number of fireplaces had survived, all of a similar style to those in the **nurses'** sitting room (Plate 27.26) and all of which produced further paper artefacts. It is likely that prior to subdivision these rooms served as common rooms for the nurses and offices for the sisters and matron.

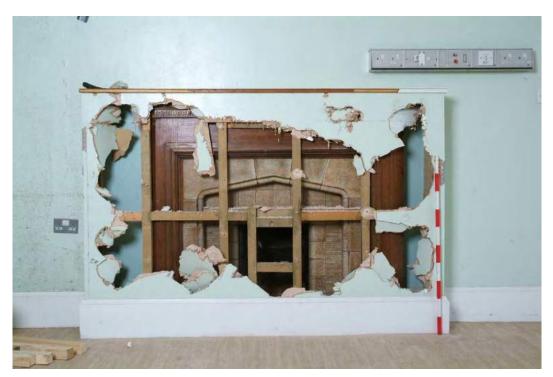
Plate 27.26: Building 27a - ground floor: detail of original fireplace in the northern wing

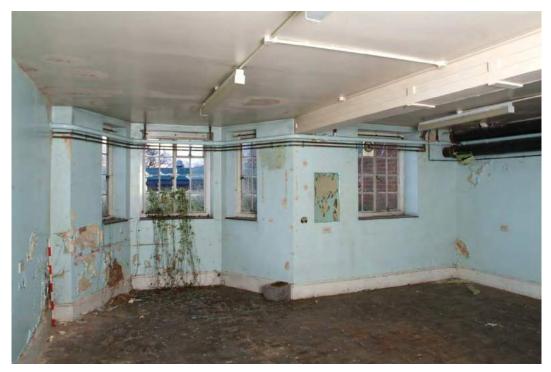
Plate 27.27: Building 27a - basement: interior of domestic staff room at north end of basement, view to the northwest

- 5.187 In the basement, the arrangement was again of rooms to the west of an eastern corridor although here the rooms were utilitarian in appearance (Plate 27.27). Despite this, a number of original features survived including doors (Plate 27.28), glazed partitions (Plate 27.29), parquet flooring and in some rooms enough of the fittings remained to allow identification of function. From this it was determined that the basement had served not only as utility rooms such as a laundry (Plate 27.30), ready room for domestic staff and storage rooms but also had some nurses' accommodation as well (Plate 27.31).

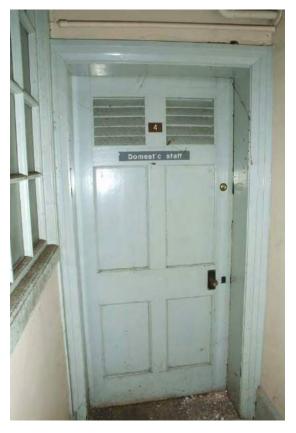
Plate 27.28: Building 27a - basement: detail of original door, view to the north

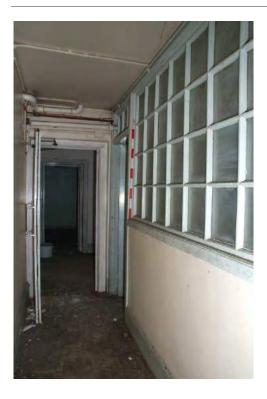
Plate 27.29: Building 27a - basement: original part glazed partition, view to the southwest

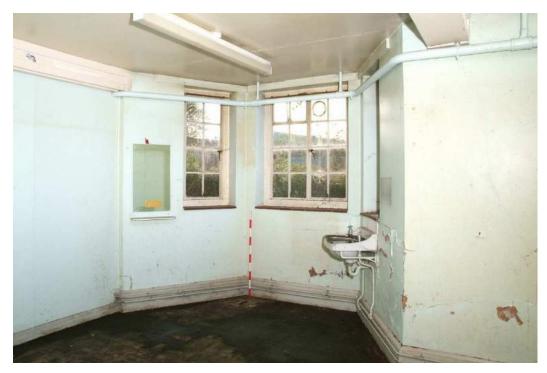
Plate 27.31: Building 27a – basement: nurse's accommodation, view to the southwest

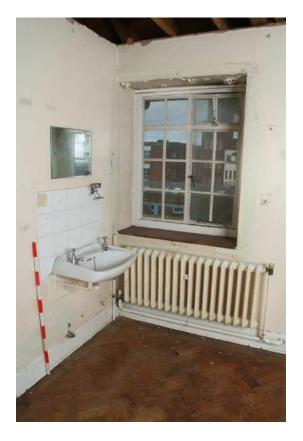
Plate 27.32: Building 27a – second floor: typical nurse's room, view to the southwest

- 5.188 Both the first and second floors were wholly given over to **nurses'** accommodation including bedrooms (Plate 27.32), bathrooms (Plate 27.33) and linen storage closets (Plate 27.34). The principal difference on these upper floors was that the main access corridor was set centrally with rooms on either side (Plate 27.35). Many of the original features survived including doors (Plate 27.36), sinks (Plate 27.37), lavatories (Plate 27.38) and even some of the toothbrush holders (Plate 27.39). The flooring appeared to be the original parquet, covered in corridors and stairs by a green linoleum (Plate 27.40).

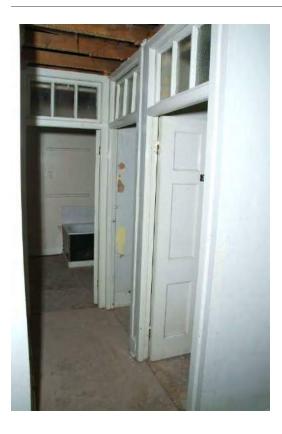
Plate 27.33 : Building 27a - second floor: original bathroom partitions, view to the northwest

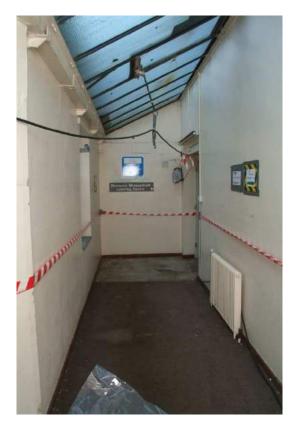
Plate 27.49: Building 27b – detail of eastern side of elevated corridor

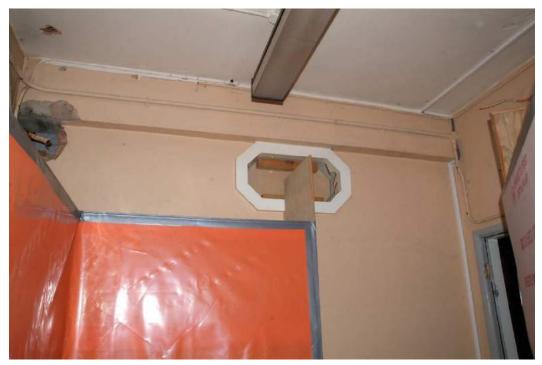
Plate 27.60: Building 27b – lower ground floor: eastern wall of archive room showing blocked projection aperture

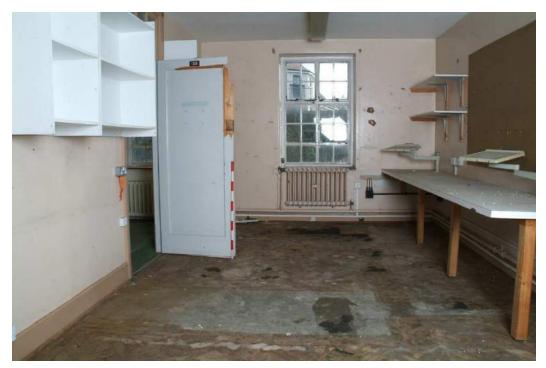
Plate 27.66: Building 27b – first floor: original sluice room and fittings, view to the south

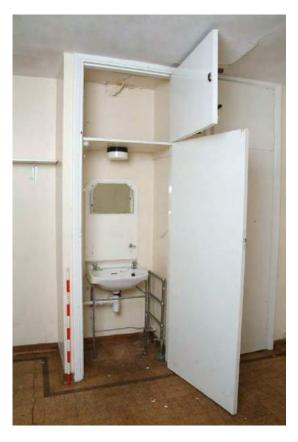
Plate 27.71: Building 27b – second floor: original bedroom view to the southeast

5.200 The top floor of the building survived in much the same condition as the floor below, although at this level, a number of the original, mid 1940s bedroom suites had survived (Plate 27.71). These comprised two tall cupboards set closest to the door, with one serving as a wardrobe, complete with dressing mirror on the back of the door and the other containing a washstand with basin and bathroom set, (Plate 27.72) complete with heated towel rail to one side and an internal light. This floor also contained some well preserved communal bathrooms closely resembling those on the upper ground floor (Plate 27.73). Contained within one of these was a 1940s sanitary bin produced under the **trade name 'Sani-can' and testifying to the predominantly female occupancy of** the upper floors of the building.

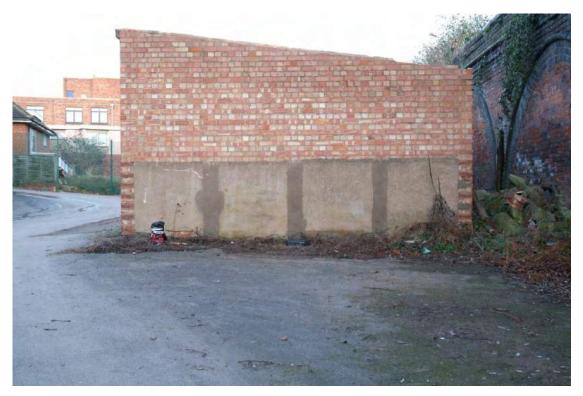
Plate 29.1: Building 29: north and east elevations showing interior

5.203 This building was built as a garage to the south of Building 30 and in the shadow of the railway viaduct (Building 47). It comprised a single storey brick shed with monopitch roof of steel trusses held on a steel beam with intermediate support (Plates 29.1 – 29.3). The lower part of the west wall was rendered and it is likely that a series of hoppers had been removed from this side, used for storing bulk materials such as road grit, sand and gravel etc. The structure dates to the 1950s as attested to by the light switches on the wall and was of no architectural or historic merit.

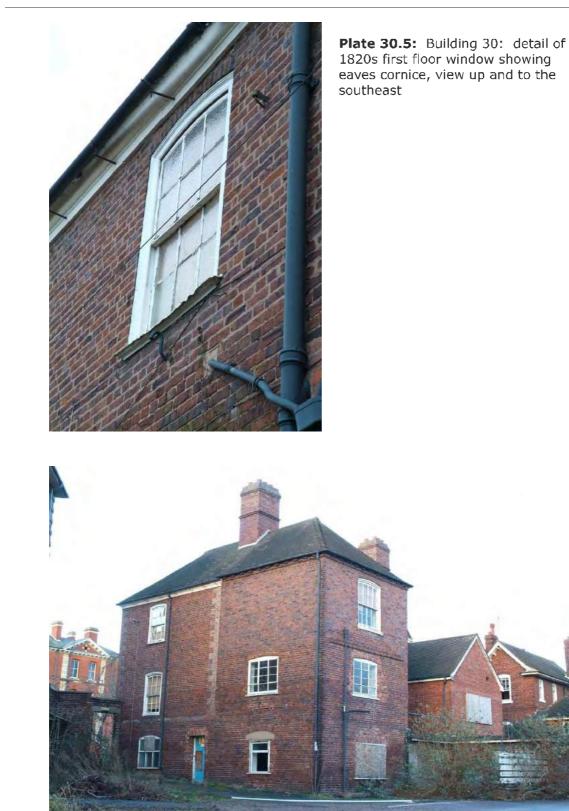
Plate 30.4: Building 30: detail of 1820s ground floor window, view to the southwest

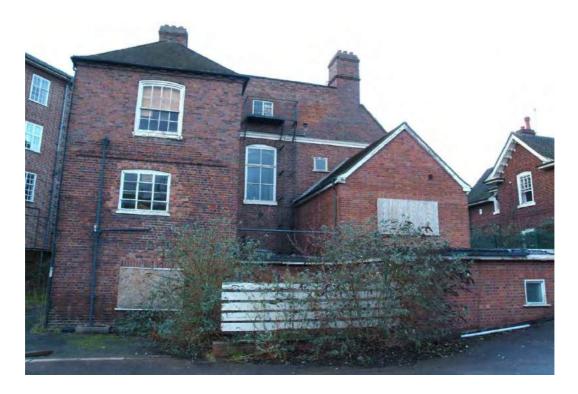
Plate 30.7: Building 30: detail of western elevation showing changes in brickwork, view to northwest

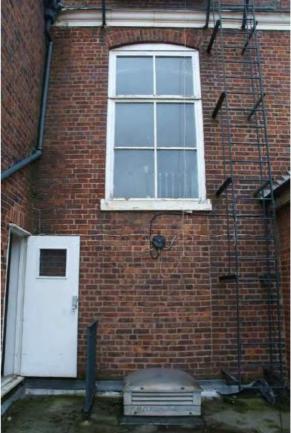
Plate 30.10: Building 30: detail of original southern elevation showing alterations to brickwork below stairlight, view to the north

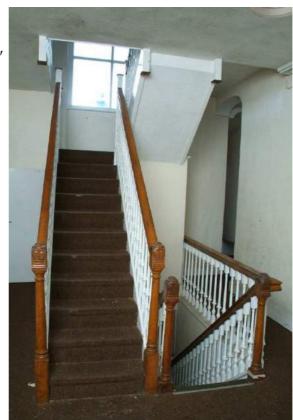
Plate 30.12: Building 30 (GF): entrance hall showing later staircase, view to the southwest

- 5.227 The central hall included a plastered cornice and architraves to the doors. The main feature was the ill-fitting timber staircase, the principal elements of which were the turned timber newels adorned to each face with a crown carving (Plates 30.12 & 30.13). The turned spindles were at close centres and supported a deep section timber hand rail.

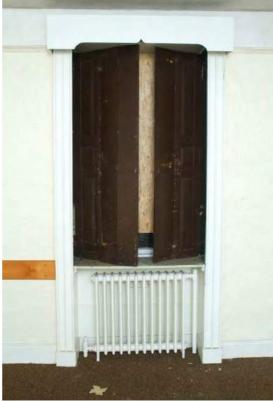
Plate 30.18: Building 30 (GF): northwest principal room showing detail of 1820s shutters, view to west

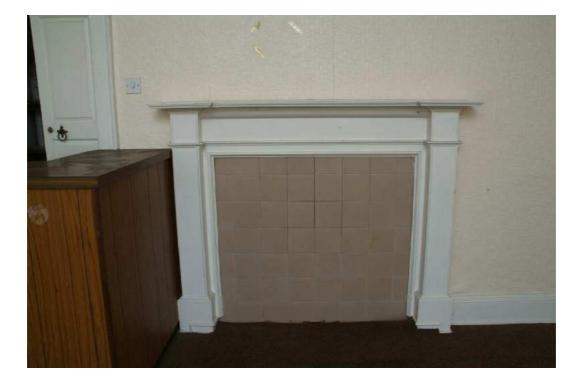
Plate 30.19: Building 30 (GF): northeast principal room, view to the southeast

- 5.226 The eastern of the ground floor rooms within the front range featured a simple skirting, picture rail and profiled timber architraves. The fireplace had been blocked, however, the simple timber chimney piece, of a style reminiscent of the front door surround, survived (Plates 30.19 and 30.20). The room also retained a panelled door from the hall and a paired leaf panel door to the eastern cupboard (Plate 30.21).

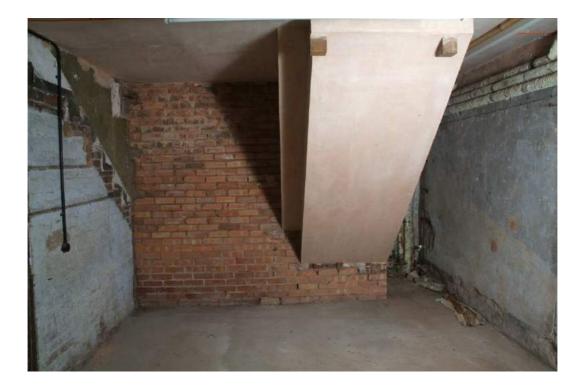
Plate 30.29: Building 30 (LGF): westernmost part of original basement showing remnants of service bell arrangement, view to the nouth

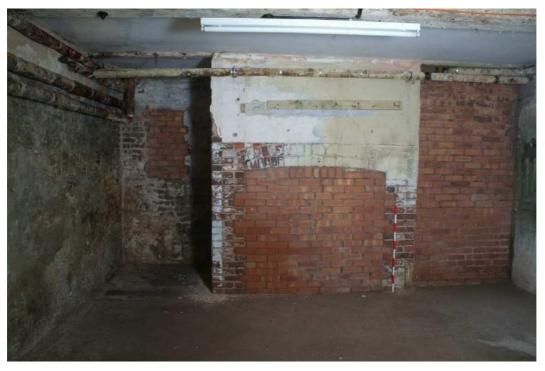
Plate 30.30: Building 30 (LGF): central part of original basement showing inserted stair enclosure and scar of former stairs, view to the south

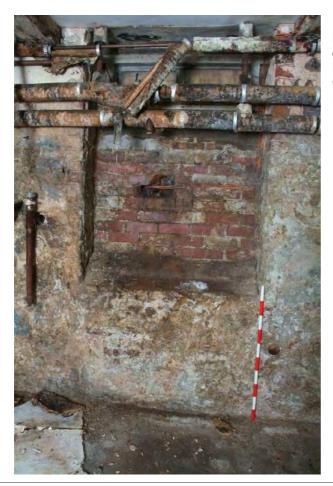
Plate 30.31: Building 30 (LGF): easternmost part of original basement showing blocked fireplace and window, view to the south

- 5.229 At lower ground floor, later refurbishments had resulted in loss of most features though the blocked fireplaces remained exposed (Plate 30.31).

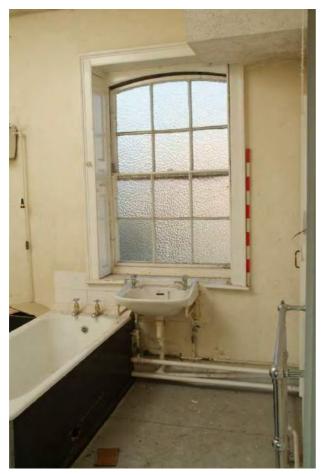
Plate 30.44: Building 30 (FF): interior of bathroom, view to the north

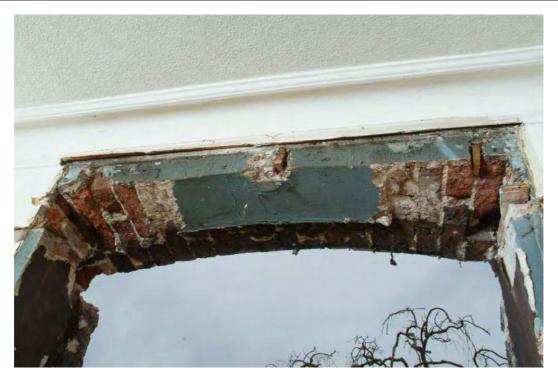
Plate 30.57: Building 30 (GF): reshaped window opening and earlier paint decoration in northwest room, view to the northeast

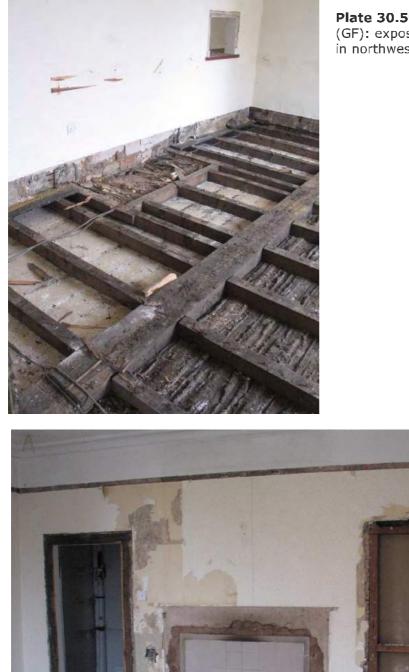
Plate 30.59: Building 30 (GF): exposed floor structure in northwest room

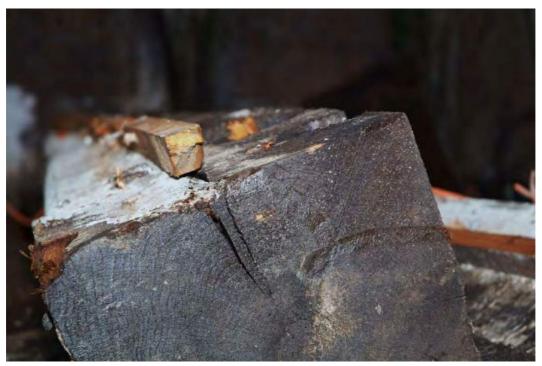
Plate 30.61: Building 30 (GF): detail of floor joist showing EH stamp in end

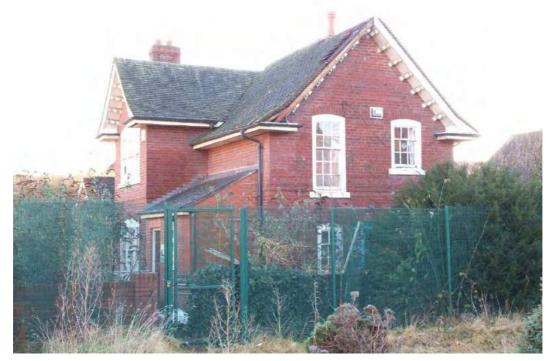
Plate 31.1: Building 31: general view showing chain-link enclosure and gate, view to the southwest

- 5.251 This building lay to the east of Building 30 within a discrete compound formed by the eastern perimeter wall of the hospital, along Infirmary Walk, by the railway viaduct to the south and by a series of high chain link fences along the north and west (Plate 31.1). Access to the compound from within the hospital site was via a locked gate in the northern part of the fence, but there was also a gated entrance through the perimeter wall (Plate 31.2) leading directly to the original main entrance of the building which is situated on the eastern elevation (Plate 31.3) within a modern lobby extension (Plate 31.4).

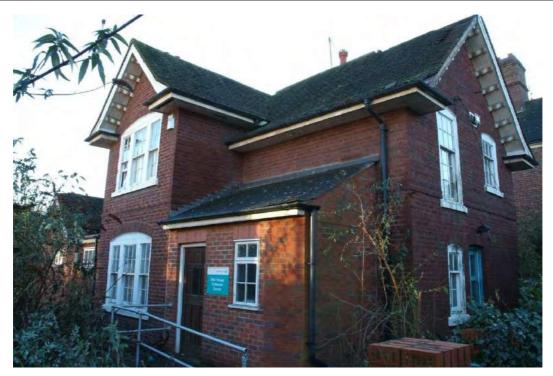
Plate 31.3: Building 31: eastern elevation, view to the southwest

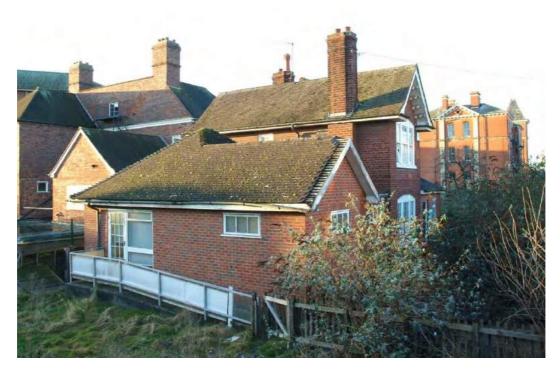
Plate 31.5: Building 31: southern extension, view to the northwest

- 5.252 The building was of two storeys and built of red brick laid in an English garden wall bond. It was symmetrical by design, comprising an east west gabled range with a shorter gabled range projecting from the centre of the north side. Both elements had pitched roofs, which projected at the eaves and gables where it was supported on carved brackets. The roof was covered with clay tiles and a two brick chimney stack rose above it, one from the ridge of the east west range and the other from the southern elevation. Along the southern side of the building, a modern single storey extension with an 'L' shaped pitched roof had been added (Plate 31.5).

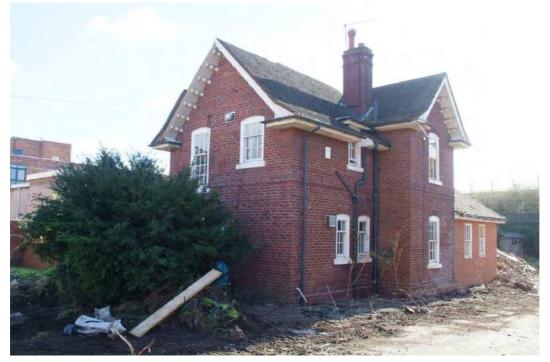
Plate 31.7: Building 31: western elevation, view to the southeast

31.7) remained in its original form with a tall window at ground and first floor levels of the gable which contrasted with the larger windows of the eastern gable (Plate 31.8) marking that out as the principal elevation. The western side of the northern range contained smaller windows with that on the upper floor projecting above the eaves to form a half dormer. The western gable of the extension had two windows which were also small paned sashes but had flat heads. The southern side of the building was dominated by the extension (Plate 31.9) which occupied the full width of the elevation at ground floor level and comprised a glazed door and sidelight to the left and small high level transom light to the right. The door was set above ground level and a long ramp rose from right to left to give wheelchair access. Above the roof of the extension, the upper storey of the original house was barely visible (Plate 31.5) but contained only a small timber sash in the centre and the projecting breast of the chimney stack to the right.

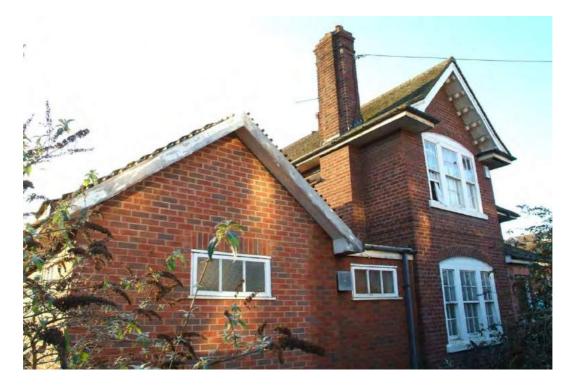
Plate 31.8: Building 31: eastern elevation, view to the northwest

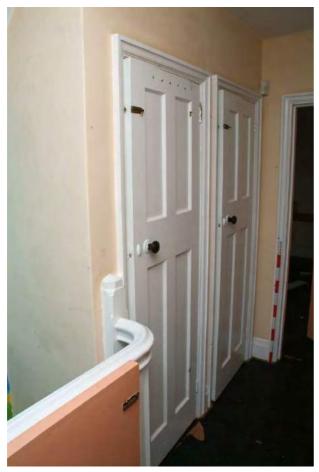
Plate 31.18: Building 31: first floor landing, view to the southeast

- 5.255 The upper floor comprised the usual domestic arrangement of bedrooms and bathroom. Like the ground floor, many of the original fixtures and fittings had survived the conversion process including doors skirting boards and architraves (Plate 31.18). The rooms had undergone some alteration to its function (Plate 31.19), although in many it was difficult to ascertain their most recent use (Plate 31.20).

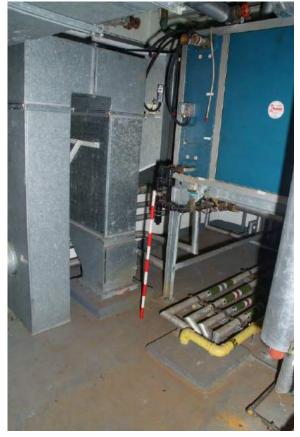
Plate 32.2: Building 32: interior of first floor plant room, view to the southeast
