Worcestershire Archaeology Research Report No.12

Historic Building Non-technical Record Report

THE FORMER WORCESTER ROYAL INFIRMARY, CASTLE STREET, WORCESTER

Part 1: Report, Appendices 1–3, Figures

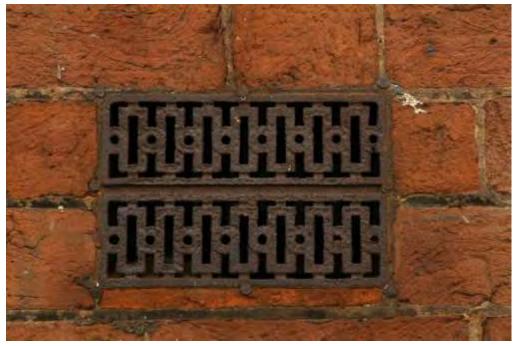
Plate 34.6: Building 34 – detail of air brick in the western part, view to the south

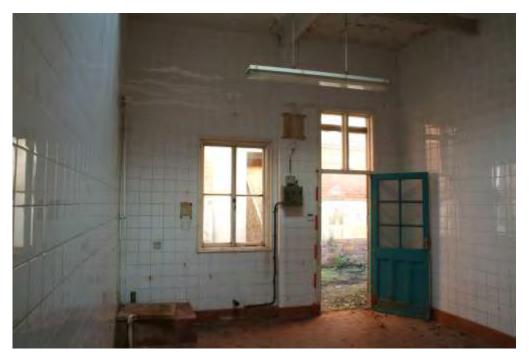
Plate 34.7: Building 34 - interior of western part view to the northeast

- 5.265 Internally (Figure 37), the two doors gave access to two separate areas. The western part (Plate 34.7) did not respect the arrangement of the roof, extending beneath the larger pyramidal part with the transition marked by a timber joist which corresponded with a thinning of the north wall in which the window was set. The walls of this room were covered with white glazed tiles to the ceiling and the floor covered with red encaustic tiles. The rooflight is set over a conical opening (Plate 34.8) and the timber joist supporting the roof is

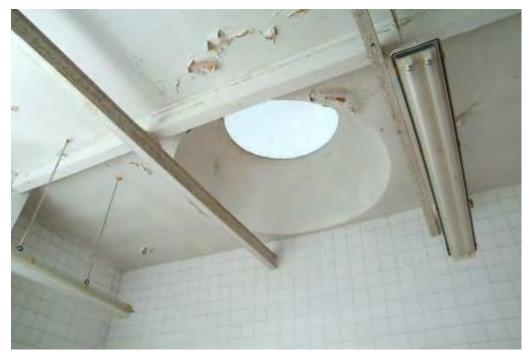
Plate 34.8: Building 34 – detail of c.1950s roof light

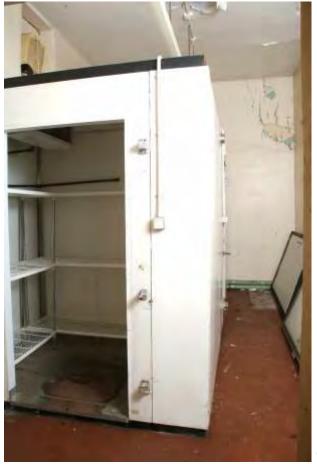
Plate 34.9: Building 34 – interior of the eastern part, view to the south

5.266 The eastern part of the building was painted white and for the most part filled with a large commercial freezer (Plate 34.9). This room also had a tiled floor and featured vents in the ceiling which was fitted with an ornate late 19th century cover (Plate 34.10) and in the east wall where one was blocked (Plate 34.11) and another refitted with a modern electric extractor fan and to the north wall which contained a closable vent (Plate 34.12) on the back of a metal cover described above.

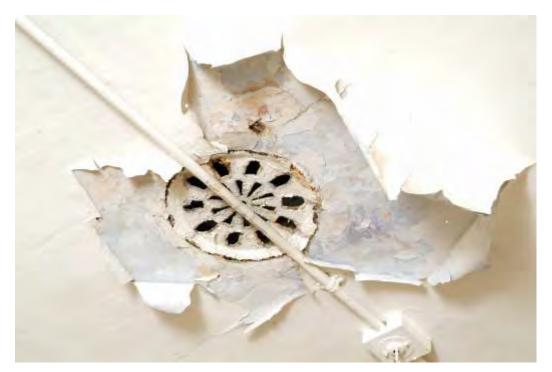
Plate 34.10: Building 34 – detail showing roof vent in eastern part

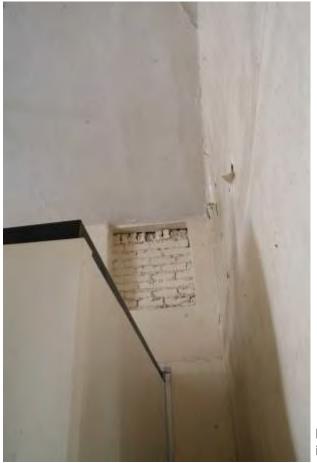
Plate 34.11: Building 34 – detail of vent in south wall, view to the south

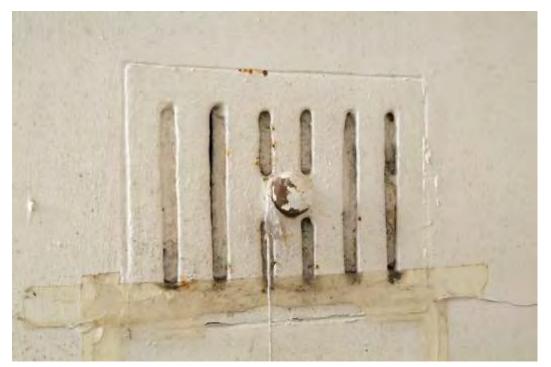
Plate 34.12: Building 34 – detail of closable vent in the northern wall, view to the north

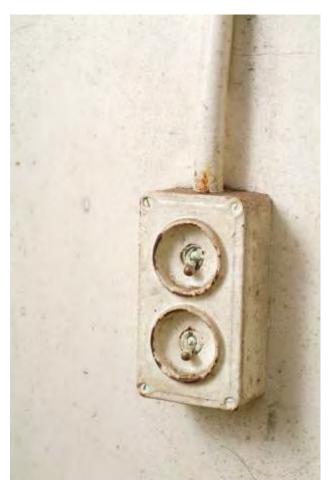
Plate 34.13: Building 34 – detail of c.1930s light switch, view to the northwest

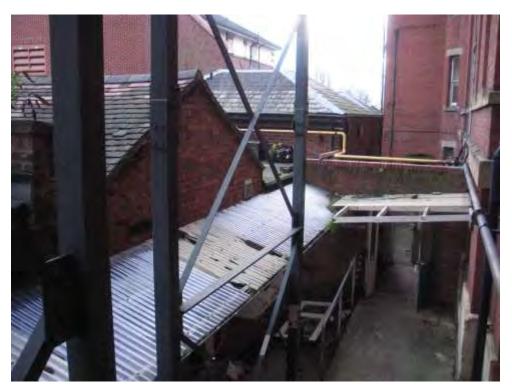
Plate 35.1: Building 35 – general view of northern elevation, view to the southwest

- 5.268 This building lies immediately to the east of the corridor to the staff dining room and was formed of two parts (Plate 35.1). The western part (Plate 35.2) was of brick, laid in Flemish bond, and had a flat roof with a wide entrance set to the right of centre in the northern facade, formed beneath a concrete lintel and containing double timber doors. A sign on the left hand door identified this as the Team Cleaners Store. The flat roof was covered in asphalt and featured a square roof lantern fitted with Georgian wired glass (Plate 35.3). To the left of this was a larger brick range with a pitched plain tile covered roof (Plate 35.4) which had a hip at the rear and pedestrian door set centrally in the northern gable. Both buildings were set against the former boundary wall of the hospital (Building 46) and incorporated it into their structure (Plate 35.5). To the right of the door was a pair of timber shelves reminding staff to return keys to porters or supervisors before signing out and consequently these shelves are likely to have held staff registers. Close to the eaves on either side of the north elevation were vents, of which the left hand one was contemporary with the building whilst that to the right was a larger modern vent cover. The doorway to this building comprised a cambered brick head, stone threshold and was fitted with a moulded timber frame but no door (Plate 35.6).

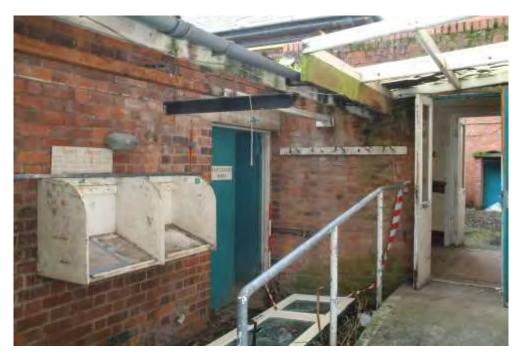
Plate 35.2: Building 35 – north elevation of western part, view to the southeast

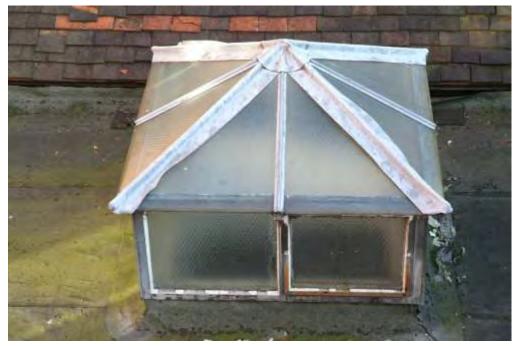
Plate 35.3: Building 35 – roof light on flat roof of western part, view to the south

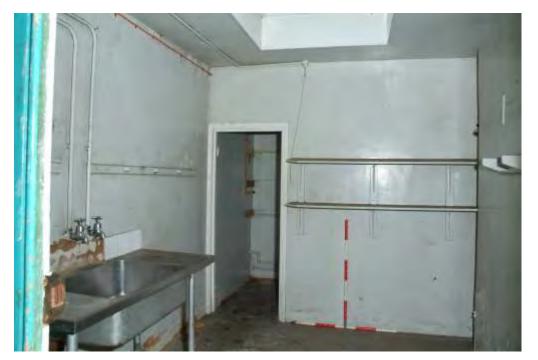
Plate 35.7: Building 35 – detail of entrance to the eastern part, view to the south

- 5.269 Internally (Figure 38), the western part of the building comprised two rooms, divided by a modern stud wall (Plate 35.7) with the northern part being the larger of the two. Both areas were devoid of significant features although the large sink and towel rail in the northern part suggested it was used as a general staff room, probably with a supervisor's office to the rear.

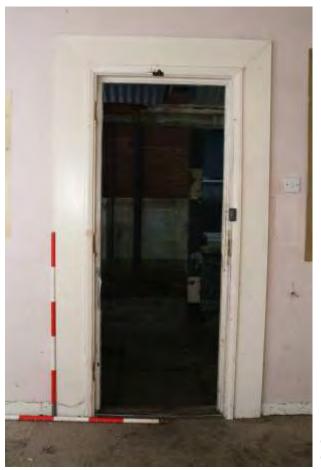
Plate 35.8: Building 35 – interior of eastern part showing architrave to entrance, view to the north

- 5.270 The right hand part was fitted with a plain, wide timber architrave to the inside of the door (Plate 35.8) and the building was also divided into two parts by a stud partition fitted with a narrow moulded timber architrave dating to the first half of the 20th century. The front part of the building was devoid of any architectural features whilst the rear part contained free standing shelving around the west, south and east sides with further shelving held on modern brackets attached to the partition to the north. At the east end, the wall stepped back and the hip of the roof was supported on a timber brassumer held on a timber bracket set across the corner of the rebate east wall. The roof comprised king post trusses (Plate 35.10) with side struts and the rafters rose to a thick roof board. The underside of the tiles was felted and all observed timbers were of machine cut softwood.

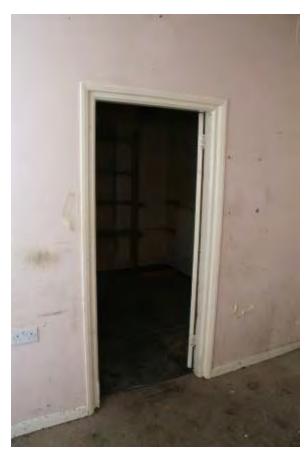
Plate 35.9: Building 35 – internal partition, view to the southwest

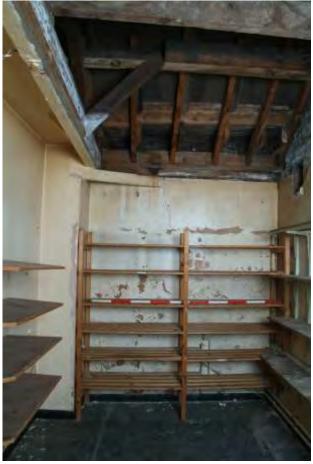
Plate 35.10: Building 35 – southern room of eastern part, view to the east

introduced into the wall, and the associated opening through the fabric was observed in the back of Building 35 (Plate 35.10).

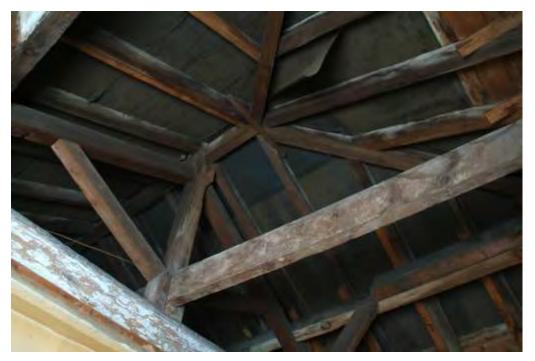
Plate 35.11: Building 35 – detail of roof structure in eastern part, view to the northeast

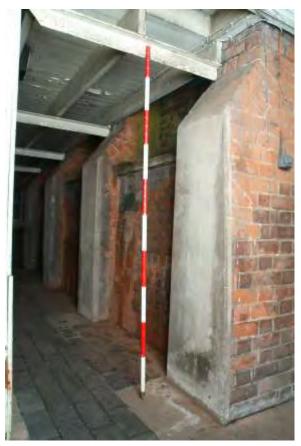
Plate 36.3: Building 36 – eastern elevation showing truncated buttresses, view to the southwest

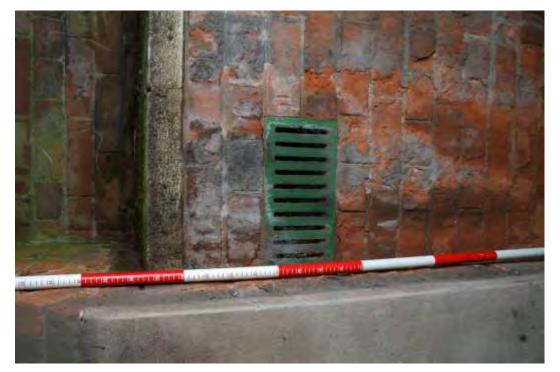
Plate 36.4: Building 36 – detail of original vent in eastern elevation, view to the west

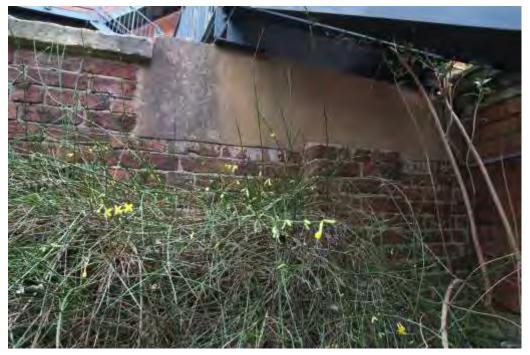
Plate 36.7: Building 36 – southern elevation showing 20th century insertion of concrete foundation for fire escape, view to the northeast

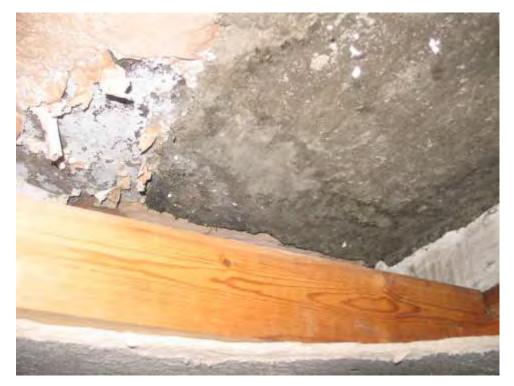
Plate 36.10: Building 36 – detail of roof structure, view to the southwest

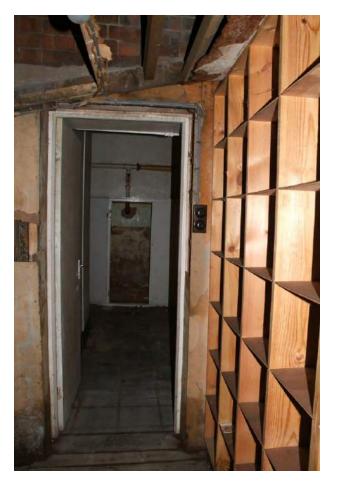
Plate 38.2: Building 38 – internal corridor along the west side looking into Building 24f, view to the north

- 5.281 Internally the building had been fitted out with shelving along the eastern side (Plate 38.2) and retained a number of early twentieth century features such as Bakelite light switches and light bulb holders (Plates 38.3 and 38.4).

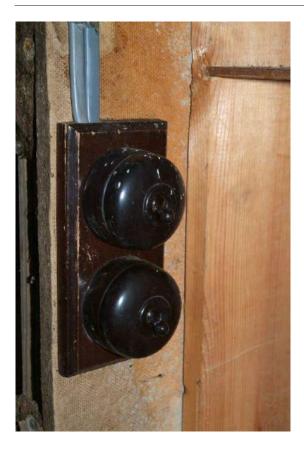
Plate 38.3: Building 38 – detail of Bakelite switches, view to the north

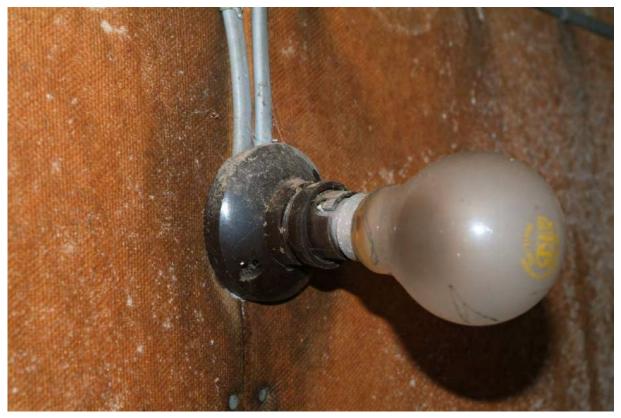
Plate 38.4: Building 38 - detail of Bakelite bulb holder, view to the southwest

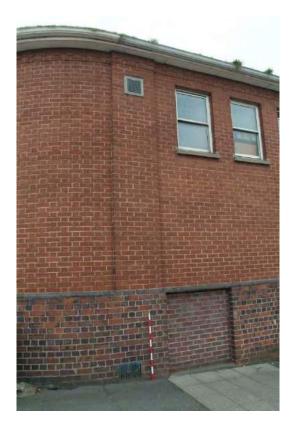
Plate 39.2: Building 39 – detail of Castle Street elevation showing change in fabric, view to the southwest

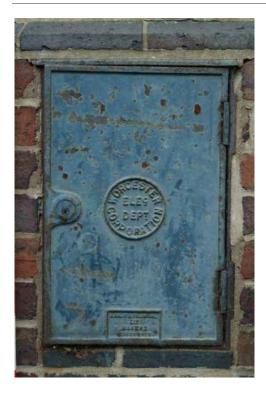
Plate 39.3: Building 39 – detail of 'Hardy and Padmore' electricity box cover, view to the south

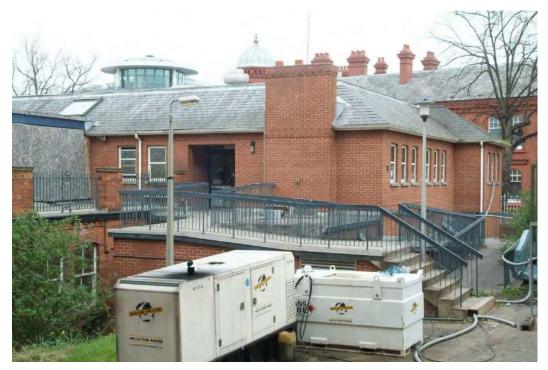
Plate 39.5: Building 39 – general view of western elevation from infirmary steps, view to the northeast

- 5.284 The main external entrance (Plate 39.5) is via a ramp or staircase over a discrete plant room (Plate 39.7) which leads onto the terrace of Building 40. The entrance to Building 39 is at this level (Plate 39.6) and opens onto a wide corridor (Plate 39.8). The corridor follows the centre of the building and gives access to all the rooms on this floor which include, consulting rooms (Plate 39.9), lab facilities (Plate 39.10) and communal waiting areas. Many of these were identified by signage above the doors (Plate 39.11). An internal staircase (Plate 39.12) is located in the north of the building and this connects the upper

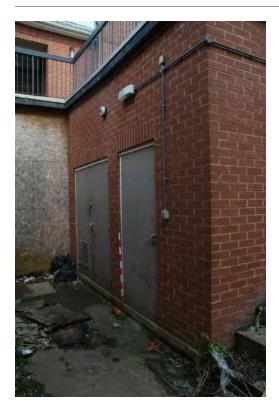
Plate 39.7: Building 39 – lower ground floor plant room, view to the southeast

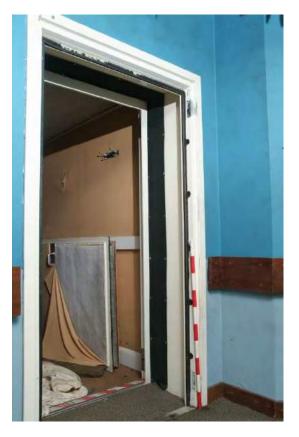
Plate 39.14: Building 39 – sound studio in speech therapy department, view to the southeast

ground floor with the lower ground floor corridor which also runs through the centre of Building 40 (Plate 39.13). In the lower ground floor part of the building a number of specially designed studios have been created (Plate 39.14) set around the corridor (Plate 39.15) which runs beneath that on the ground floor, terminating at the southern lower ground floor mentioned above. In addition to the treatment rooms on this floor there are a number of plant rooms (Plate 39.16) containing machinery to regulate and supply various gasses required in the treatments and procedures undertaken. Unfortunately there was no indication of the gas types.

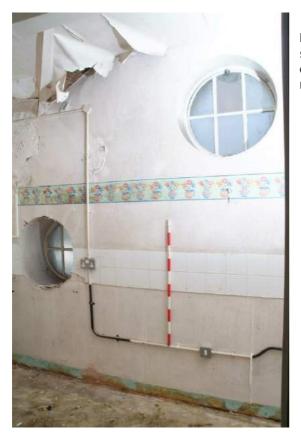
Plate 40.23: Building 40 (UGF): splint room [Room 1.8] showing oculus windows, view to the northwest

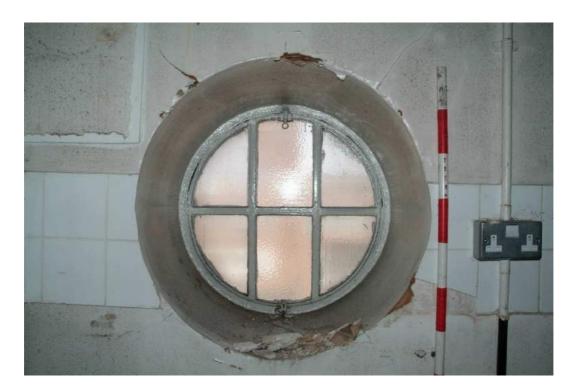
Plate 40.24: Building 40 (UGF): detail of oculus window, view to the north

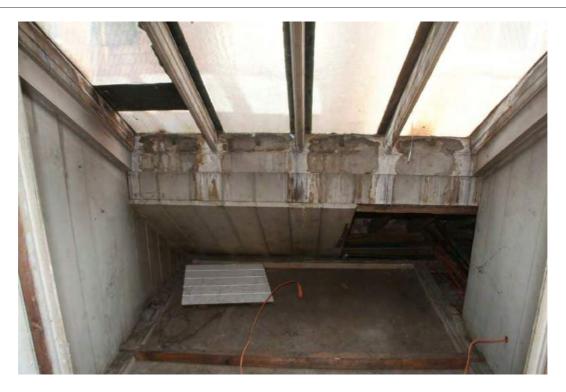
Plate 40.25: Building 40 (UGF): interior of roofspace showing rooflight over western flanking range

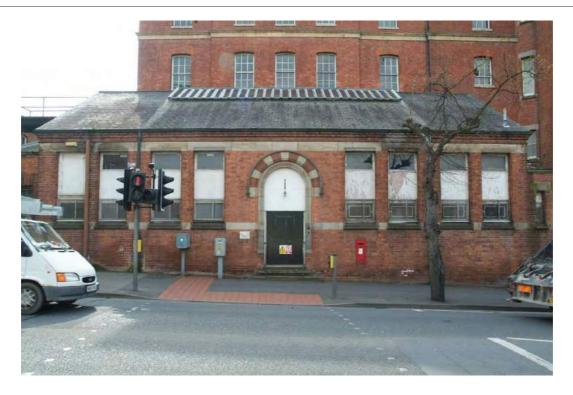
Plate 41.1: Building 41: northern elevation

- 5.295 The outpatients department comprises a single storey building to the west of the Edward VII Memorial Building and comprises a red brick shed, the brickwork laid in English bond, with pitched roof and central roof lights and functional southern elevation onto Castle Street. The north elevation (Plate 41.1) is based around a round headed centrepiece (Plate 41.2) with stone architrave, rubbed brick and stone voussoirs and stone hood with stops and leaf consoles. The doors and tympanum have been boarded over as have the central portion of the tall windows leaving a small light at top and bottom. The eaves are finished with dentiled terracotta lobate fringe and stone lintel and sill bands. The gables have a small oculus with stone lintel (Plate 41.3). The remaining sides are abutted by other buildings and are not visible. Set to the right of the door is a George VI letter box (Plate 41.4).

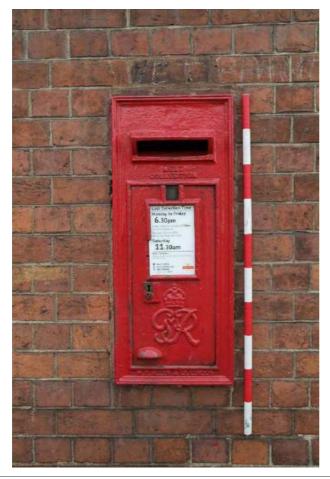
Plate 41.4: Building 41: detail of George VI post box in northern elevation

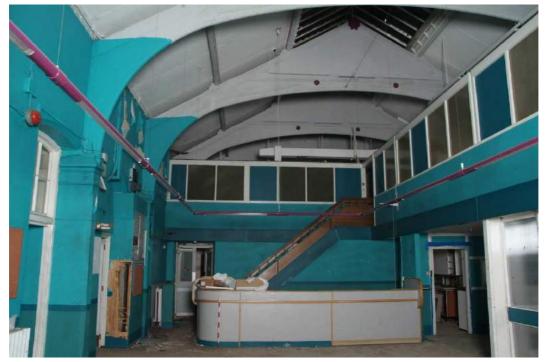
Plate 41.5: Building 41: general view of the interior showing inserted mezzanine, view to the west

- 5.296 Internally (Figure 40) the majority of the building was given over to a large hall into the north and west side of which, a mezzanine had been introduced. The roof of the hall was supported on wooden trusses which have been infilled with board (Plates 41.5 and 41.6) which has obscured much of the detail. The tie beam forms a shallow arch and is supported on pilasters with chamfered edges and ornate heads (Plate 41.9) set against the north and south walls. The trusses clasp the purlins and have small bosses or elaborate nuts painted red.

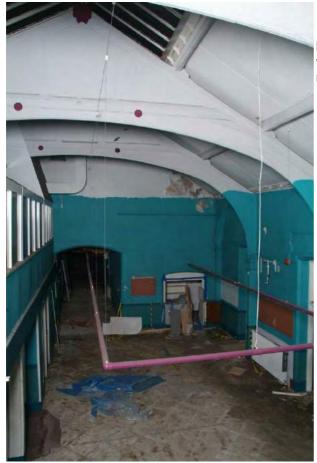
Plate 41.6: Building 41: general view of the interior from mezzanine, view to the east

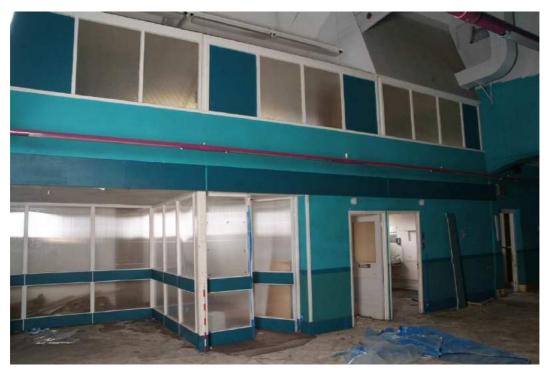
Plate 41.7: Building 41: former street entrance enclosure and inserted offices below mezzanine, view to the northeast

- 5.297 The area beneath the mezzanine to the west has been partitioned to form a series of small rooms and the staircase to the mezzanine floor rises from behind a reception counter at that end. Beneath the northern part of the mezzanine, the ground floor has also been subdivided (Plate 41.7) into a number of small offices as well as a glazed enclosure around the front door to which there was no access.

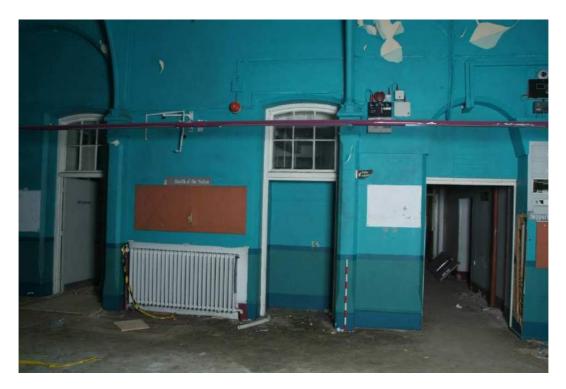
Plate 41.8: Building 41: south wall showing openings to infirmary, view to the south

- 5.298 The wall of the Infirmary to the south has had a number of openings introduced into it along with shallow arched rebates to the others (Plate 41.10). These include the opening to the ground floor corridor of the main Infirmary building (Plate 41.8). In the east, beside the opening to the central lower ground floor corridor of Building 40, which may well be the original external door, there was also the serving counter of the outpatients buffet (Plate 41.11) along with a smaller pedestrian door, now blocked but with the same chamfer treatment to the arrises (Plate 41.12). It is from within these rooms that the reason for treatment to the front windows becomes apparent. A plaque attached to the wall in this room states that the room had been furnished by the 'Friends of Worcester Royal Infirmary'.

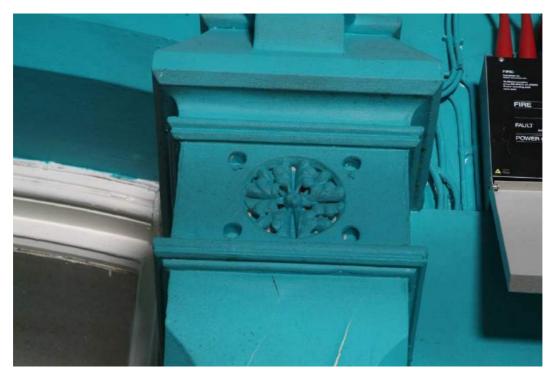
Plate 41.9: Building 41: detail of typical pilaster head, view to the south

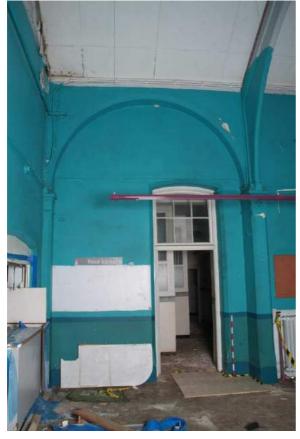
Plate 41.10: Building 41: entrance to the dermatology department, view to the south

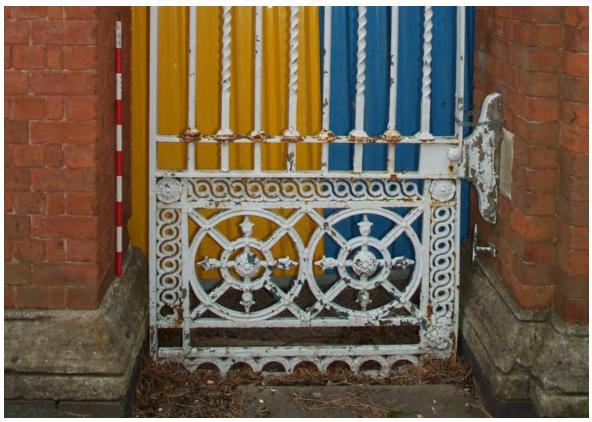
Plate 42.7: Building 42 - detail of lock in pedestrian gate

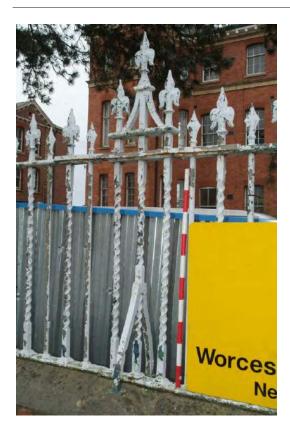
Plate 42.8: Building 42 – detail of lower ironwork in pedestrian gate

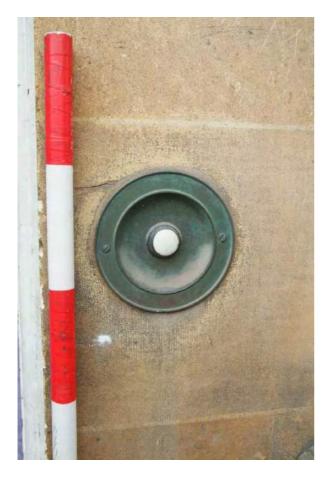
Plate 43.6: Building 43 – detail of original door bell in principal elevation

and on the right hand side of the doorcase is an original doorbell button with circular brass surround (Plate 43.6).

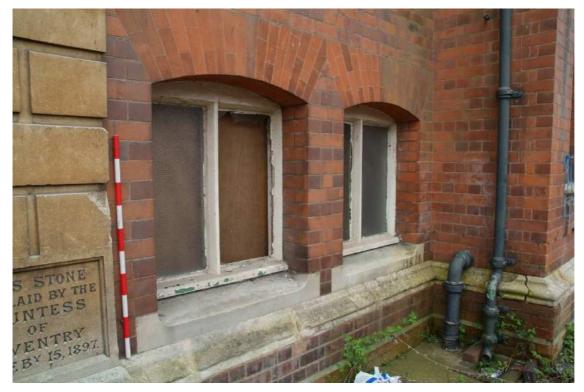
Plate 43.7: Building 43 – detail of low level windows in principal elevation

- 5.309 The symmetry of the facade is upset by a side door in the right hand bay of the southern wing formerly giving access to a north south corridor and a pair of low set small window openings with two fixed panes which light the steps to the basement (Plate 43.7). Above this, on the first floor, is a similar single window which lights the stairs at that level. The windows on the right hand bay of the central range are narrow, marking the location of WCs. This is not replicated on the right hand side. The facade is unchanged from its original composition except for the addition of mid 20th century steel fire escapes to both side wings which have marred its appearance.

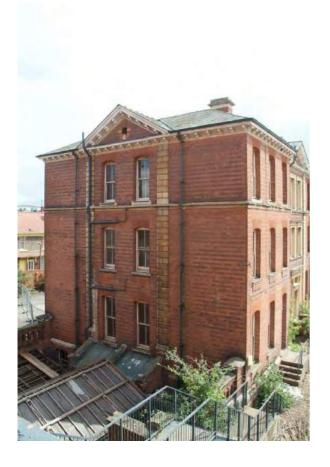
Plate 43.8: Building 43 – north elevation, view to the southeast

- 5.310 The north elevation (Plate 43.8) is of four bays with those on the outside being blind (Figure 42). The centrepiece reflects that on the east side and has tall windows with cambered brick heads. Unlike the other elevations, the north side extends down to the basement where a central porch gives access from the lower ground floor of the main Infirmary building. The porch occupies the whole of the central two bays and has a glazed lean-to roof with parapets to the sides. The entrance comprises a utilitarian timber door (Plate 43.9) with four flush panels and the sidewalls of the porch are pierced with narrow 1 over 1 sashes with cambered brick heads and stone sills (Plate 43.11). At this level the outer bays also contain windows comprising small 2 over 2 sashes (Plates 43.12 and 43.13), again with brick heads and stone sills. To the right of the

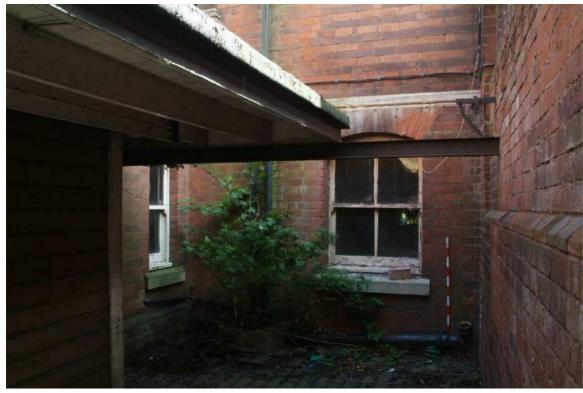
Plate 43.12: Building 43 - basement window to the west of the porch, view to the south

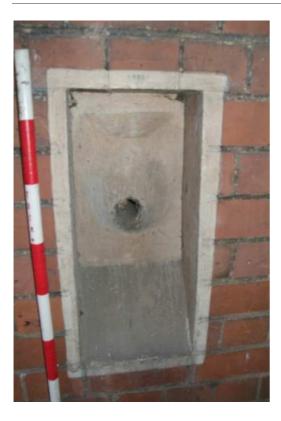
Plate 43.13: Building 43 – detail of former bell pull rebate to west of basement door, view to the southeast

door is a rebated stone panel with sloping base, scooped back and off-centre hole, which formerly contained the bell pull (Plate 43.13).

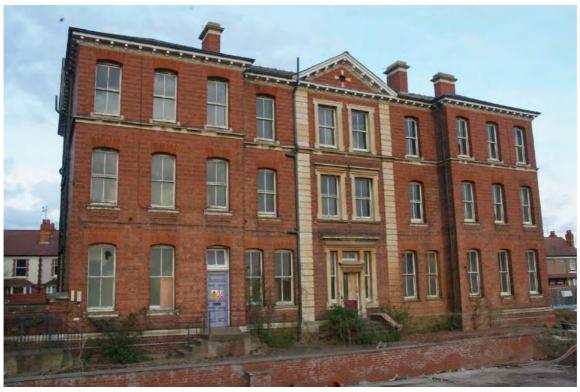
Plate 43.14: Building 43 – western elevation

- 5.312 The western elevation (Figure 43) closely resembles that on the east and given its provenance at the time of construction, could equally be considered as the principal elevation. The key differences lie in the fenestration of the main range (Plate 43.14) which has a five bay arrangement at ground floor level and a four bay arrangement above. The ground floor has a central door with less ornate stone surround (Plate 43.15) to that on the east, comprising a shouldered architrave containing side and overlights and with an inner architrave with cornice for the door, which although original, has been modified through the insertion of a large glazed panel occupying the upper two thirds. The lower part contains two embossed panels. Above this, the centrepiece contains two windows on each storey, all with shouldered stone architraves. To either side of the centrepiece are two lights at ground floor level and one on the floors above. Like the eastern elevation, the left hand wing contains a single subservient door in the right hand bay and this is fitted with a five panelled door (Plate 43.16) which probably reflects the original design of the central door prior to The door has a two paned hopper style overlight and is modification. approached by a two sided flight of concrete steps with brick facing wall and is likely to be a replacement of an original open sided stair. The southern elevation (Plate 43.17) is identical to the northern side but without the basement level (Figure 44).

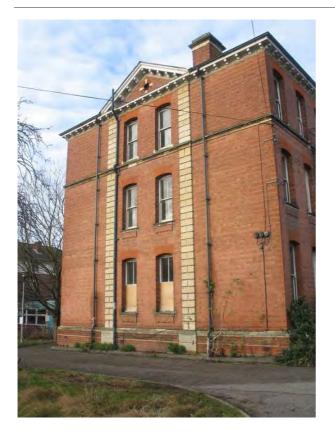
Plate 43.17: Building 43 – south elevation

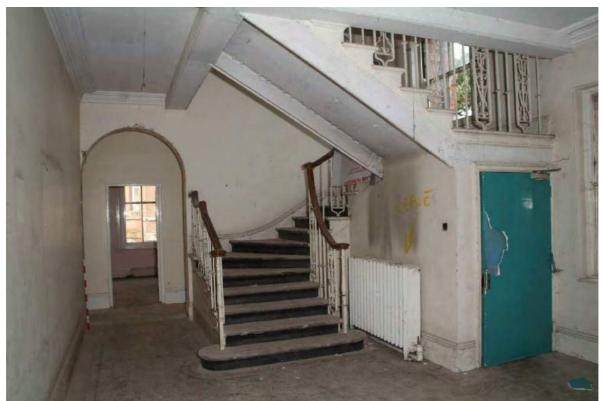
Plate 43.18: Building 43 – ground floor: entrance hall showing formerly blocked opening to the north range and entrance basement, view to the north

- The ground floor (Figure 45) is arranged around a central corridor with 5.313 perpendicular corridors serving the wings. The principal entrance opens onto a large hall (Plate 43.18) with terrazzo floor, high moulded skirting (Figure 49) and elaborate ceiling cornice. The northeast corner is given over to the only staircase in the building with the central corridor running off from the southwest corner (Plate 43.19). The entrances to both wing corridors had historically been blocked off so that the hall gave access only to the upper floors. These blockings were re-opened immediately prior to this record. The lower step of the staircase has a round ended form in which is set the steel newel post and the terrazzo floor respects this detail in its banded border (Plate 43.20). The remainder of the balustrade is also steel and comprises stick balusters and scrolled wrought iron panels supporting a hardwood handrail. The staircase is out of keeping for the building, being rather understated and plain. It has concrete treads supported on brick walls at the lower level and by bolted steel joists above (Plate 43.21). A modern panel door set beneath the half landing of the stairs opens onto the basement steps (Plate 43.22).

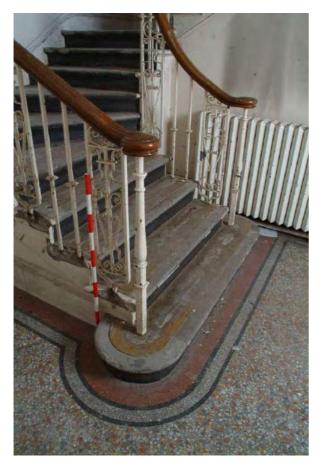
Plate 43.20: Building 43 – ground floor: detail of terrazzo in around foot of stairs, view to the east

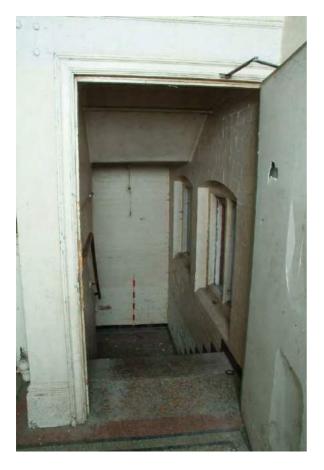
Plate 43.21: Building 43 – ground floor: detail of later strengthening to staircase

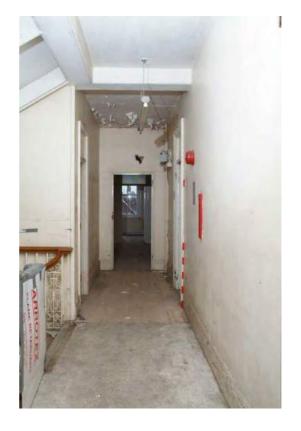
Plate 43.51: Building 43 - first floor: part blocked opening to northern range, view to the north

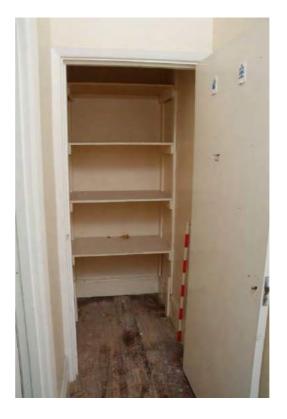
Plate 43.60: Building 43 - first floor: inserted cupboard on east side of central corridor, view to the east

- 5.328 The room to the south of the bathroom has been divided into two parts and an opening created in its eastern wall with the interior of the western part converted to a linen cupboard (Plate 43.60). The remainder of the room continues to be accessed from the south, but the corridor on that side has been removed and the entrance to the room in the southeast corner of this floor set across the former line of the corridor producing a larger room with an en-suite

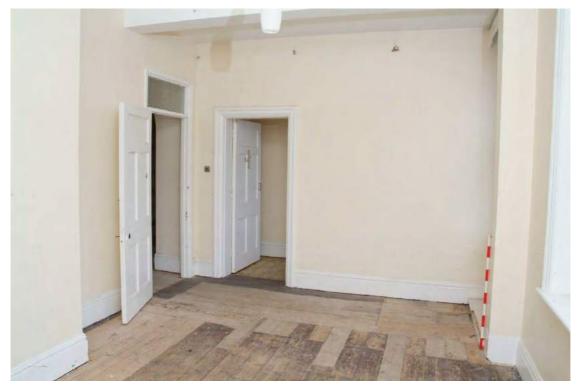
Plate 43.61: Building 43 - first floor: eastern bedroom showing line of former corridor and original communal entrance to the W.C., view to the north

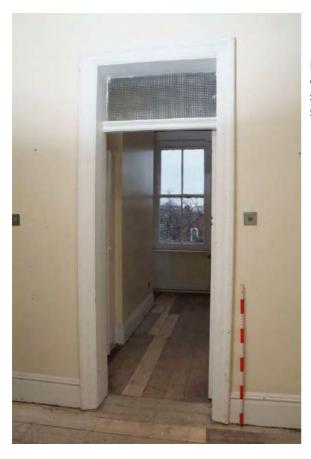
Plate 43.62: Building 43 - first floor: original doorway to central bedroom in southern range showing blocked fireplace beyond, view to the south

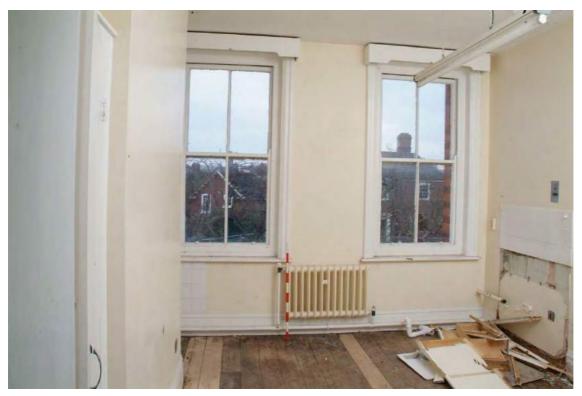
Plate 43.63: Building 43 - first floor: western bedroom in southern range, showing blocked fireplace and former sink surround, view to the south

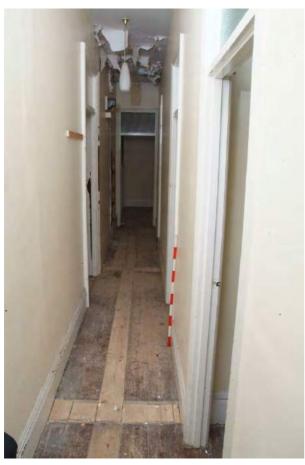
Plate 43.64: Building 43 - first floor: corridor in northern range showing rearranged northern end

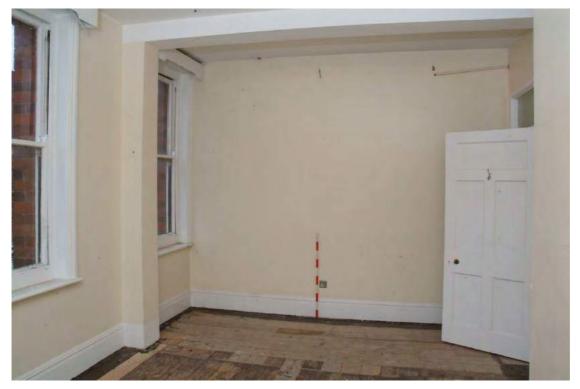
Plate 43.65: Building 43 - first floor: eastern bedroom in northern range showing line of former south wall, view to the southeast

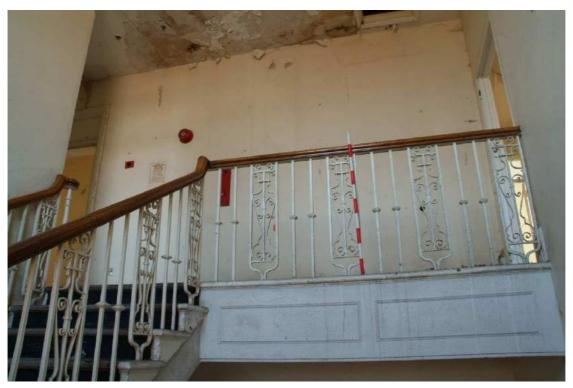
Plate 43.66: Building 43 - first floor: landing showing string and terminal balustrade, view to the west

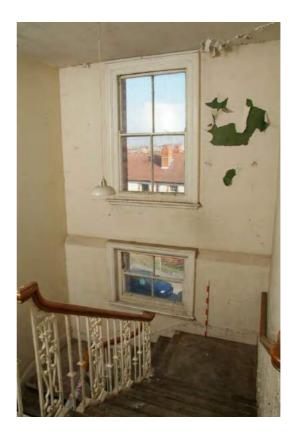
Plate 43.69: Building 43 - second floor: landing showing original door to bathroom, view to the south

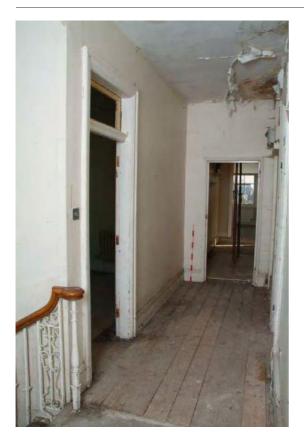
Plate 43.70: Building 43 - second floor: bathroom in central range showing original vertical pipe box, view to the east

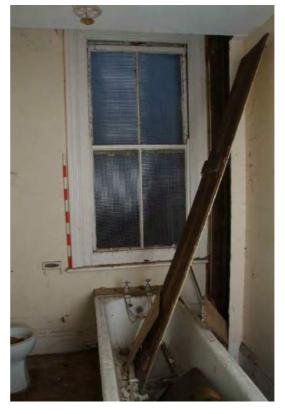
Plate 43.71: Building 43 - second floor: detail of pipe box, view to the south

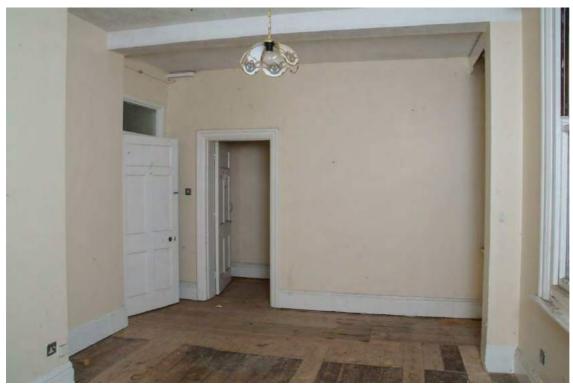
Plate 43.72: Building 43 - second floor: eastern room of southern range showing identical alterations to room below, view to the northwest

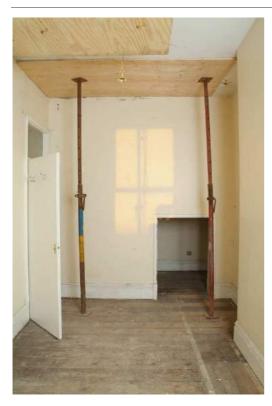
Plate 43.73: Building 43 - second floor: southern bedroom of central range showing identical alterations to room below, view to the northwest

allow for a separate corridor with the room in the north being converted to form a bathroom and that in the south having a fire escape (Plate 43.73).

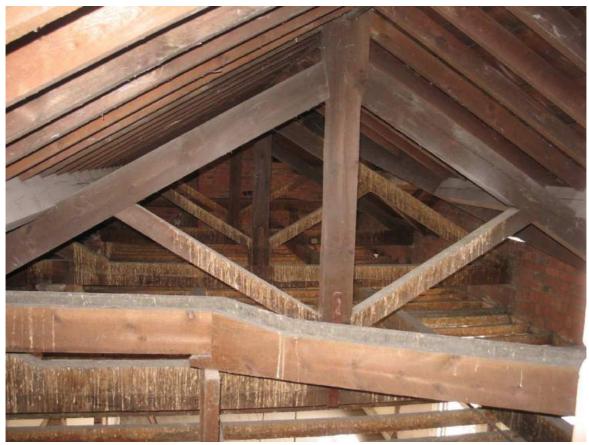
Plate 43.74: Building 43 – roof space: typical roof truss, view to the north

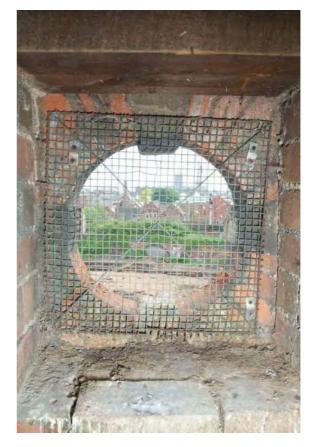
Plate 43.76: Building 43 - roof space: internal detail of brick formed oculus in pediment, view to the south

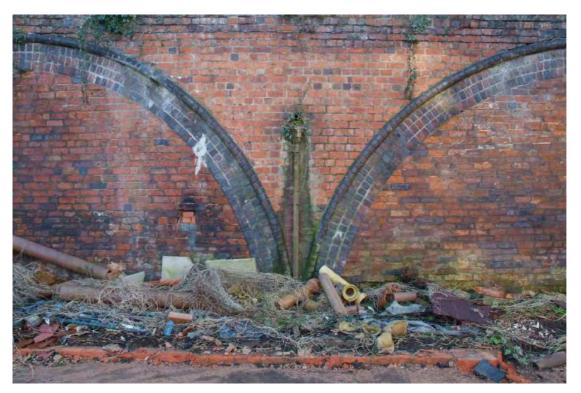
Plate 44.4: Building 44 – original drainage goods, view to the south

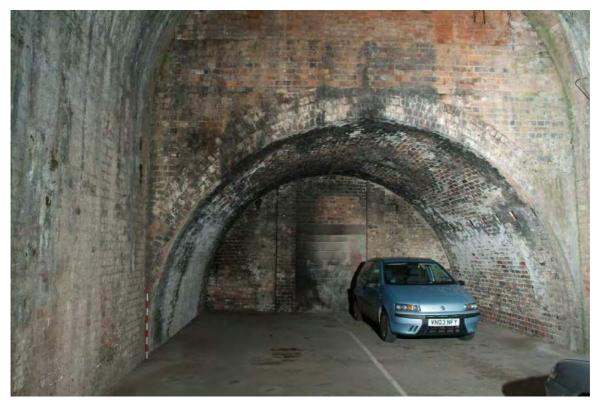
Plate 44.9: Building 44 – detail of arch structure, view to the north

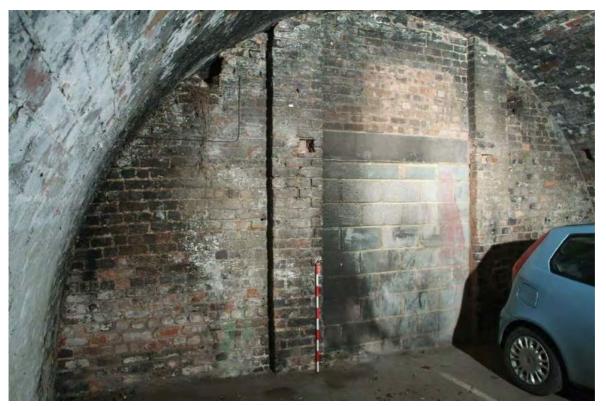
Plate 44.10: Building 44 – detail of blocking wall, view to the northeast

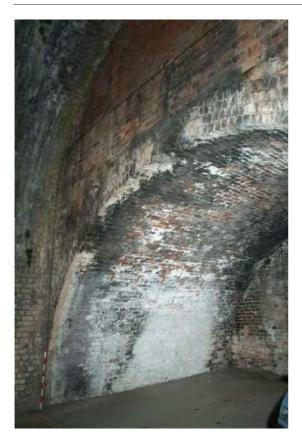
Plate 44.11: Building 44 – detail of joint between Butts Siding (right) and viaduct , view to the northwest

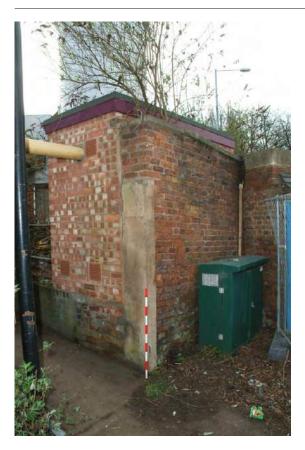
Plate 45.1: Building 45 – southern extremity of pre 1897 boundary wall backed by building 9, view to the southwest

- 5.348 This wall served as the southern boundary of the hospital and survived in a number of short lengths across the centre of the site. At the western end, a surviving three metre length survived, running roughly perpendicular to the Croft Road boundary wall and was abutted on the south side by Building 9, the main water inlet building, and by a telephone exchange box on the north (Plate 45.1). Here the wall stood some three metres tall and was capped by concrete pavers. The eastern end had been rendered to finish the truncated brickwork and the upper part appeared to be rebuilt. In general the brick-work was mixed although for the most part in English bond and did not contain any recognisable features.

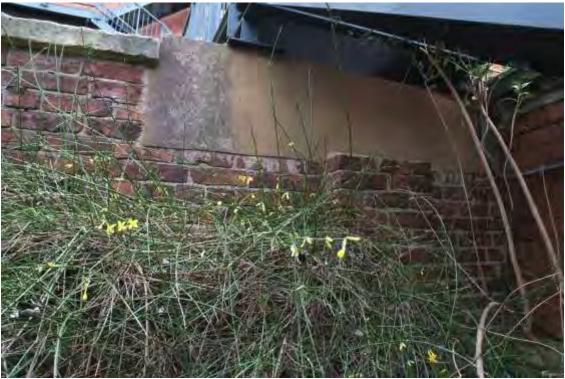
Plate 46.2: Building 46 –southern face to south of Building 36 showing concrete insert for fire escape, view to the northeast

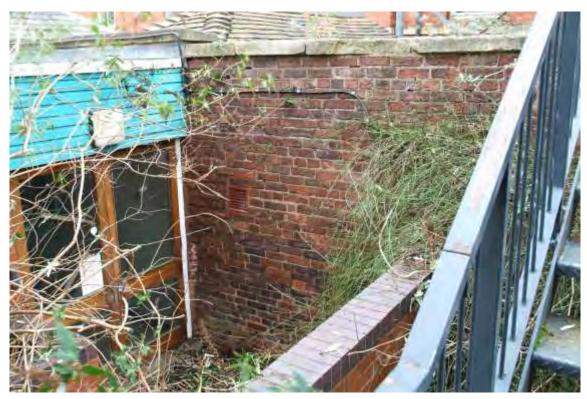
Plate 46.3: Building 46 - southern face to south of Building 35 showing concrete insert for fire escape, view to the northwest

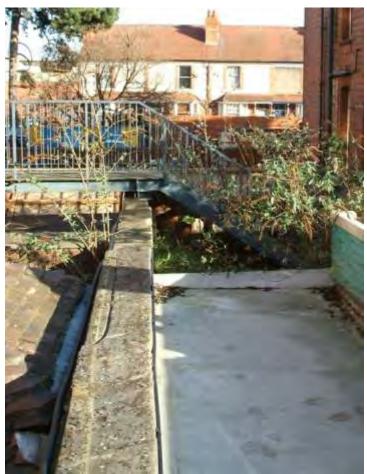
Plate 46.4: Building 46 – capping of wall between Buildings 35 (left) and 49, view to the east

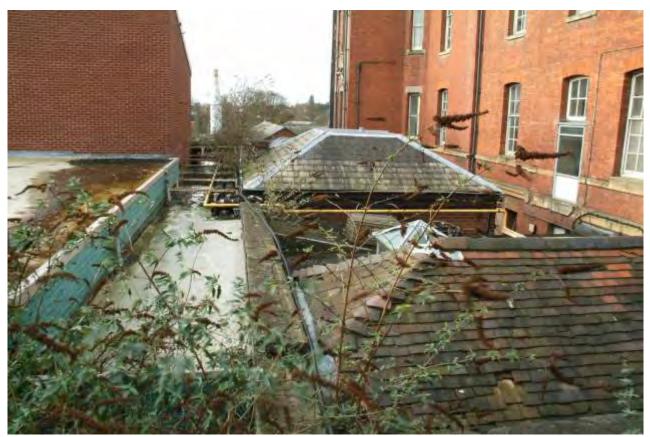
Plate 46.5: Building 46 - capping of wall between Buildings 49 (left) and 35/23, view to the east

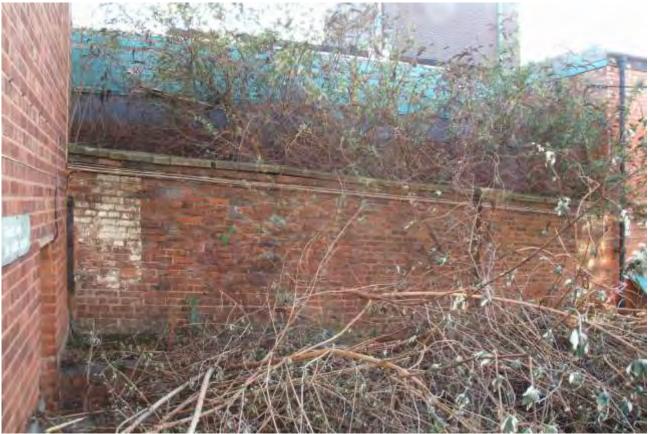
Plate 46.6: Building 46 – north elevation between buildings 13 (left) and 12.

5.350 The only other identifiable length of this wall ran between the west end of the medical secretaries' block (Building 13) and the east end of the boiler house (Building 10 - Plate 46.6). This length featured a pier which projected on both faces and was again capped with stone slabs. No change in the brickwork was observed in this length.

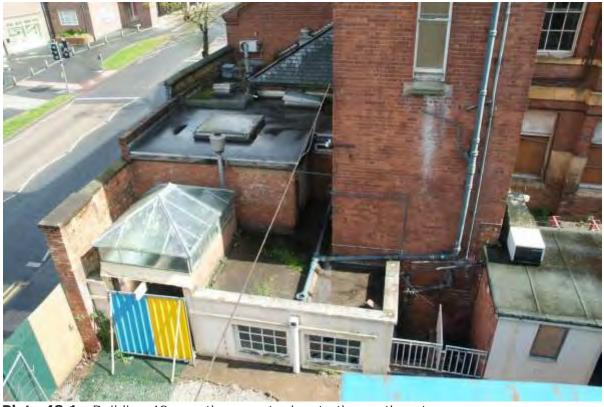
Plate 48.1: Building 48: northern part, view to the northeast

- 5.358 These two buildings lie to the west of the outpatients department but are otherwise unconnected. The group falls into two parts with the northern group forming an above ground extension to the outpatients department and a large below ground boiler house with canopy to the west (Plate 48.1). The southern element (Plate 48.2) comprises a monopitch roofed brick built store with openings on the west. The two are given some unity by a metal railing fitted with gate which runs between the two buildings and gives access to the boiler room stairs. The railing makers mark (Plate 48.3) gives the name J and F Hall Limited of Worcester. The back of the southern element is blind (Plate 48.4) and the interior comprises a single open space containing gas bottle holders (Plate 48.6). The appearance of the building and fabric suggest that it dates to the 1970s.

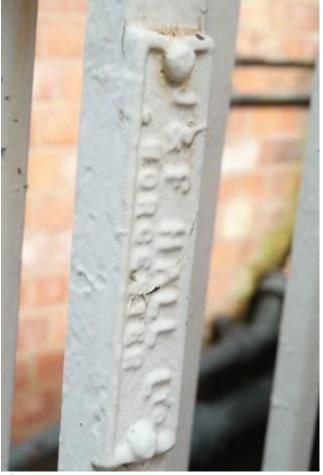
Plate 48.3: Building 48: detail of railings around stairwell to basement

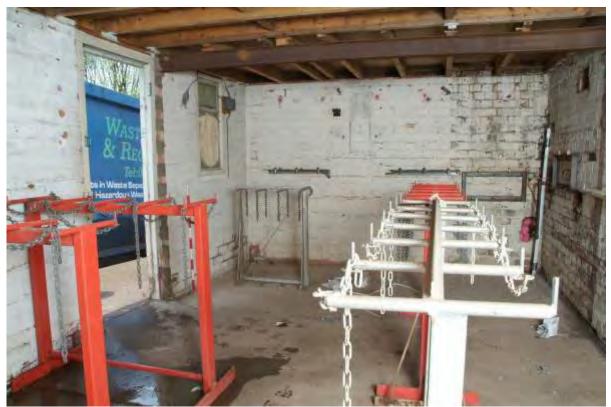
Plate 48.6: Building 48: interior of southern part, view to the north

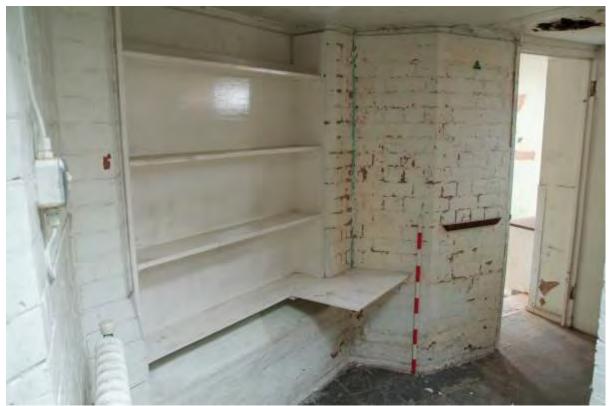
Plate 48.8: Building 48: access to northern part, view to the southwest

room had most recently been used for storage. The area was accessed via the lower ground floor corner tower rooms which had external doors in the connecting range and a separate door in the north side of the tower itself (Plate 48.8).

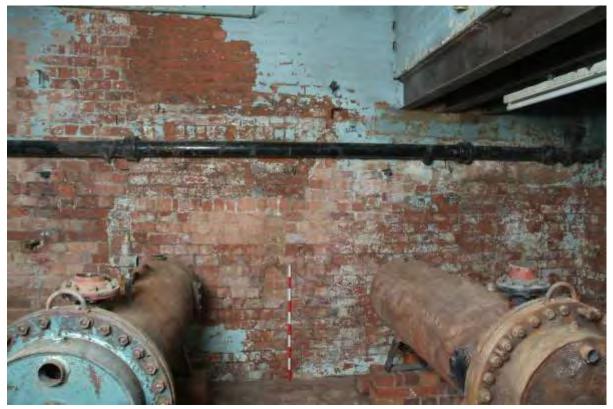
Plate 48.11: Building 48: basement – detail of north wall showing infilled arch

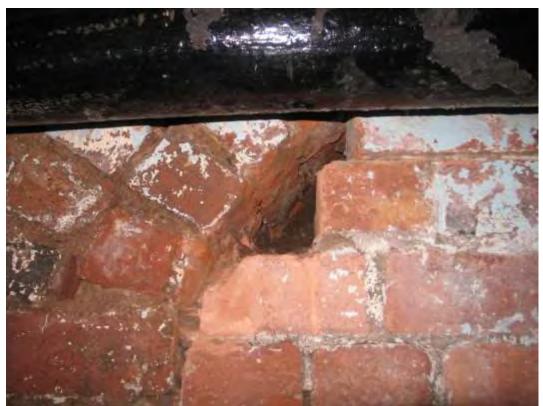
Plate 48.12: Building 48: basement – detail of brickwork following partial removal of blocking, view to the north

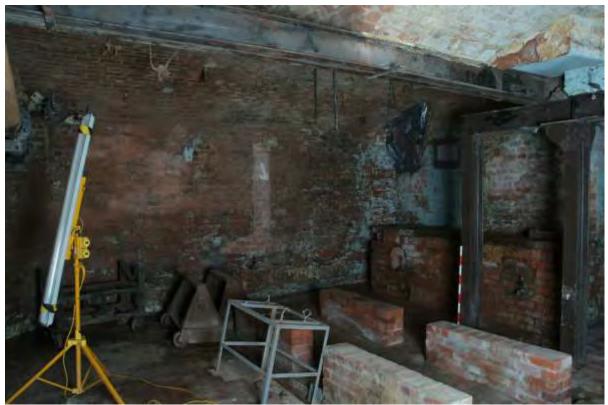
Plate 48.14: Building 48: basement – interior of main eastern part, view to the southeast

- 5.361 To the west of this the roof of the basement is supported on large metal joists and this was thought to represent the west end of Building 40. The space beyond (Plate 48.14) had a barrel vaulted roof of brick and set across the floor were a series of brick plinths set in parallel rows comprising the supports for two boilers. To the west of these and built against the east wall of the corner tower was a long brick structure with two blocked circular holes in the front. This was interpreted as the exhaust manifold for the boilers, serving to channel smoke and waste gases from the exhaust pipes of the boilers to the chimney which runs up the side of the corner tower.

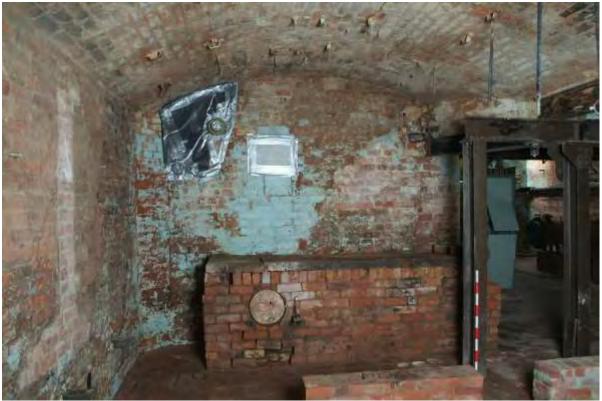
Plate 48.15: Building 48: basement - view of boiler exhaust manifold, view to the west

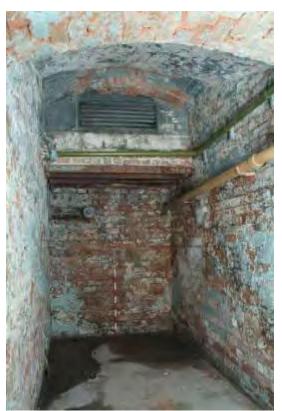
Plate 48.16: Building 48: basement – coal bunker, view to the north
