Worcestershire Archaeology Research Report No.12

Historic Building Non-technical Record Report

THE FORMER WORCESTER ROYAL INFIRMARY, CASTLE STREET, WORCESTER

Part 1: Report, Appendices 1–3, Figures

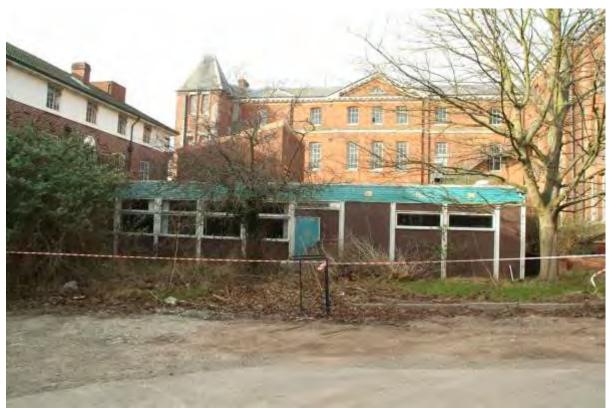
Plate 49.1: Building 49 – general view from the green outside Building 27a, view to the northwest

- 5.365 The staff canteen was situated between Mulberry House and the 1932 Nurses' Home (Building 27a). It comprised a comprised a single storey temporary building with flat roof (Plate 49.1 and 49.2). The building had entrances on the northeast corner and also directly from the Nurses' Home (Building 27a) by means of a covered porch and from the main Infirmary via Building 23. Much of the building was lit by high level transom windows, although to the southwest the walls were effectively half glazed.
- 5.366 The interior was functional (Plate 49.4) with ribbed rough carpet and a suspended polystyrene roof, but an effort had been made to provide interest through the insertion of stud walls fitted with doors and windows to create different dining areas (Plate 49.5).

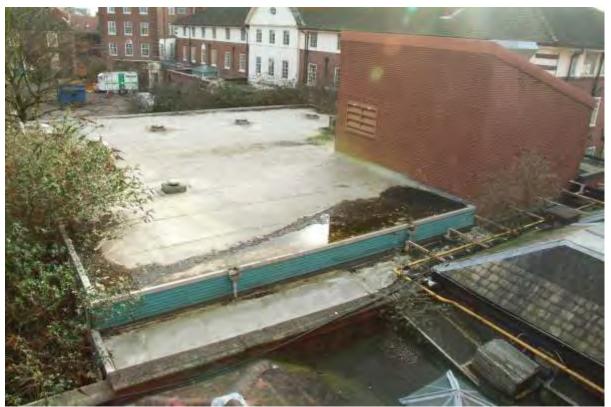
Plate 49.2: Building 49 – roof, view to the southwest

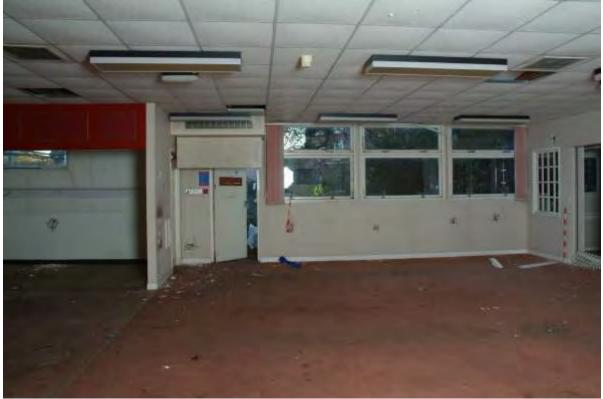
Plate 49.5: Building 49 - interior of southern dining area, view to the southwest
