# Flood Risk Management and the Historic Environment

An analysis of historic environmental practices in  
respect of planning for, and responding to flooding

This document has been created as part of an Historic England funded project undertaken by Worcestershire Archive and Archaeology Service (WAAS) in partnership with Landscape Research & Management.

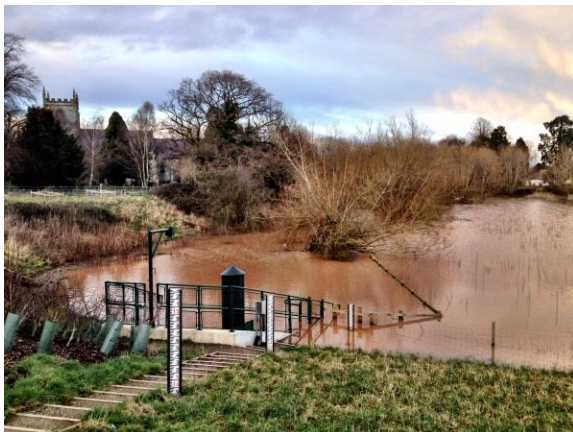
Figure 1: The completed Kempsey Flood Alleviation Scheme in operation in February 2014

The Kempsey Flood Risk Management Scheme comprises a 180m long flood protection embankment and a system designed to pump rising flood waters from the Hatfield Brook into the River Severn. The scheme was substantially completed in September 2012 and, apart from a problem in November 2012 when a pump failed to operate correctly, has successfully reduced flooding of the village including during the very high flood levels along the Severn in January 2014.

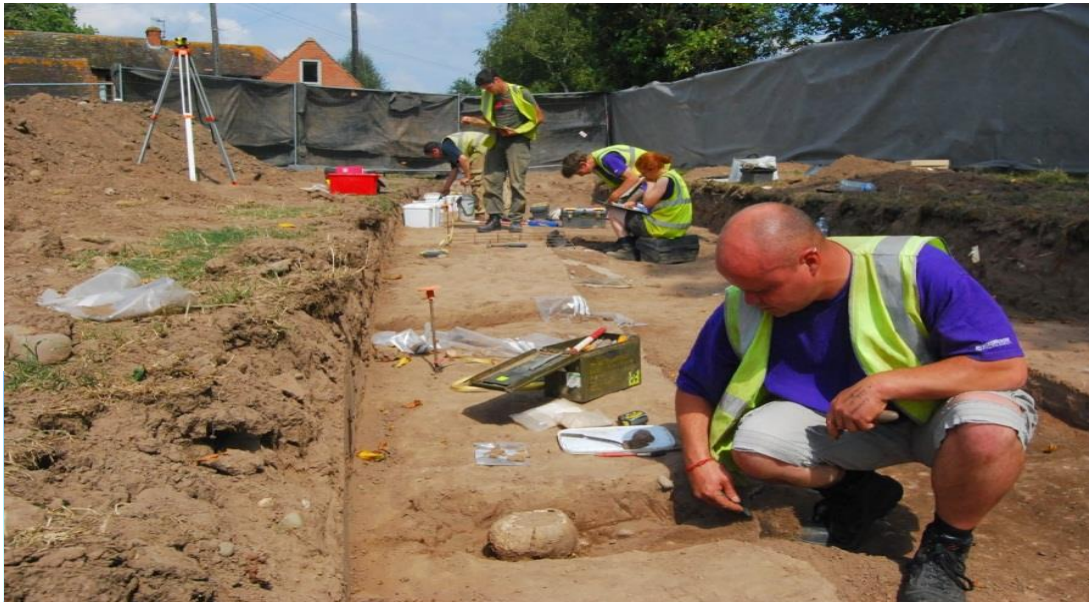
Figure 2: Excavation of the access road through the graveyard at Kempsey

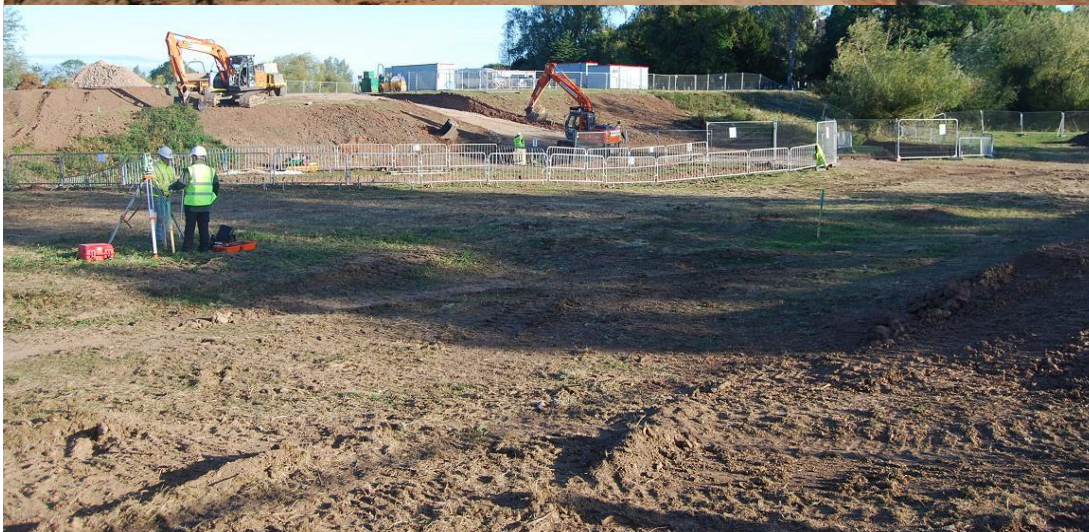
Figure 3: Archaeology watching brief on the access road, Kempsey

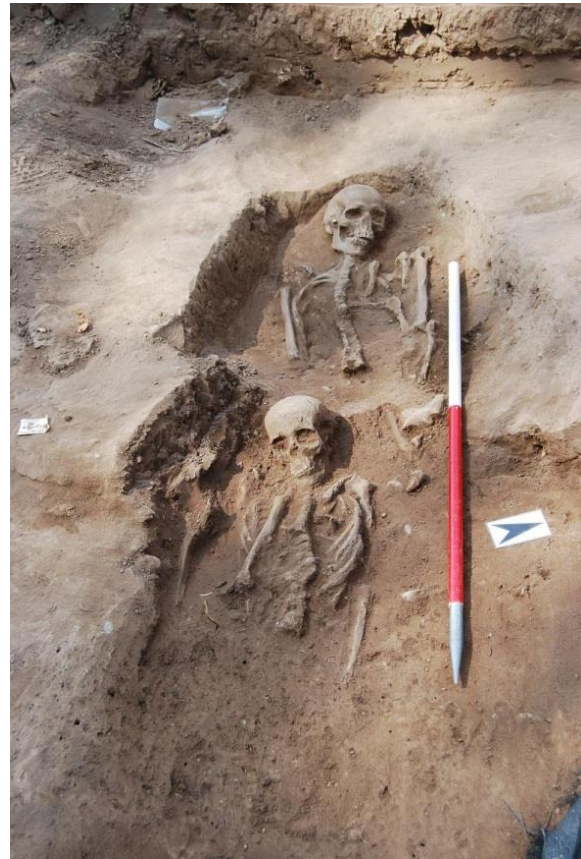
Figure 4: Remains of two members of Kempsey's early medieval population

Assessment of the human remains for condition, completeness, age, sex and pathology has been undertaken and further analysis is planned at the time of writing. Assessment has indicated that the majority of the individuals were adults and, where gender could be determined, males and females were present in almost equal numbers. Detailed analysis will reveal the age and sex of many of the bodies recovered and hopefully will provide information on origins, migration and diet of the local community some 1000 years ago.

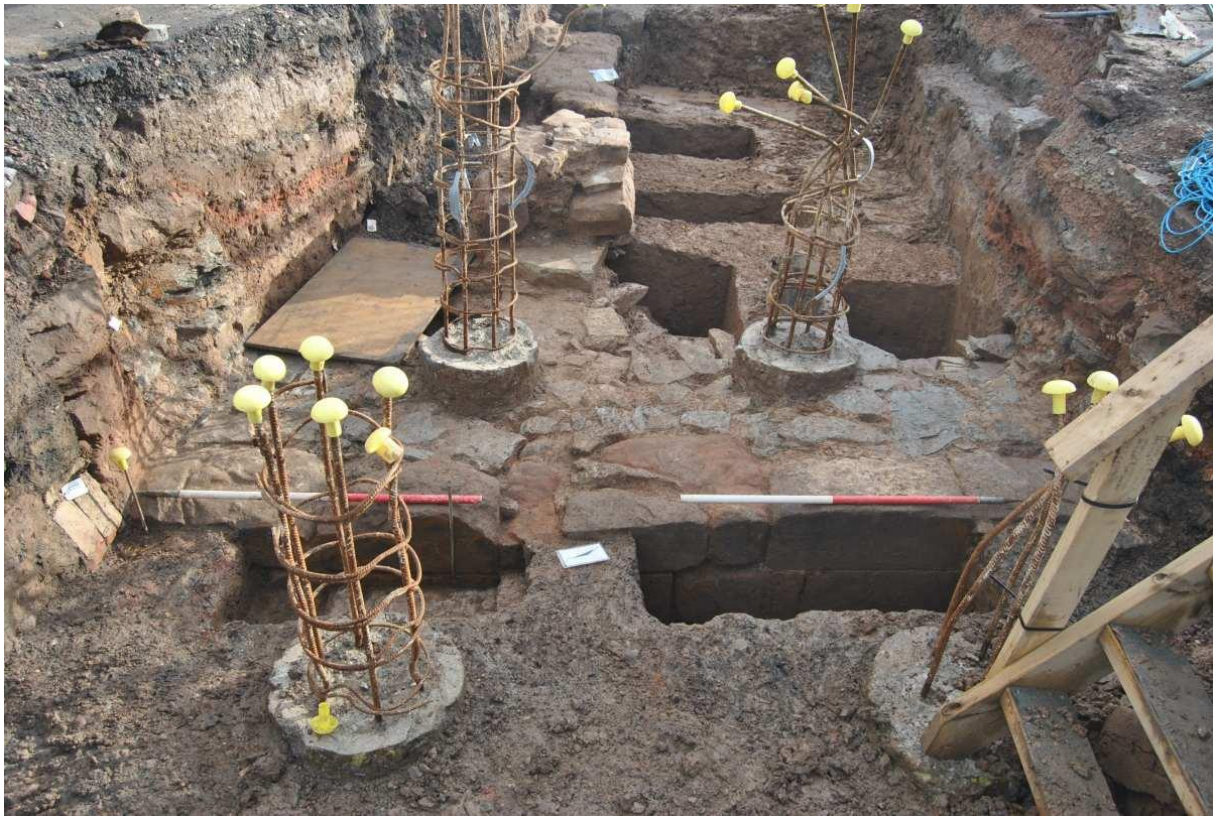
Figure 6: Remains of the early 17<sup>th</sup> century bridge disturbed by modern piles, Upton-upon-Severn

The work provided a wealth of information. In front of the King's Head the remains of the red sandstone bridge, completed in 1609, were recorded, along with the later drawbridge, built in 1854, to replace the, by then, collapsed stone bridge. Remnants of the swing bridge which replaced the drawbridge in 1883 were also identified.

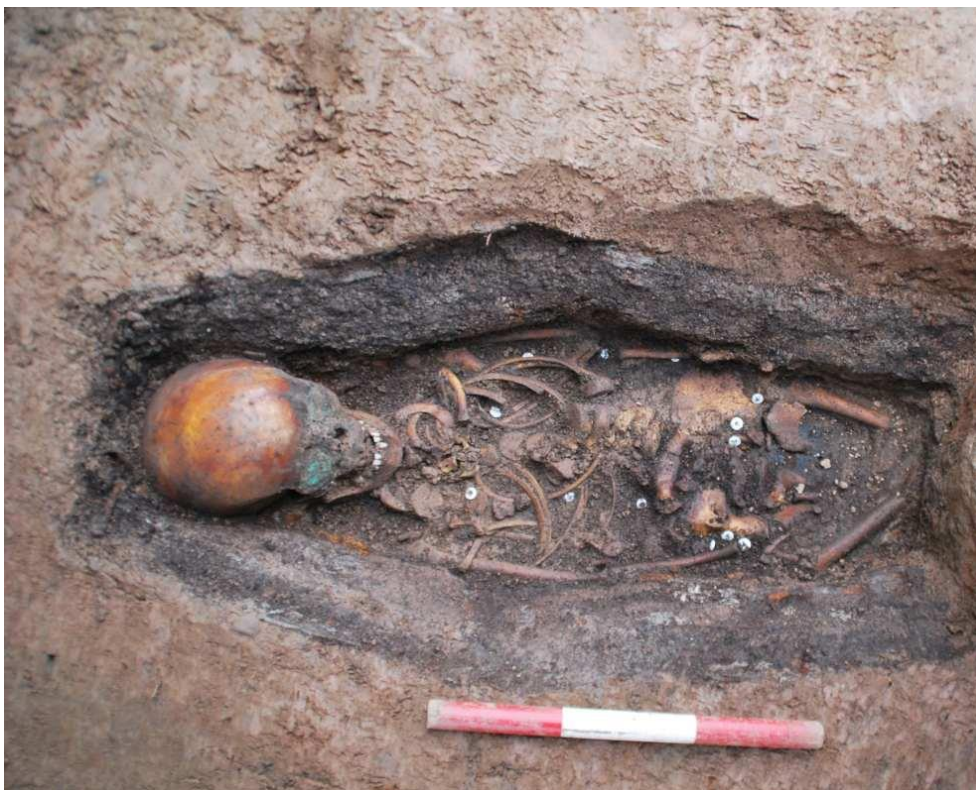
Figure 7: Burial with pennies in eye sockets and porcelain buttons across the torso. Upton-upon-Severn

Evidence of preparation of the body for burial was present. Pennies were noted in the eye orbits of one sub-adult. This is a rare discovery; only one other example of this practice has been identified in the archaeological record for the post-medieval period in Britain. The practice of placing pennies over a deceased person's eyes may stem from the practicality of holding the eyes shut before rigor mortis set in. Myths about needing a coin to pay the ferryman date back to ancient Greece and can be traced into the Medieval period in Britain, but physical evidence of this is rare.

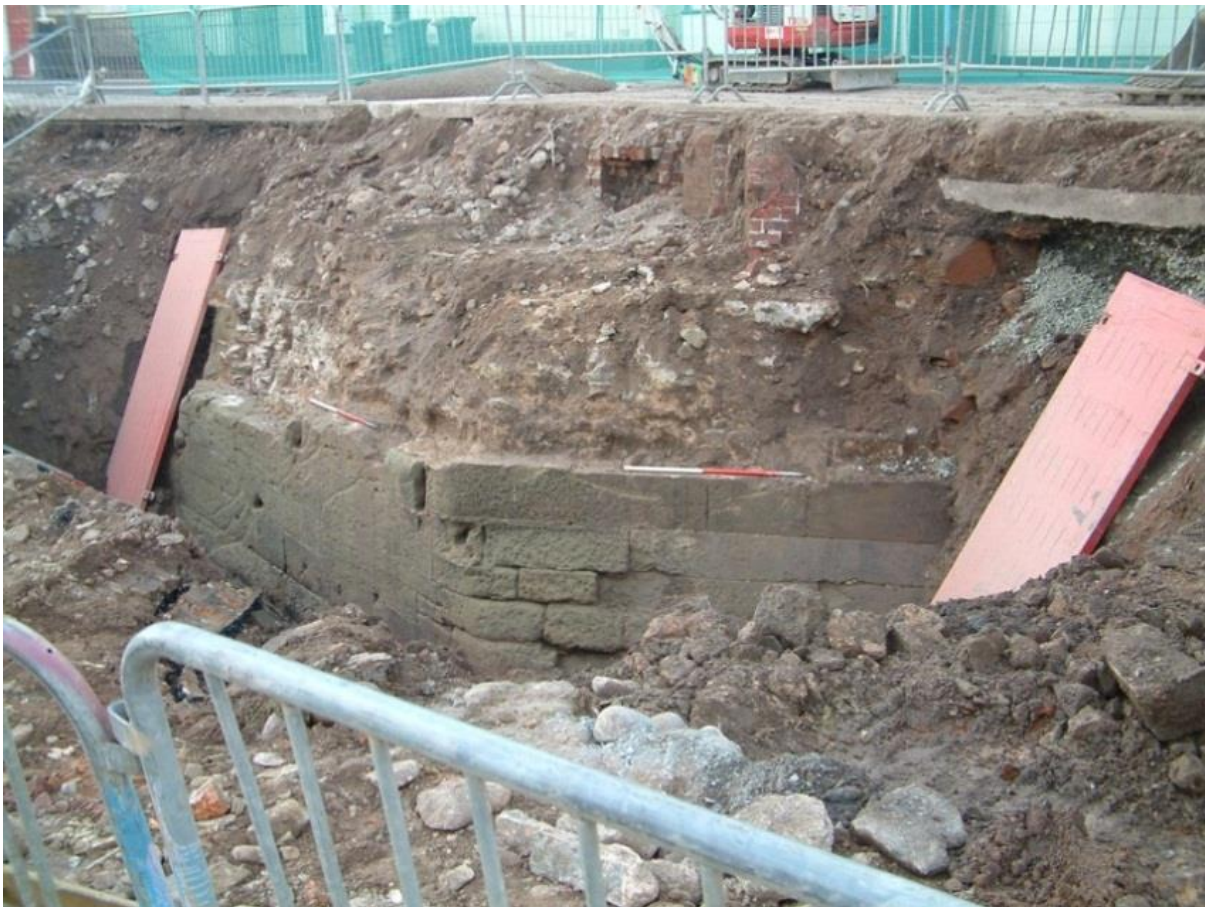
Figure 8: 15<sup>th</sup> century bridge abutment, Bewdley

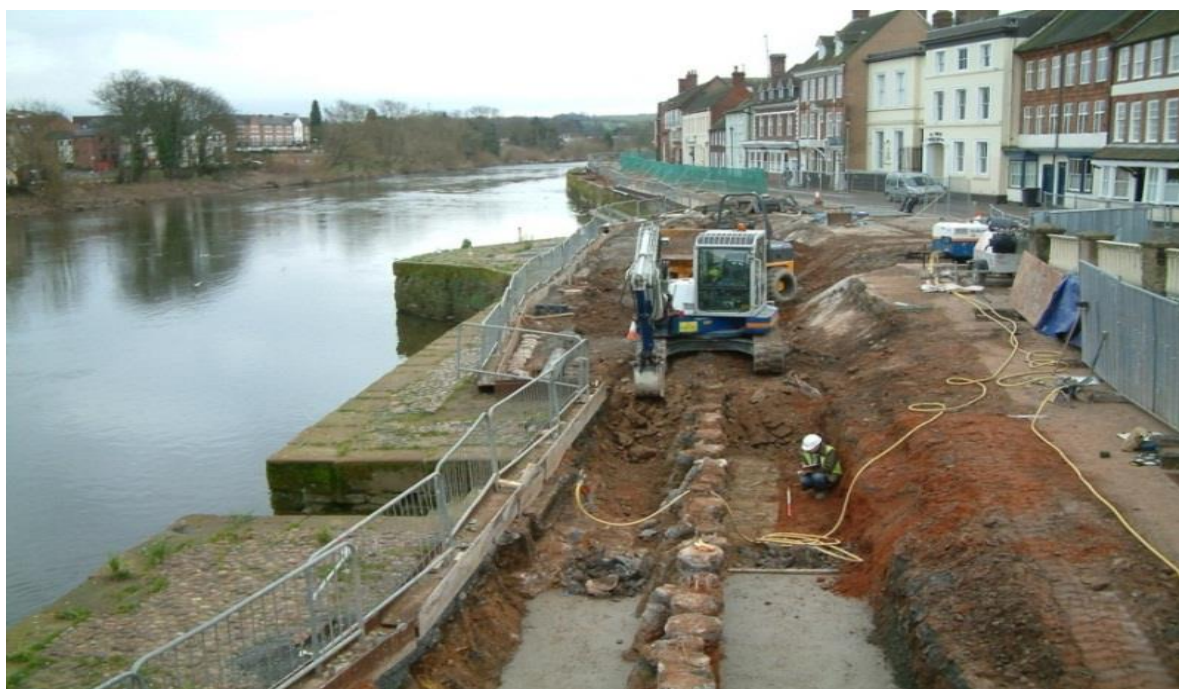
Figure 9: 17<sup>th</sup> to 18<sup>th</sup> century wall revealed near the present bridge at Bewdley

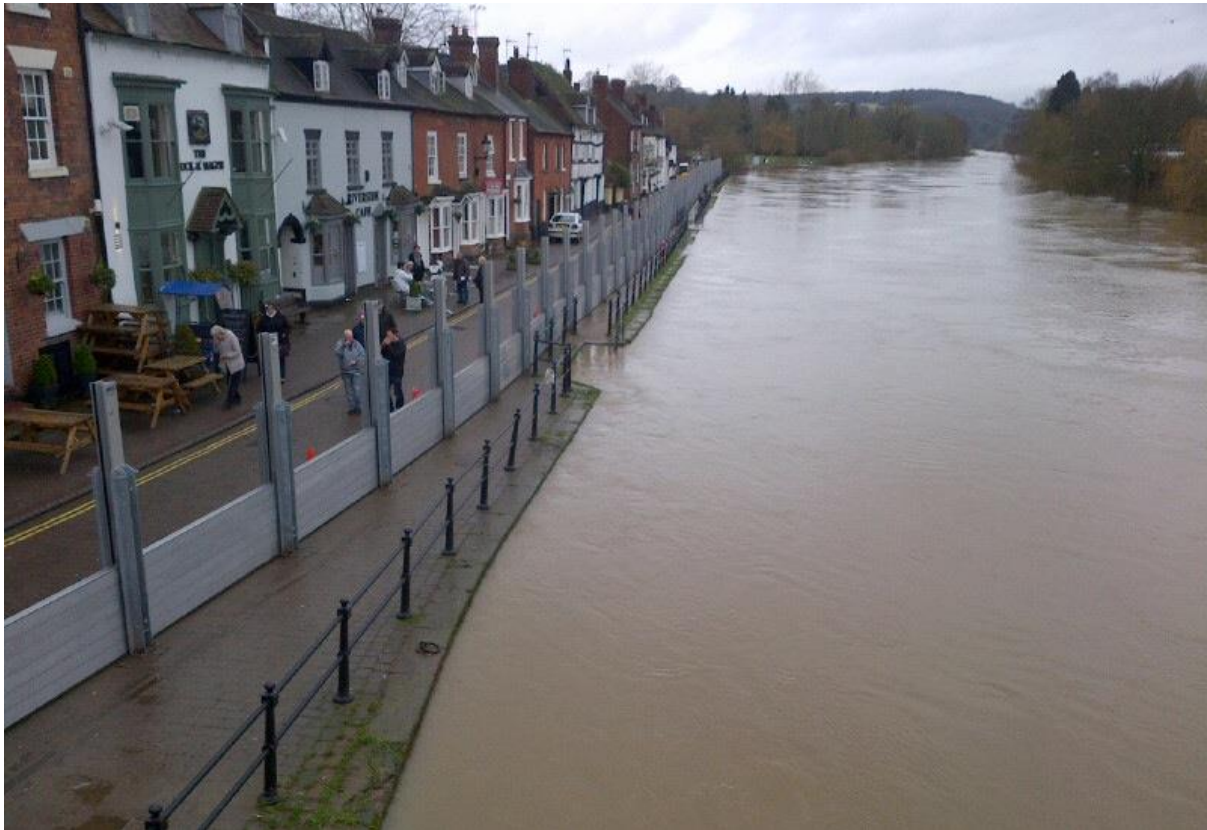
Figure 10: Environment Agency demountable defences in action at Bewdley. © Dave Throup

The scheme that resulted did not visually impact on the historic quayside and river frontage and in addition there was the added bonus of a new open space with handrails, steps, ramps and walkways, which conceal the line of the flood defences, but give easy access to the riverside thus enhancing the amenity value of the area.
